**AIRCRAFT ACCIDENT REPORT 3/94**

**Air Accidents Investigation Branch**

**Report on the incident to  
Boeing 737-2Y5A, 9H-ABA  
at London Gatwick Airport  
on 20 October 1993**

**Aircraft Accident Report No: 3/94**

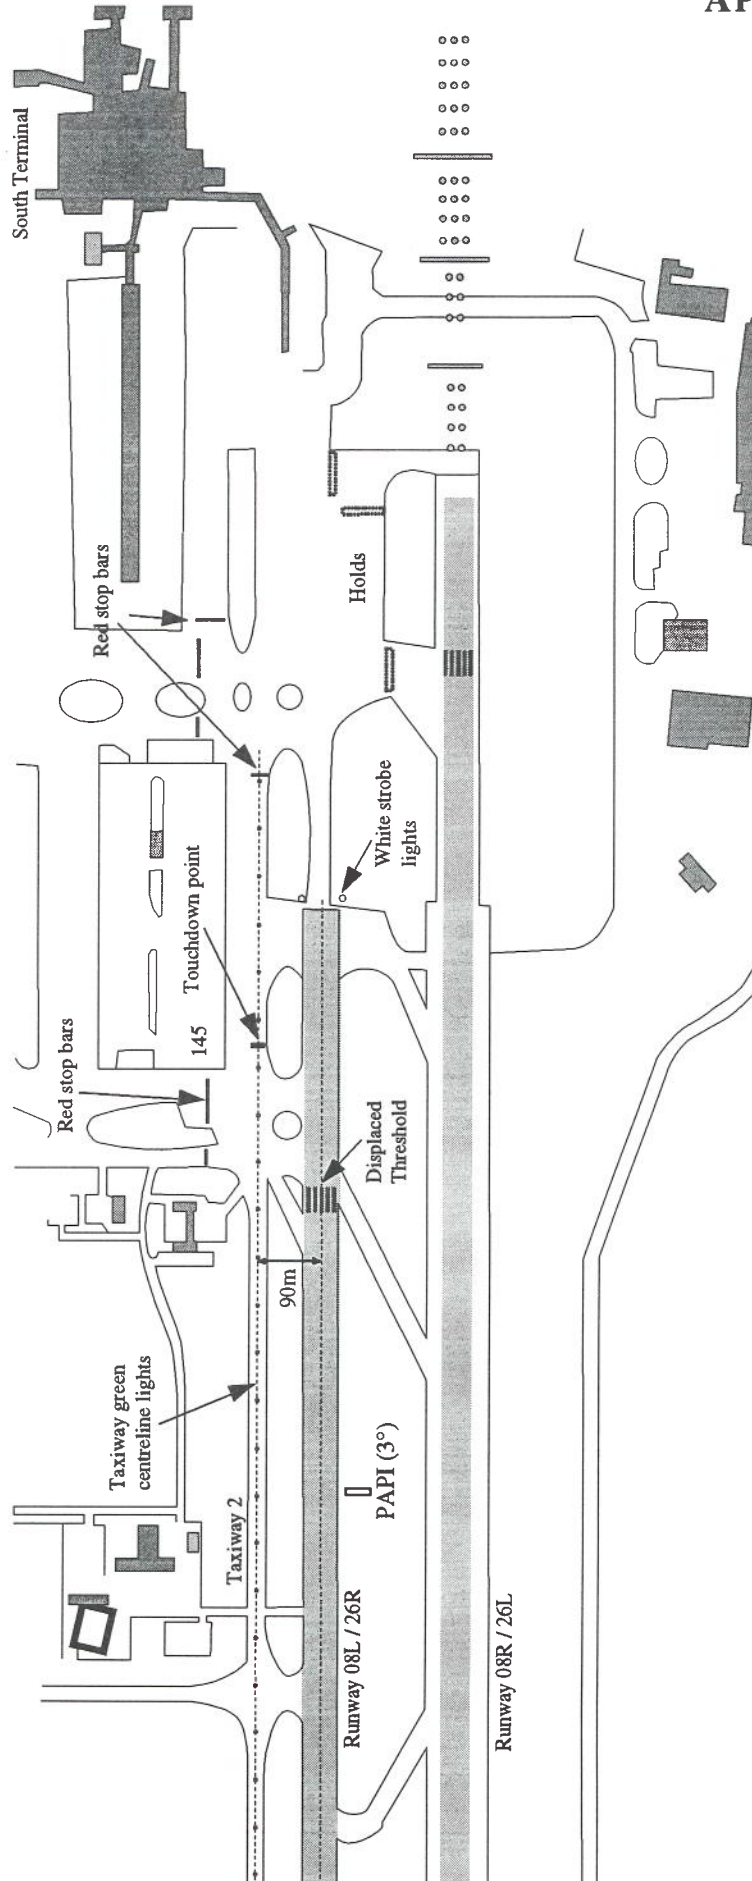
## APPENDIX A

Taxiway 2 measures 2,875 metres from the Lima holding point at its western end, to the junction with Taxiway 6 at the eastern end. This taxiway is parallel to and displaced 90 metres to the north of Runway 26R/08L and is 300 metres longer. A plan of the eastern end of the airport is shown at Appendix A.

Runway 26R is provided by a single straight line of bi-directional green centreline lighting. Taxiway 2 is similarly lit with a single straight line of bi-directional centreline green lights. A red stop bar is sited across the complete width of Taxiway 2 immediately opposite Stand 142 (see Appendix A).
