AIRCRAFT ACCIDENT INVESTIGATION REPORT

**ETHIOPIAN AIRLINES B767 (ET-AIZ) AIRCRAFT ACCIDENT
IN THE FEDERAL ISLAMIC REPUBLIC OF THE COMOROS,
IN THE INDIAN OCEAN ON NOVEMBER 23,1996**

**ETHIOPIAN CIVIL AVIATION AUTHORITY
FLIGHT SAFETY DEPARTMENT
P.O.Box 978
ADDIS ABABA - ETHIOPIA**

**ETHIOPIAN AIRLINES B767-260ER, ET-AIZ AIRCRAFT ACCIDENT IN THE
FEDERAL ISLAMIC REPUBLIC OF THE COMOROS, IN THE INDIAN OCEAN
ON NOVEMBER 23, 1996. REPORT NO. AI-3/96 RELEASED
BY CIVIL AVIATION AUTHORITY, ETHIOPIA**

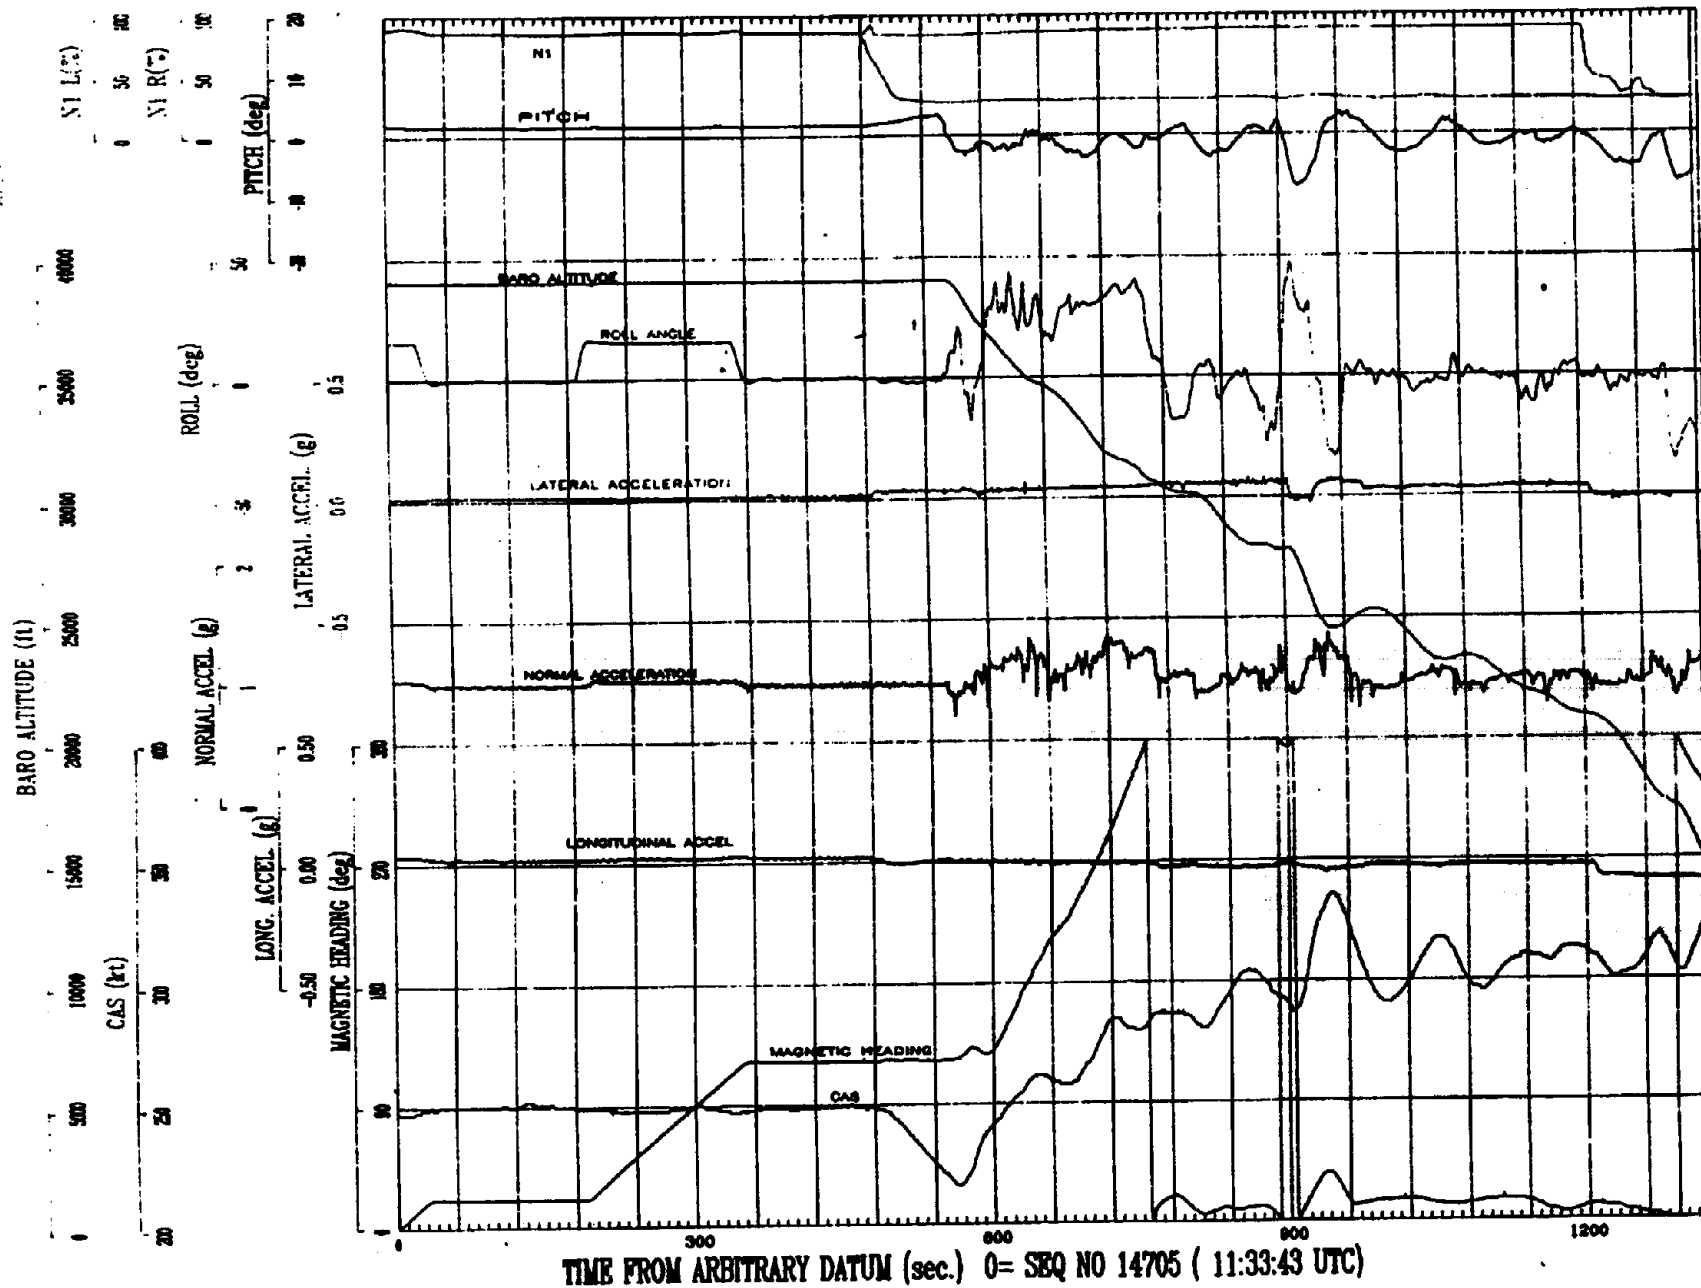
ACCIDENT TO BOEING 767, ET-AIZ - SELECTED DFDR PARAMETERS

At 11:07:43 a race track-like pattern to the left was begun. The APU was started at 11:15:19. The right aft fuel pump indicated low pressure at 11:39:15, followed by a similar indication of the right forward fuel pump at 11:41:39. Some 4 seconds later at 11:41:43 the right engine ran down to windmilling speed. The aircraft gradually increased pitch to maintain altitude as the speed decayed to 216 kt, at which point the aircraft started to descend and increase speed. The autopilot was inadvertently disconnected by the hijacker at this time. Some 11.5 minutes after the right engine failed, the left aft fuel pump indicated low pressure followed 8 seconds later

During the descent, after the first engine failed, the flight was erratic with air speed varying between 216 kt and 336 kt. The altimeter reading did not show a steady descent, but indicated a temporary increase in altitude.

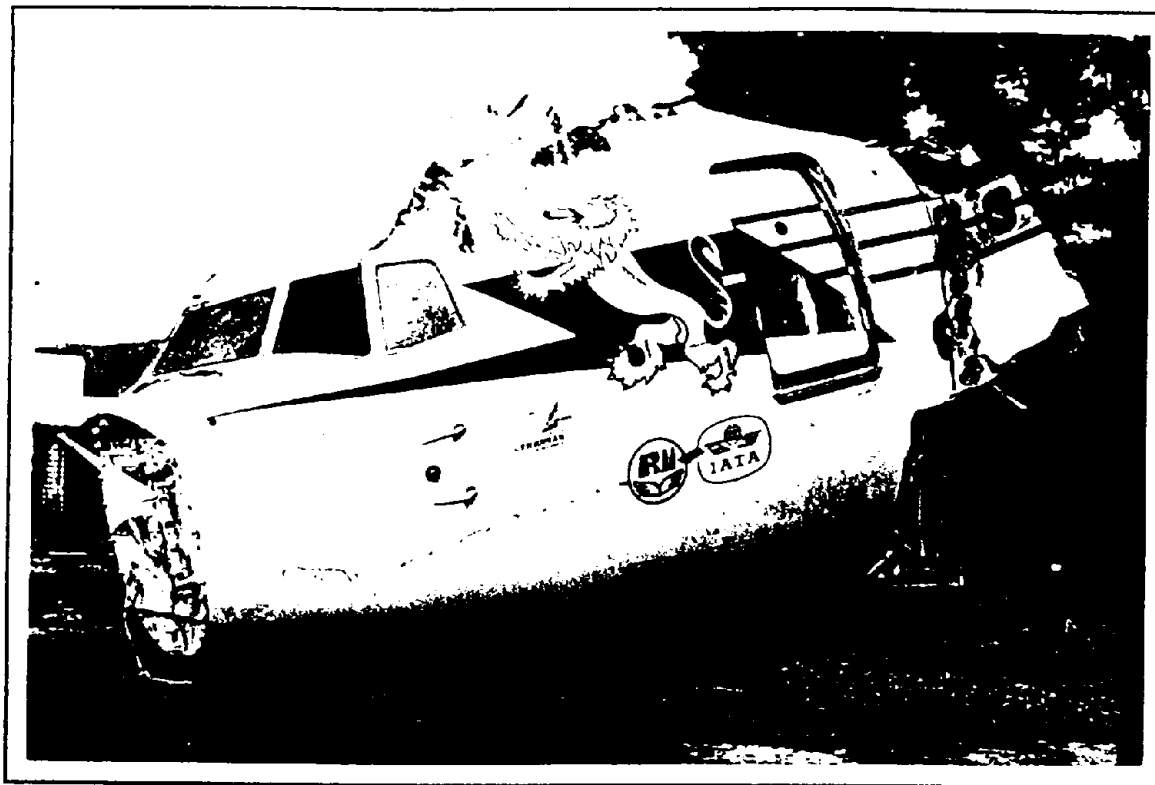
Figure 1. Left side of cockpit.

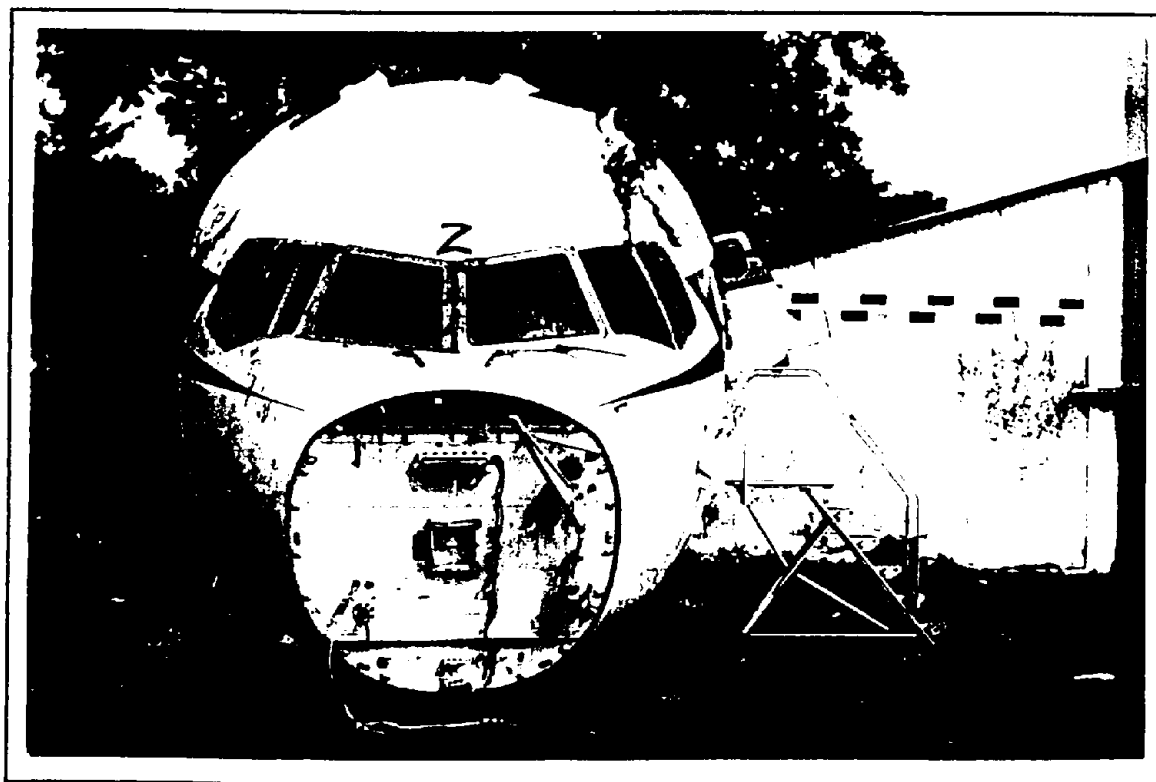
Figure 2. Front side of cockpit.

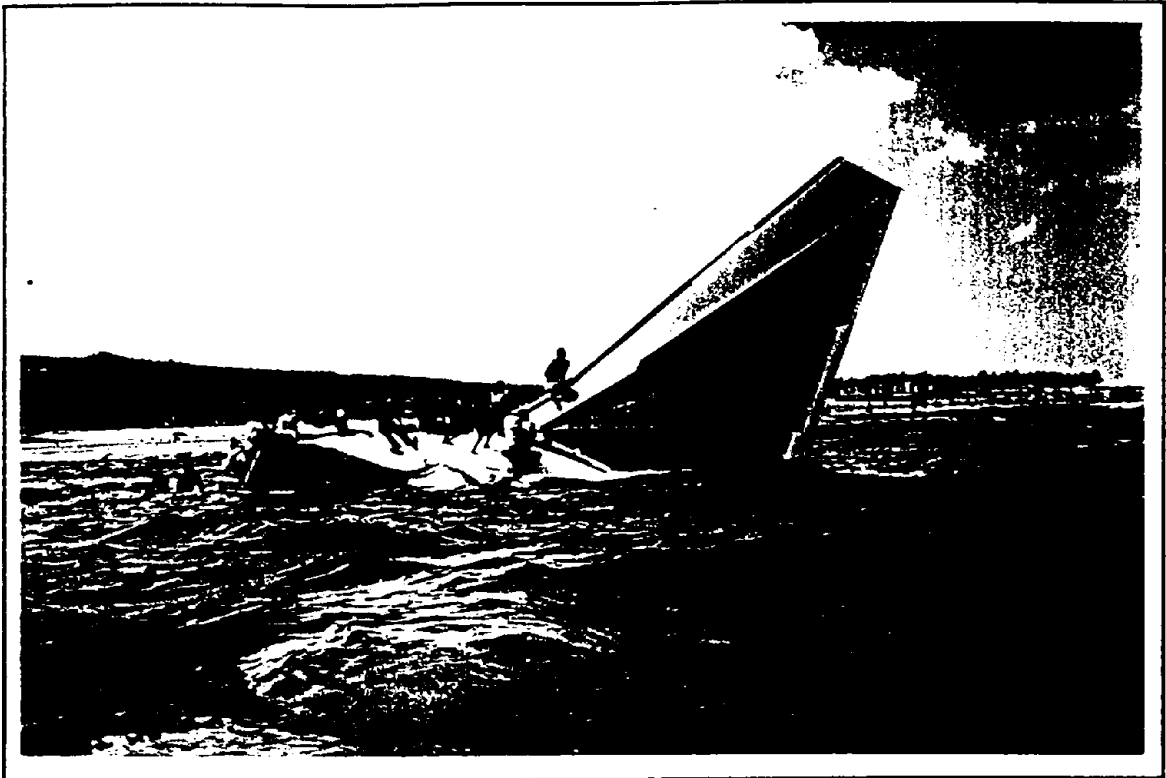
Figure 5. Tail section.

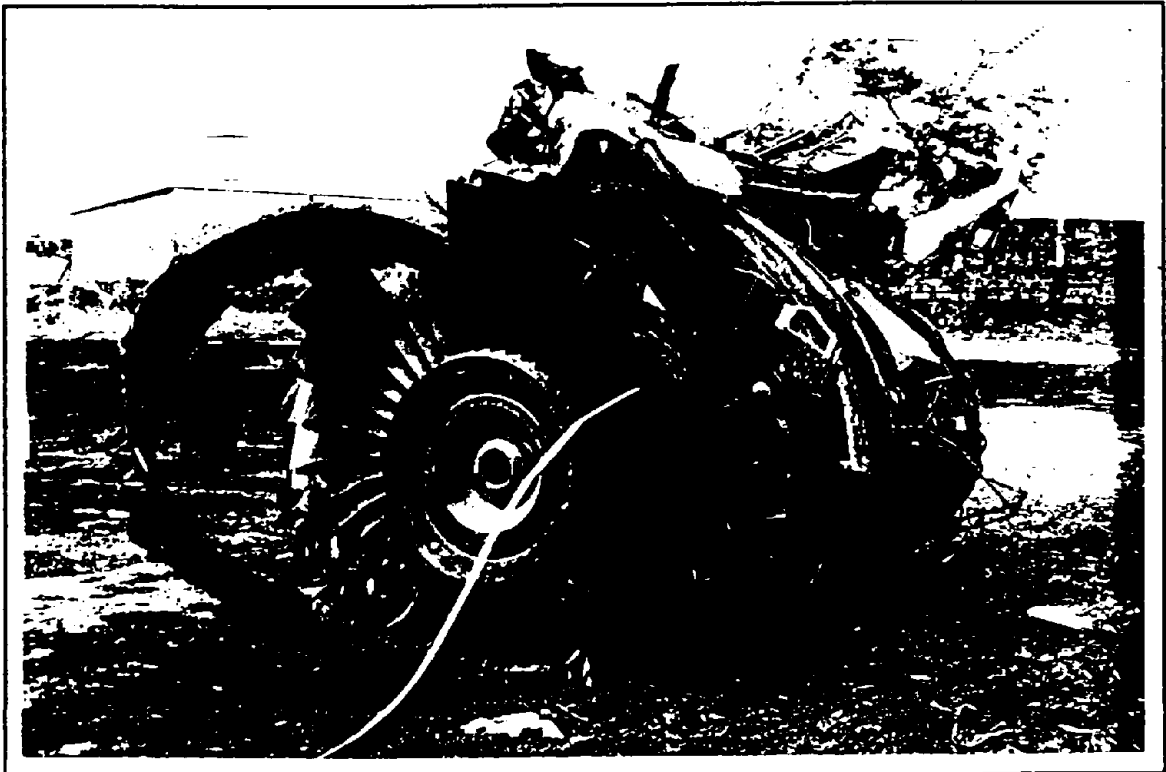
Figure 6. Left engine.

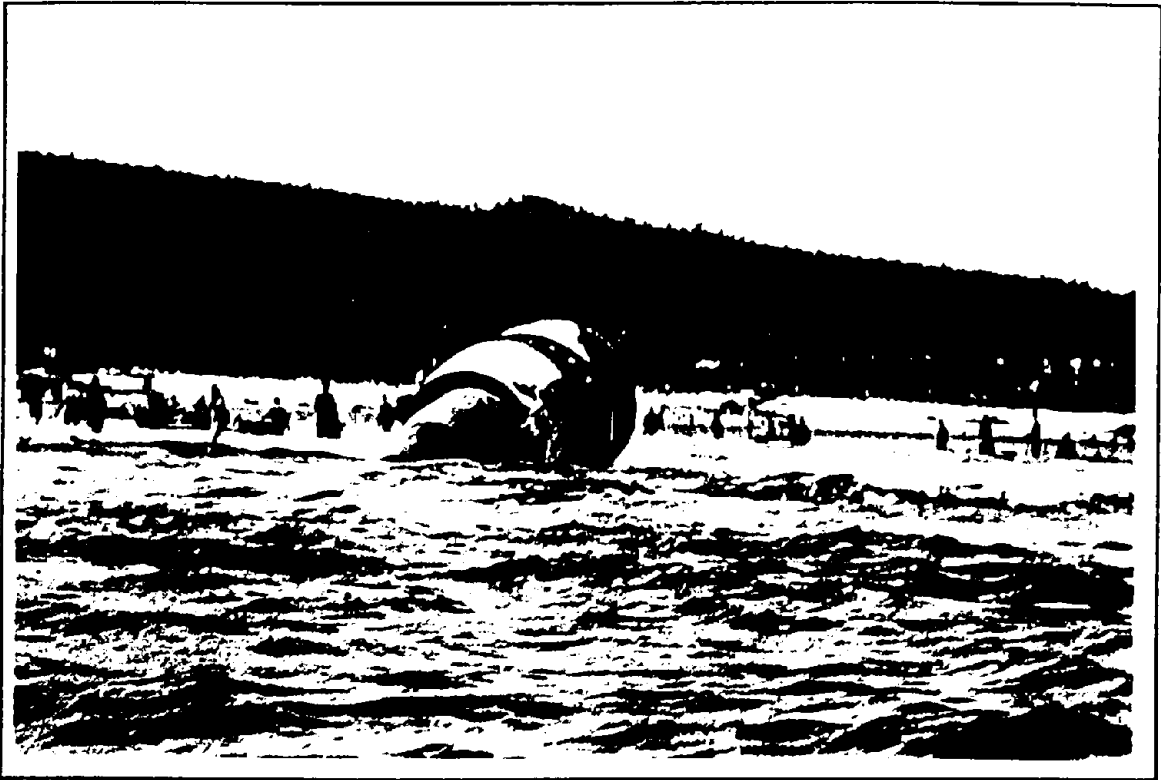
Figure 7. Right engine.

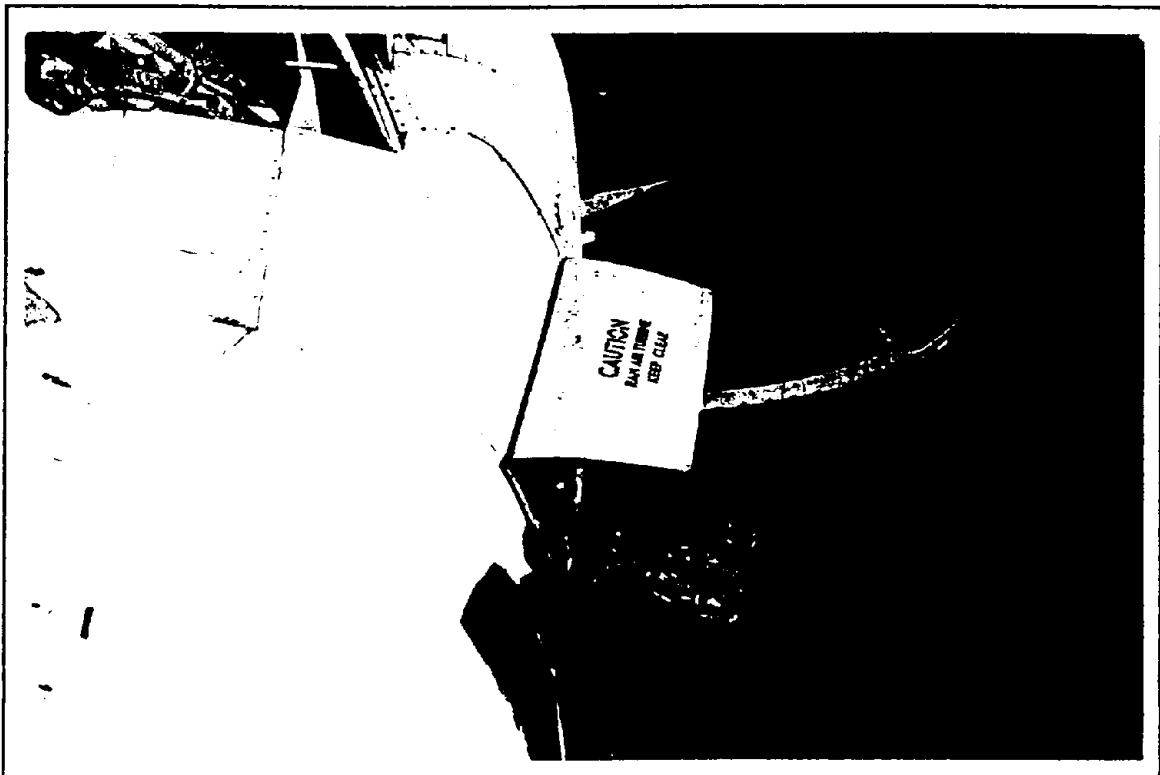
the wing, were found in an area of 400 meters in radius, at the edge of the reef. The right engine was later recovered from the sea. The part of the aircraft from station No. STA 360 up to 615 was not recovered. At the time of the impact, the landing gears were in a retracted position with the doors closed. The RAM Air Turbine was deployed. The wing flaps were up.

Figure 8. Ram Air Turbine deployed.
