FINAL
KNKT.12.03.04.04

Aircraft Serious Incident Investigation Report

SilkAir PTE LTD

A319-133; 9V-SBH

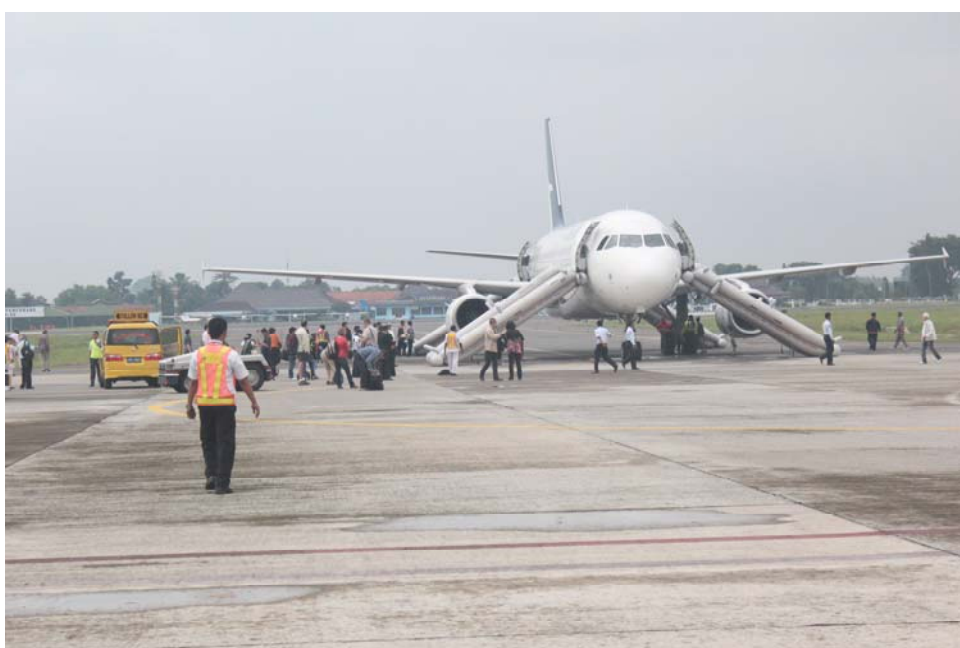
At 0204:04 UTC, the SLK pilot declared emergency and evacuated the passenger by the escape slides. One of the passengers had a minor injury during the evacuation.

Figure 1: 9V-SBH evacuation between the taxiway bravo and apron

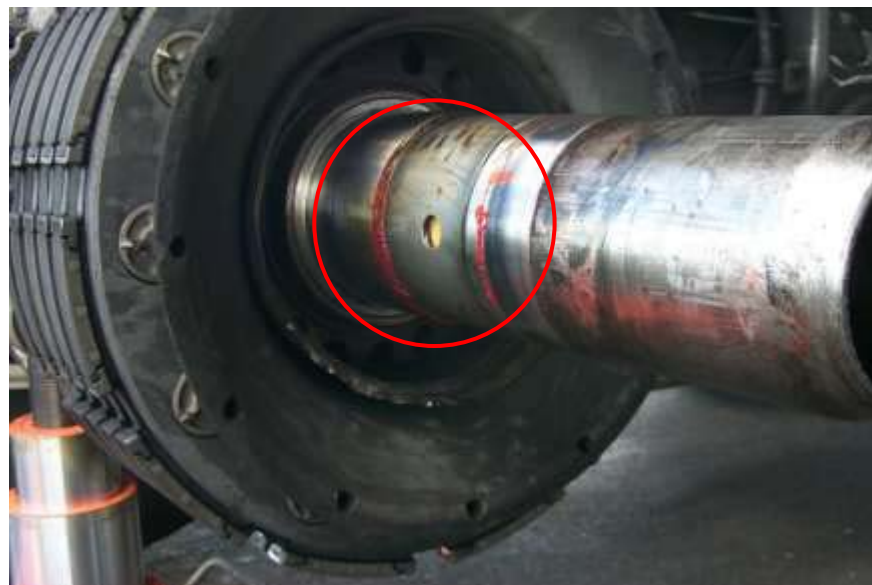
The brake unit number 2 (inner left main landing gear) was replaced prior the aircraft departed to Solo. During the installation of the wheel after brake replacement there was possibility of excess grease. On gear-up position, the grease could migrate to the heat sink. The grease is pushed by inner bearing up to torque tube bushing.

During the brake application on landing the temperature of the heat sink increased and heated the excessive grease and created smoke.

Figure 4: Hole that may allow excess grease to migrate to hot brake area
