FINAL REPORT

SERIOUS INCIDENT
To B737-800, Registration EI-DAV,
On approach to Rome Ciampino and Fiumicino Airports
September 7th 2005

AGENZIA NAZIONALE
PER LA SICUREZZA DEL VOLO

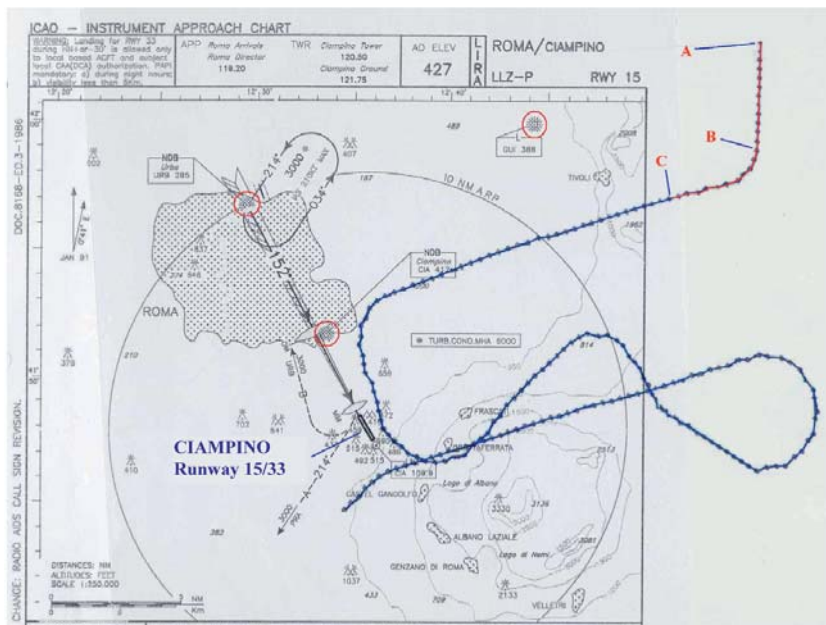
Figure 1: The path of the aircraft approaching CIA, positions A, B and C.

Initially the crew accepted to proceed towards Guidonia, but soon after, they asked again to proceed directly to the Outer Marker because of adverse weather conditions over Guidonia (ref. position “A” in figure 1).

At 12.03.47 Rome ACC air traffic controller, realizing that RYR 9672 was not proceeding towards the Outer Marker as instructed, asked for how many more miles they needed to maintain the present heading. The crew answered with the following not very clear communication («We intercept ... to the Outer Marker and we need further descent RYR 9672»), requesting clearance for further descent (ref. position “B” in figure 1).

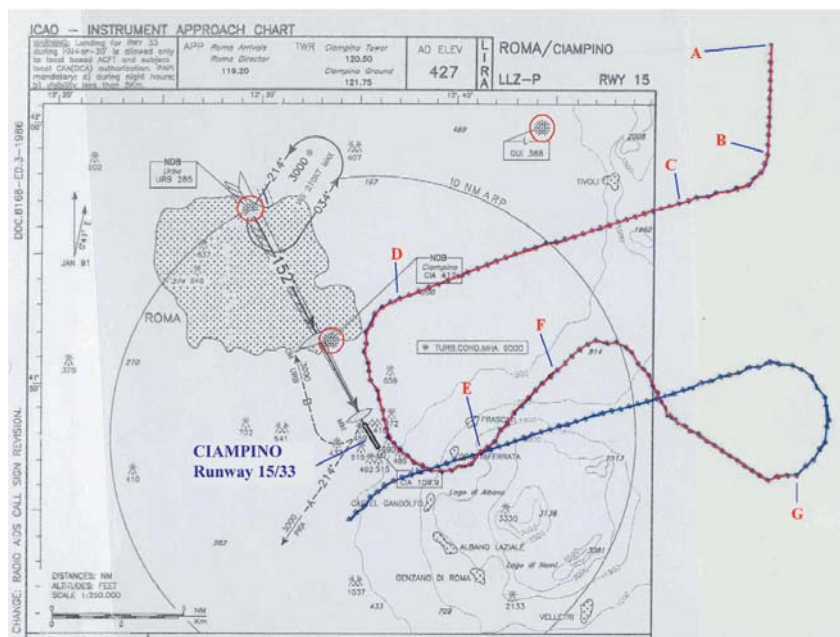
Figure 2: the path of the aircraft on approach to CIA, positions D, E, F and G.

At 12.07.11, RYR 9672 turned left onto an heading of approximately 170° (ref. position “D” in figure 2).

Rome ACC air traffic controller asked if they could continue the left turn until heading 290°, but RYR 9672 replied that it had to maintain a heading of 050° to avoid the storm. At 12.10.13, RYR 9672 requested to turn to the right to avoid large cloud formations on its left, and received clearance to assume heading 150° (ref. position “F” in figure 2).

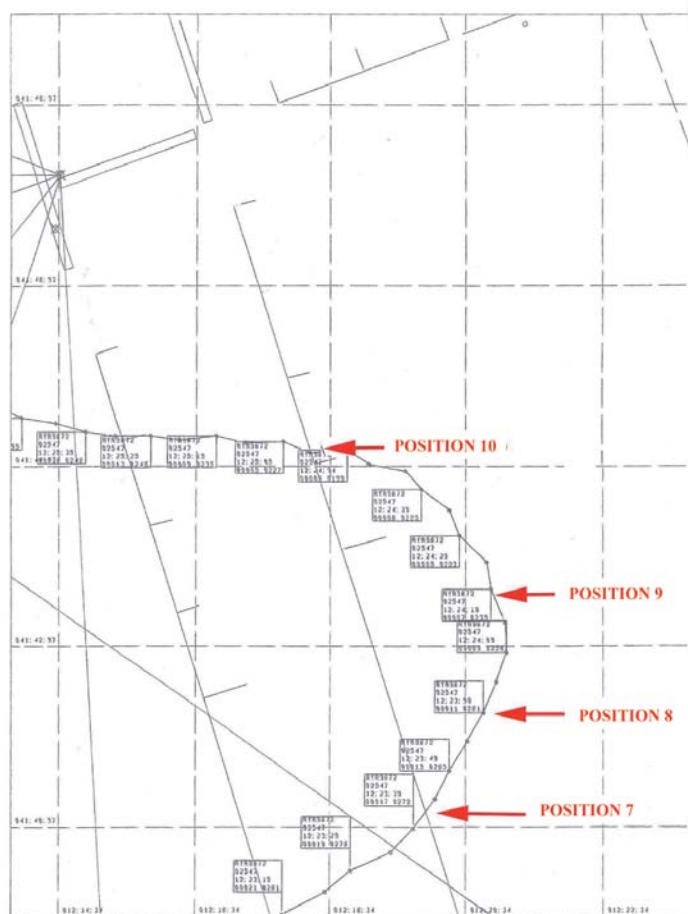
Figure 5: Radar tracking with indication of the positions referred to.

At 12.23.43, RYR 9672 crossed Runway 34R centreline extension at an altitude of approximately 1650 ft, on heading 030° and a speed of approximately 270 knots, about 3 nautical miles behind ISG 332, who was proceeding on the ILS of the same runway 34R with a slower speed (ref. position n. 7 in figure 5).

34R. At that moment the aircraft was on a heading of 022° turning left, with a speed of 265 knots and at an altitude of approximately 1300 ft (ref. position n. 8 in figure 5). The air traffic controller did not inform RYR 9672 that the altitude, indicated on the Instrument Approach Chart, for that position was 2200 ft, while the aircraft was flying at 1300 ft, 900 ft too low. The captain declared that at about this altitude the aircraft encountered a strong downdraft (*microburst*). RYR 9672 replied: «Stand-by 9672».
