NATIONAL TRANSPORTATION SAFETY COMMITTEE

AIRCRAFT ACCIDENT REPORT

PT. Garuda Indonesia GA421

B737-300 PK-GWA

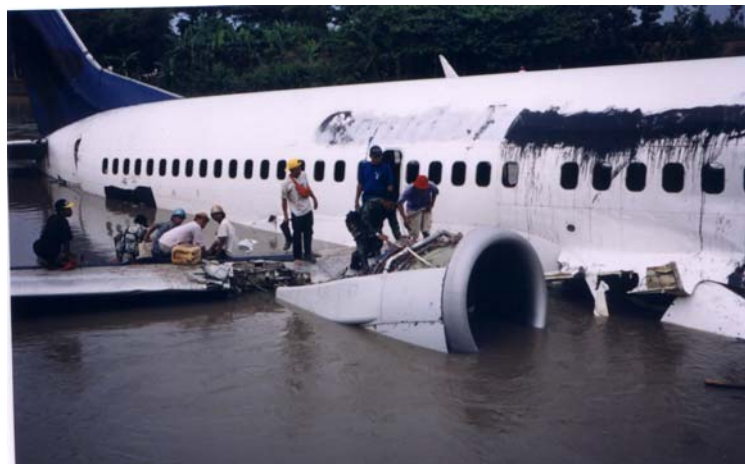
The aircraft was damaged beyond repair and is considered a total loss.

Figure 1 Damage to the aircraft

The aircraft impacted on the river with nose up position as indicated by the damage of the rear lower part of the fuselage (including the detachment of rear toilets and galleys) and damage on the engine pylon. The aircraft came to a stop with its nose pointing to the West (to the right of the landing path

The airframe suffered heavy damage at the bottom aft of the right hand cargo door. The airframe also was heavily damaged between the cockpit section bulkhead and the front wing spar bulkhead. The aircraft main frame structure showed skin buckling aft just in front of the vertical stabilizer. The nose landing gear and right hand main landing gear was found detached from their attachments, approximately 50 meters from the aircraft final rest.

The left hand aft lavatory and lower part of the aft galley were ripped apart from the aircraft and a large hole was found in the floor at the aft cabin section.

The damage of the aft fuselage section was due to impact on landing and its detached parts and components were found downstream. This suggested that the aircraft was on a pitch-up attitude during landing.

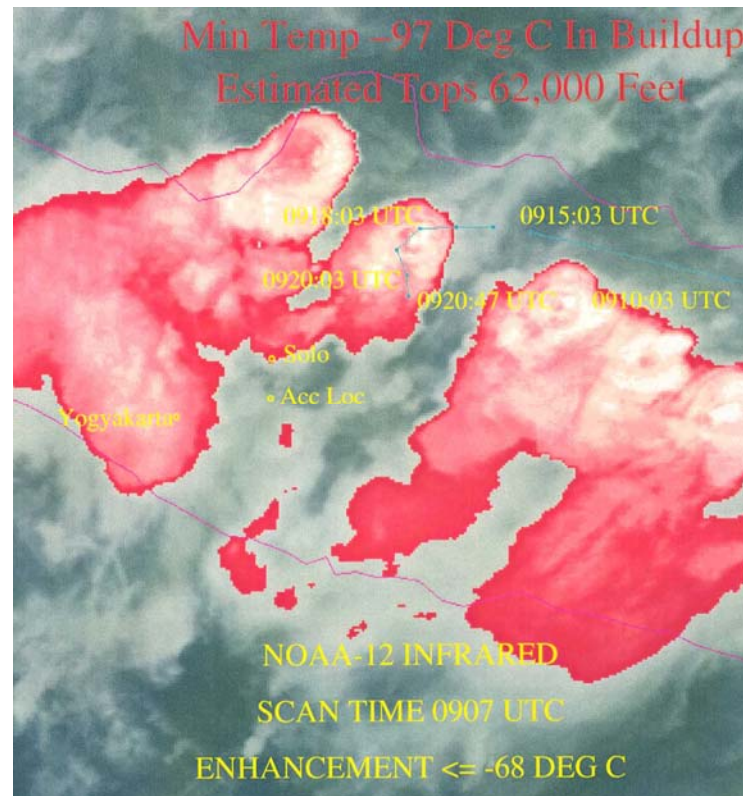
Figure 2 NOAA cloud coverage

The NOAA satellite cloud picture (at 09.07 UTC) shows the active super cell of the Cumulonimbus (Cb) Cloud along the track. January is the peak season over most of the Java Island, in which high frequency activity of the convective cloud is a common weather condition.

On 16 January 2002, the satellite observed an active super cell over the area as indicated by NOAA Cloud Coverage in Figure 2. As the cell of Cb. was active over land during afternoon hours, the mature stage of Cb. cloud would disturb the aircraft. As forecasted over the Solo/Adi Sumarmo Airport between 09.00 – 12.00 UTC would be temporary rain showers and thunderstorm. However, no weather information was made available about adverse weather condition along the airplane track (SIGMET).

The NOAA weather satellite image 14 minutes prior to the accident indicated that there was a super cell of Cumulonimbus clouds (see Figure 2), that may have topped out as high as 63,000 ft. The NTSB meteorology experts believe that such cells would feed-up each other and that it is possible for most probable adverse weather condition.

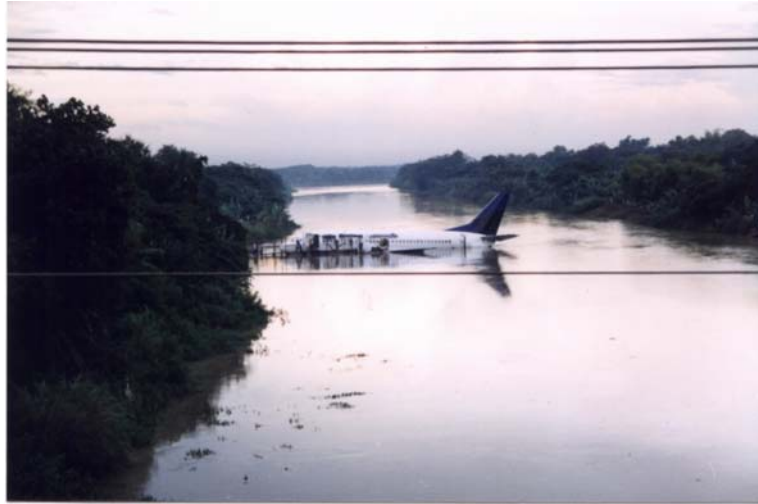
The APU and battery was found underwater about 4 weeks after the accident downstream approximately 300 meters from the aircraft, and the CVR was found approximately 200 meters from the aircraft. Test performed on the electrical components are discussed on the section 1.16.4. The APU inlet door was found closed (see picture).

Figure 3 Wreckage location

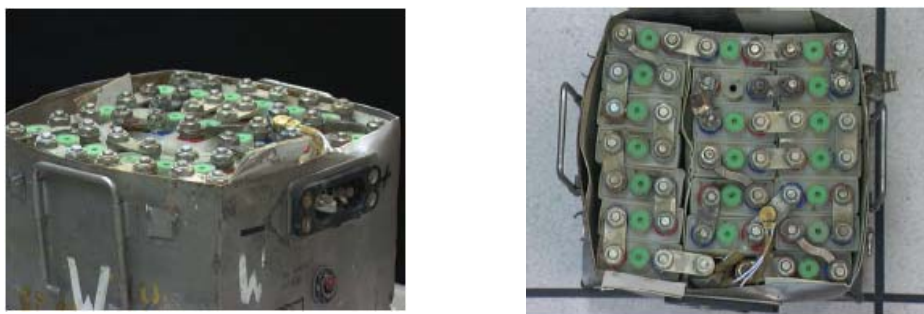
Figure 6 Damage to the battery

Battery examination found that the battery casing was damaged due to impact (see Figure 6), which caused mechanical damage on cells no 1 & 2. The examination also found that the thermostat sensor mounting (at the linkage between cells no 11 to 12) was found severely corroded and the sensor was missing. The metallurgical analysis showed that the corrosion was not caused by being submerged in river water, and therefore has

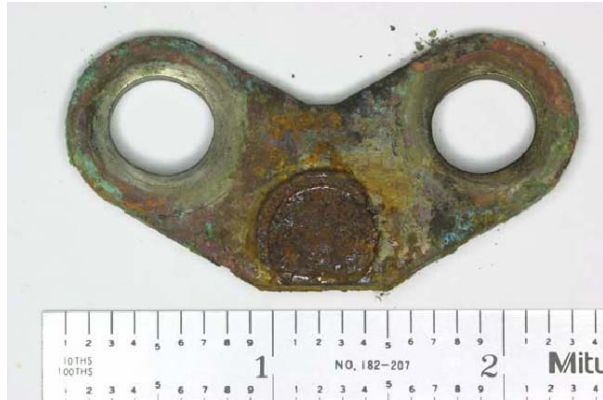
happened before the accident and the detachment of the sensor was not caused by mechanical force (see Figure 7).

Figure 7 Linkage between cells no 11 and 12 (high temp sensor mounting)

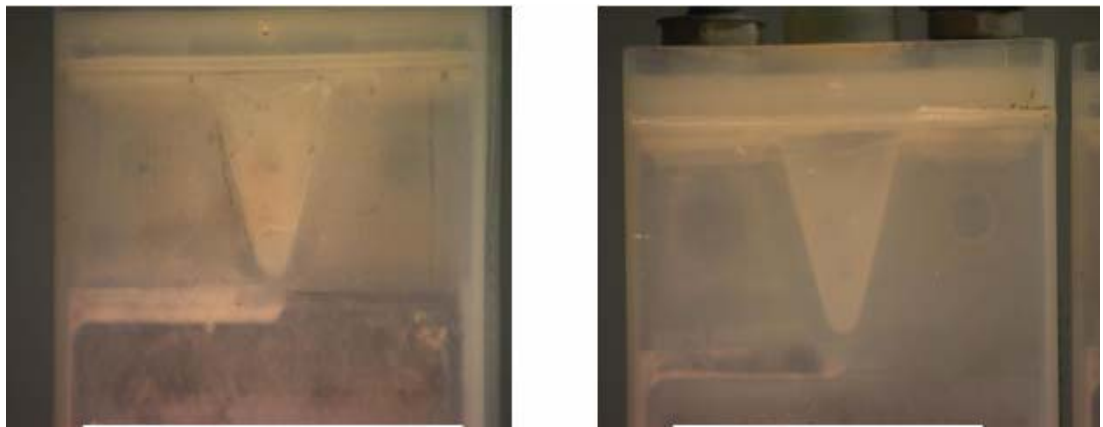
Figure 8 Cell no 12 (left) showed no electrolyte as compared to the cell no 13 (right)

The highlight of the examination result was the cell no. 12, which was found to have very little electrolyte left although the KOH (Potassium Hydroxide) concentration level was calculated to be normal after the cell was re-conditioned. It meant that the electrolyte was spewing through the vent valve on the top of the cell (convective movement of KOH and water out of the cell), and not due to evaporation or electrolyze processes. It is to be noted that cell no. 12 is the newest cell in the battery, as it was installed in 1999, while the rest of the cells were installed in 1996. The position of the cell was in the hottest location of the battery, which is why the high temperature sensor is located in the linkage between cells 12 and 11.

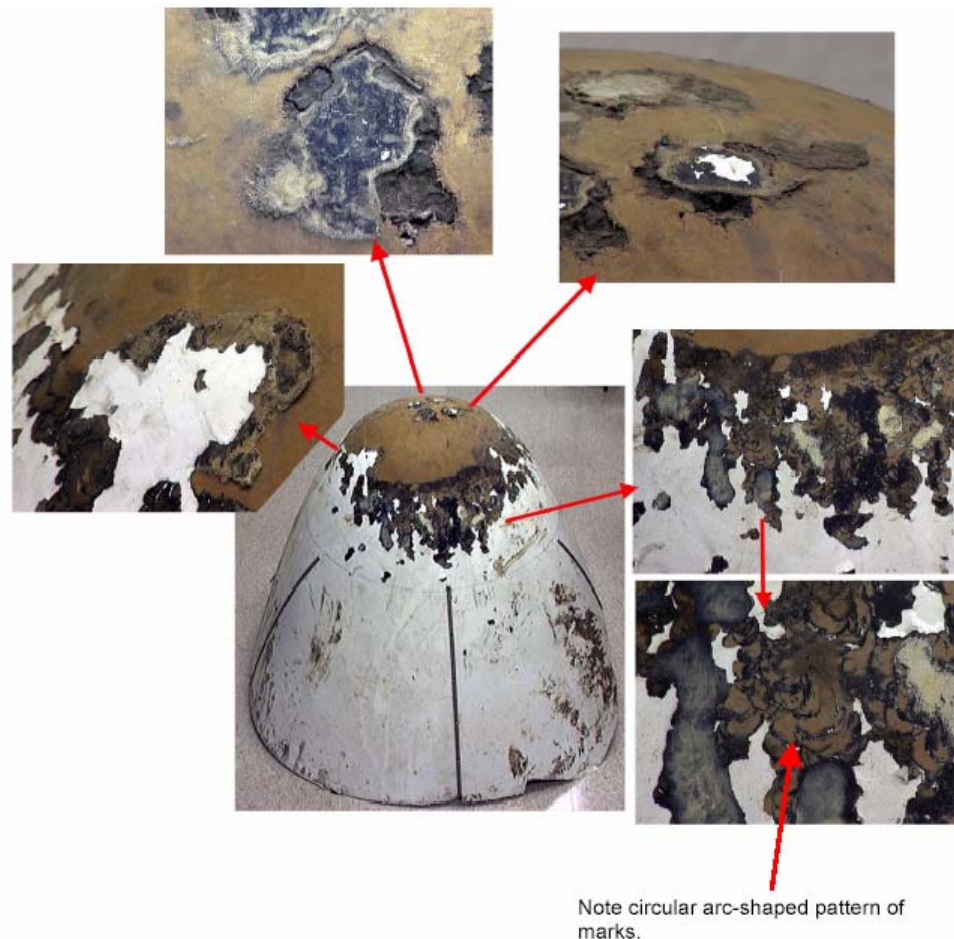
The forward portion of the nose radome which was cut from the original component was examined. The examination of the nose radome showed that the damages are as follow:

- The paint/coating had been eroded completely to form a circular area, approximately one foot in diameter, at the front.
- Within the eroded area there were four areas of damage to the underlying material. It appeared to be areas of previous damage and repair.
- Around the periphery of the completely eroded area, there were areas of partial erosion and paint damage having arc shaped (partial circular patterns) marks in the remaining coating.
- There were also numerous areas of damage to the paint as well as stains and dirt deposits.

Figure 9 Details of damages on the nose radome.

All the above are indications of damage by external causes.

It could be concluded that damages on the nose radome were caused by external forces, perhaps in the form of hail.

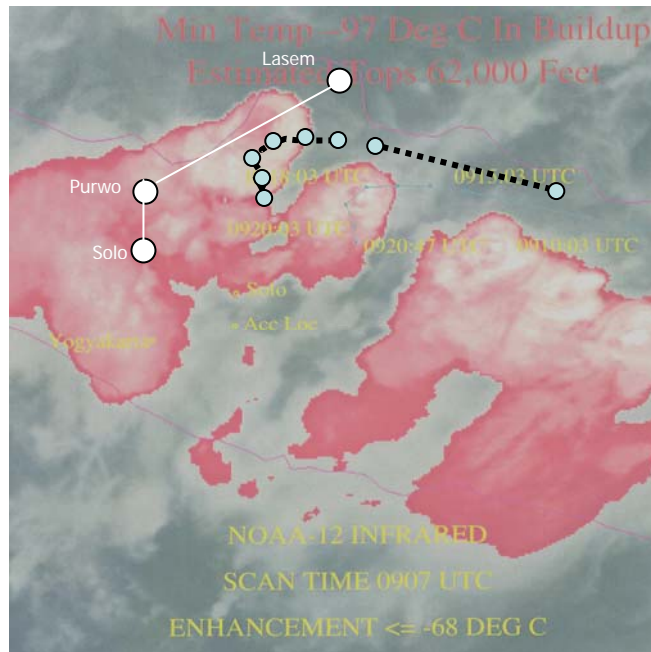
Pilot interview mention that PiC had decided to turn left considering that an area between two formations of clouds displayed on radar was the safest area due to the fact that mountainous area (quote: Merapi mountain was on his right aircraft position) and military restricted area on his left. NOAA 12 cloud picture at 09.07 UTC showed that further left was the clearer weather.

Figure 10 Shows the actual flight track flown (as a black line), and part of the air way W-16 from Lasem, W-17 N Purwo and Solo (as White line)

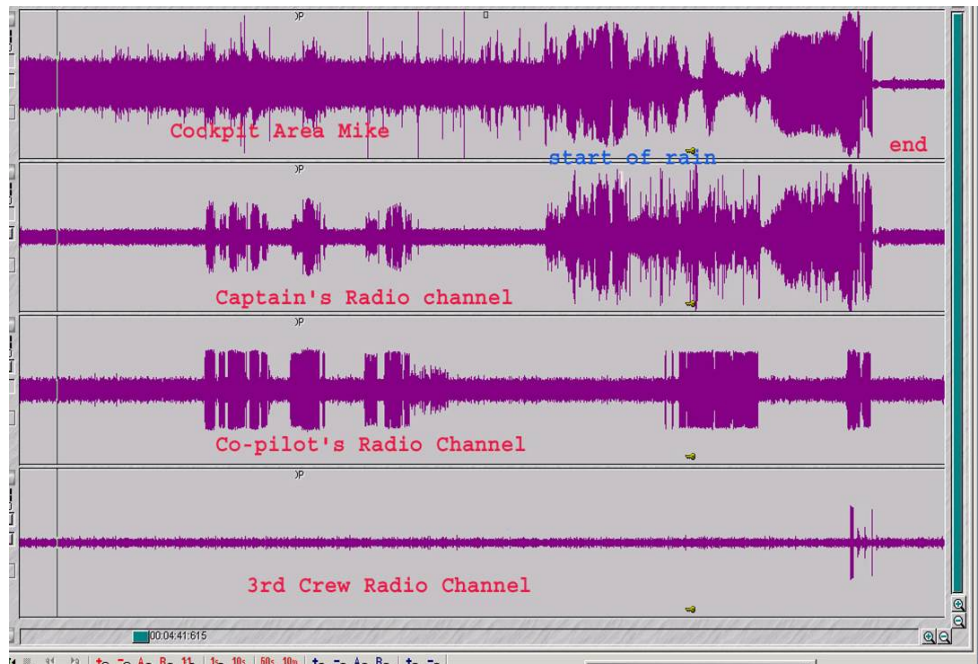
Figure 14 Plot of the recorded sound intensity prior to the engine flame out

From preceding discussions, it can be concluded that the aircraft had encountered hail beyond the engines' certified capabilities which subsequently caused both engines flame out.

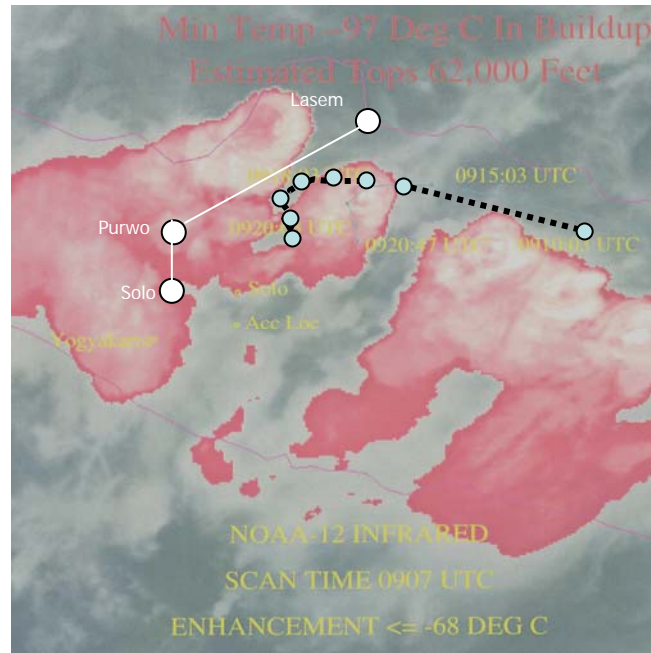
The measurement (plotted from the Scanned weather chart) from clearer weather area was about 10 till 15 nm wide down way through the south west direction in the military restricted area.

Figure 15 NOAA cloud coverage inside Military Restricted Area

At 0920:47 was the last point of aircraft recorded by the NOAA-12 radar, while this point was about 5 nm from the area of clearer weather areas, it indicated that: this clearer weather area is inside the Military Restricted Area which can be flown by the civil aircraft in coordination with ATC authorities.
