FINAL REPORT

BOEING B777-200 REGISTRATION OE-LPC COLLISION WITH AN AEROBRIDGE AT SINGAPORE CHANGI AIRPORT ON 17 JANUARY 2006

AIB/AAI/CAS.031

**Air Accident Investigation Bureau of Singapore
Ministry of Transport
Singapore**

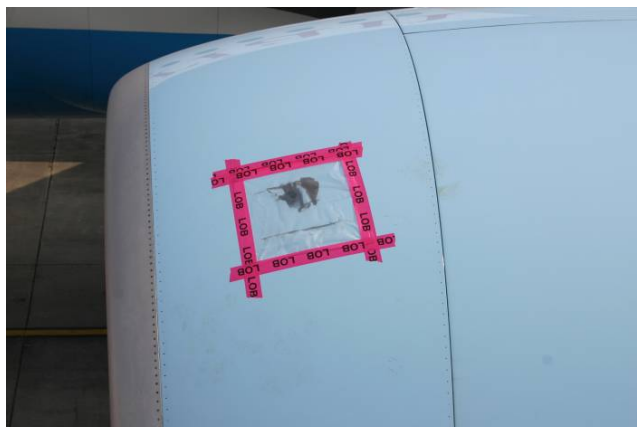
- 1.3.1 The left engine cowl suffered a puncture at the one o'clock position from making contact with the aerobridge (Figures 1 and 2).

Figure 1. Left engine cowling damage location at 1 o'clock position

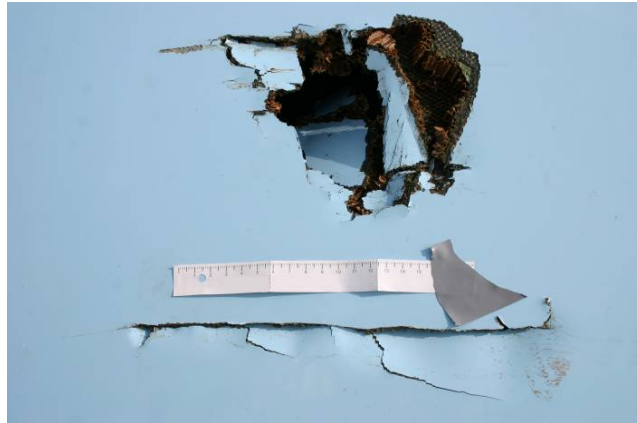
Figure 2. Damage to left engine cowling (close-up view)

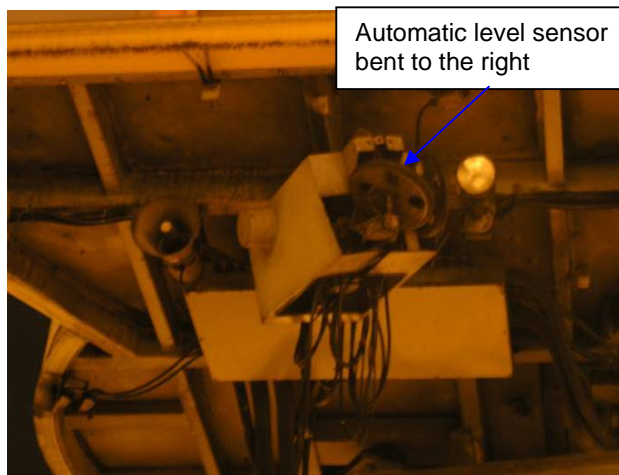
1.4.1 The aerobridge's automatic level sensor was damaged (Figure 3).

Figure 3. Damage to aerobridge automatic level sensor

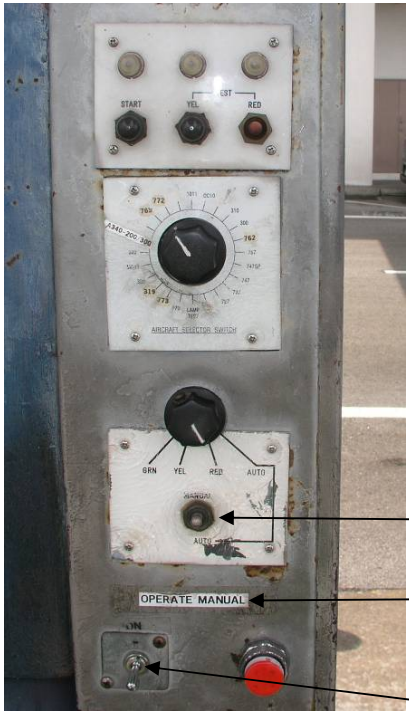
Figure 9. Bay F58 ADGS control panel

- 1.9.10 To ensure that the ADGS was kept in the manual position, an “Operate Manual” warning label was placed close to the toggle switch. The investigation team noted that at a number of bays, some of the “Operate Manual” labels as well as some other labels on the toggle switch section of the control panels were missing or partially painted over (Figures 9, 10 and 11).

- Toggle Switch 'Manual' 'Auto'
- 'Operate Manual' label
- Master Power 'Off' label missing

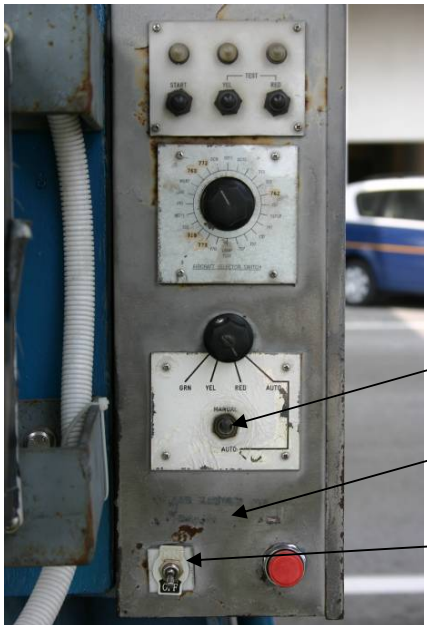
Figure 10. Bay F54 ADGS control panel

- Toggle Switch 'Manual' 'Auto'
- Operate Manual label missing
- Master Power 'On' label missing
