**Report on the accident to
Fokker F27 Mk 500 Friendship, G-CEXF
At Jersey Airport, Channel Islands
on 5 June 2001**

AIRCRAFT ACCIDENT REPORT 4/2004

Air Accidents Investigation Branch

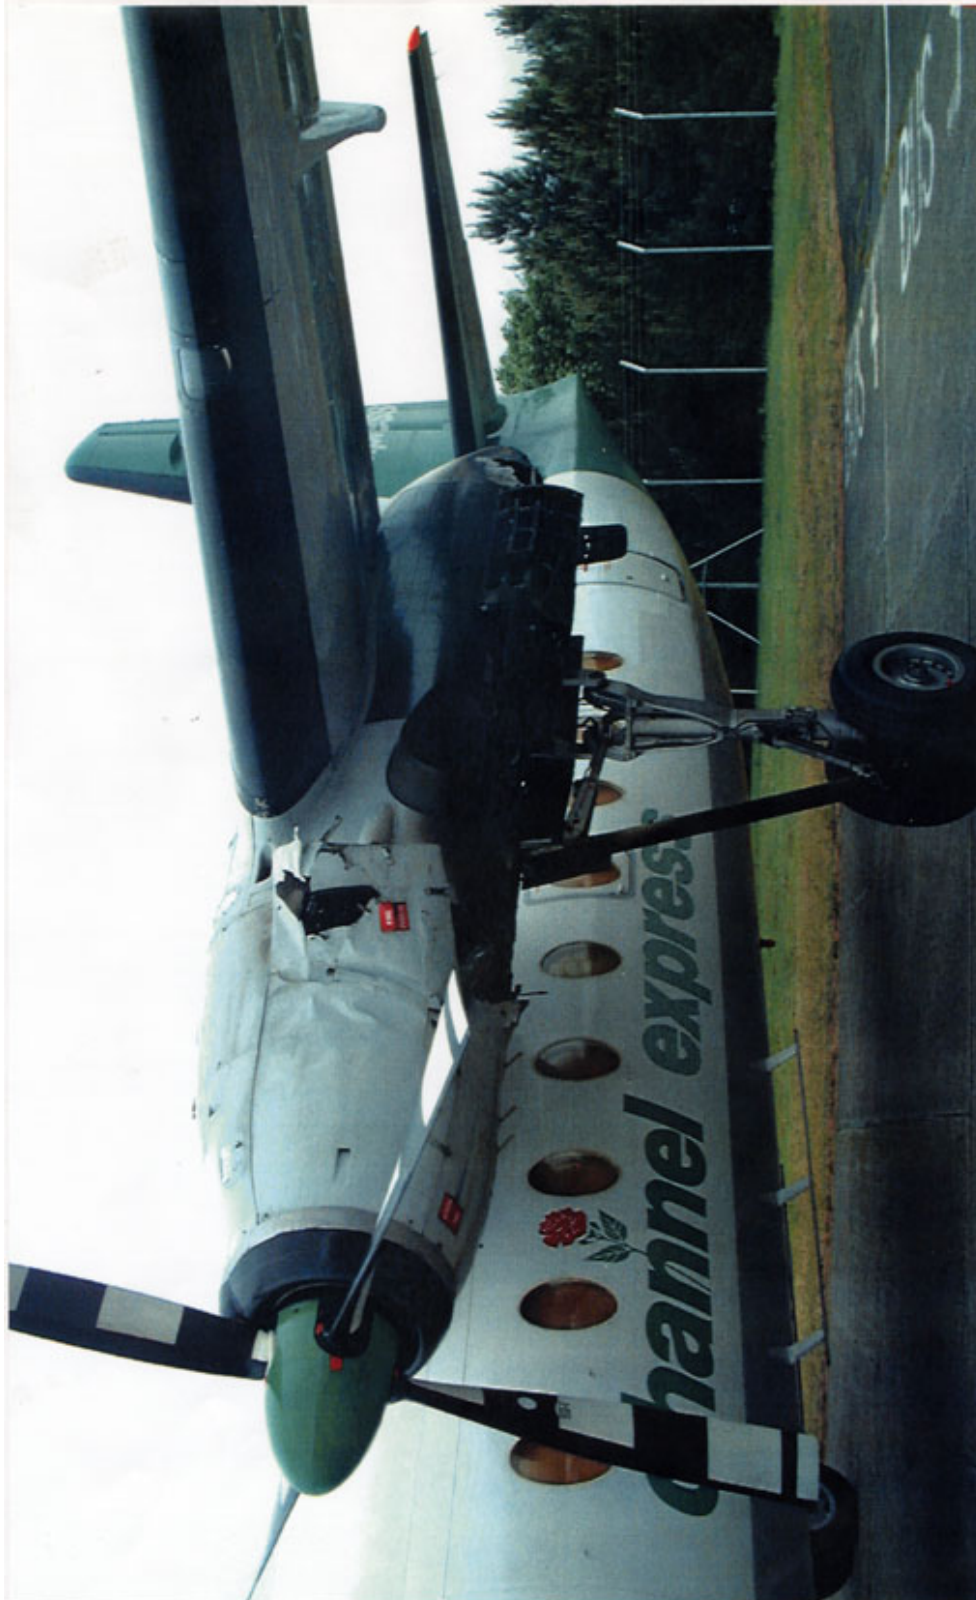
Figure 1 General view of left nacelle showing external damage

Aircraft damage consisted of severe disruption and fire damage to the No 1 powerplant, landing gear doors and engine nacelle, and minor damage to the left Main Landing Gear (MLG) and propeller, Figure 1.

Examination of the aircraft at Jersey Airport revealed all damage to be confined to the left engine and its nacelle, left propeller and left main landing gear (MLG). The left engine hinged cowls had remained in place but exhibited two major exit holes, one each in the outboard and lower cowls, in line generally with the plane of rotation the HPT. Severe distortion was present to one of the steel struts of the engine support frame adjacent to the lower left attachment at the firewall, where the attachment fitting itself was distorted and no longer connected to the engine support frame. This distortion was also in line with the plane of the HPT. The mechanical linkages to the engine HP fuel cock, power and propeller controls, which also pass through this region, had been severed. This mechanical damage was consistent with a high speed (and hence high energy) failure of the HPT and the subsequent non-containment of one or more sections. The low pressure fuel pipe from the nacelle firewall to the engine had also been severed in this region and it was readily apparent that fuel had discharged from the open end into the slipstream, caught fire and caused severe heat damage to the structure of the nacelle. Lesser damage to the left MLG had resulted as this remained retracted for the duration of the fire. The cowls were generally free from any effects of a sustained fire and the wing showed no evidence of fire damage at all.

The left engine cowl doors had remained in place but ragged holes had been punched in the outboard and lower doors in the region of the HPT and it was evident that this had been caused by impact from engine debris. There was evidence of only slight fire damage to the inside of these doors but major fire damage was present to the lower section of the nacelle from the firewall to its aftmost point. In many areas, holes had been burnt through the nacelle skins.

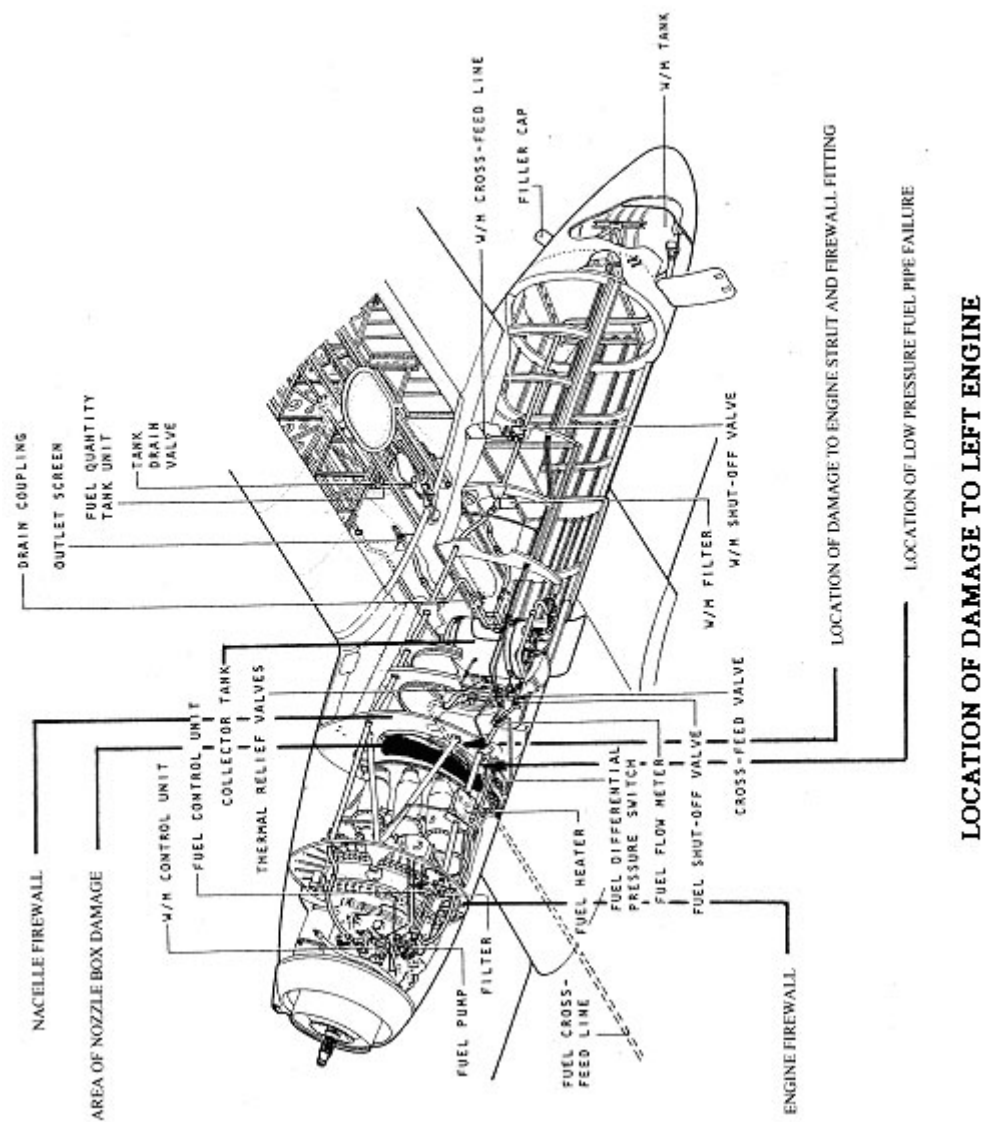
Figure 2 Location of damage to left engine

Examination showed that the left engine had suffered severe non-containment damage in the region of its turbine assembly, and this was associated with serious mechanical and fire damage to the left nacelle.

The hot section of the engine had been severely damaged, with the nozzle box/turbine module burst open in the plane of the HPT over a 150° arc around the left and lower side. The HPT was not present within the engine but the severely damaged IPT, and a surprisingly lightly damaged LPT, remained within the module. The intermediate casing had fractured over 360°, detaching the nozzle box from the rest of the engine, and this had rotated approximately 25° in the same direction of rotation as the engine spool. The nozzle box rotation had caused the combustors to disengage from the nozzle box discharge nozzles and/or the compressor diffuser outlet elbows, and from the combustion chamber interconnect tubes.

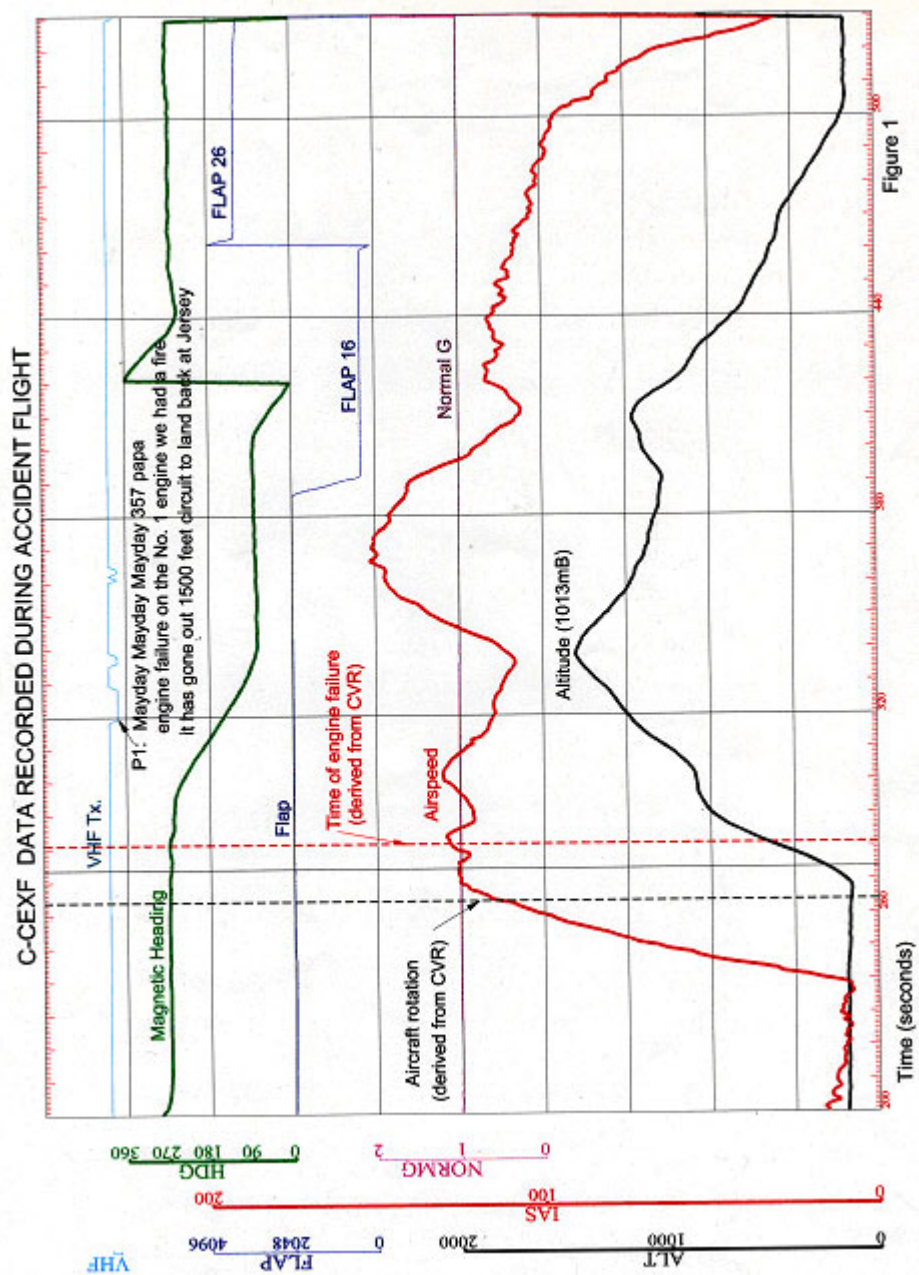
Figure 6 G-CEXF data recorded during accident flight

The CVR and FDR recordings were time correlated using the VHF transmissions from the aircraft. From this it was possible to identify the point at which the engine failed on the FDR time history and a plot of the recorded FDR data is at Figure 6. From this it was determined that the engine failure occurred 17 seconds after takeoff, by which time the aircraft was approximately 400 feet above the runway (670 feet amsl). The absence of recorded aircraft attitude prevented any analysis of the aircraft's behaviour when the engine failed or during the subsequent circuit and landing.

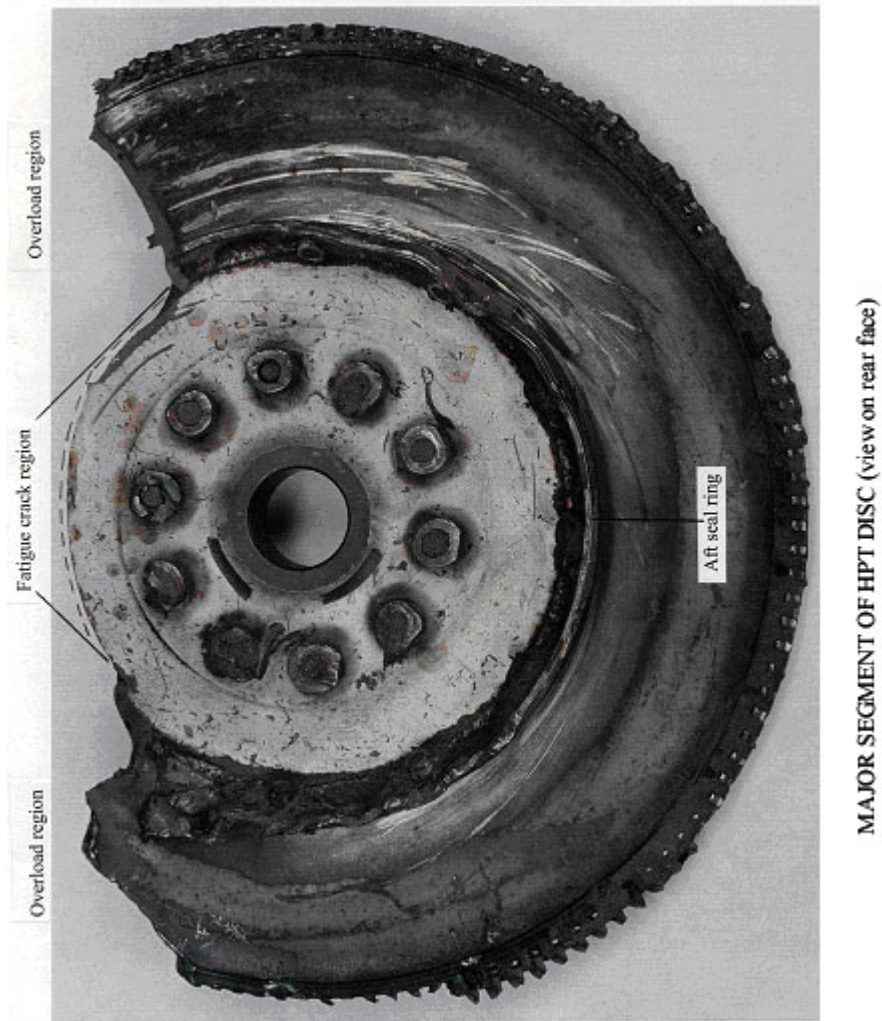
Figure 7 Major segment of HPT disc

The disc portion recovered measured some 15 x 11.5 inches overall and weighed 7.973 kg (17.57 lb), Figure 7. The main part of the disc fracture was circumferential, following the inner radius between the disc aft seal arm and the diaphragm around approximately 40% of the circumference. There was an approximately radial fracture at one end, and a secondary circumferential fracture at the other, which also led to an approximately radial fracture. The face of the main circumferential fracture was mostly flat, and generally banded with a series of light-coloured conchoidal markings. The fracture face had not suffered any appreciable impact damage and only minimal degradation by oxidation. The secondary fracture was also generally flat and similarly marked, Figure 8.

Detailed laboratory examination was carried out by the engine manufacturer in conjunction with the AAIB, using optical microscopy, scanning electron microscopy and transmission electron microscopy of replicas of the fracture. Hardness checking was also carried out. The evidence indicated that the circumferential cracks had been caused by high-cycle fatigue (HCF) and, although corrosion pitting was present on the face of the disc in the region of the two crack faces, their likely origins were not associated with any such corrosion. Pits generally had depths of between 2.2 and 5.5×10^{-3} inches and were similar to numerous others associated with fairly extensive light corrosion present on the disc surface, particularly in the aft seal ring inner radius area.

There were no signs of any other anomaly at the origins of the two related fatigue cracks, such as a material defect, inclusion or forging lap, and it was judged that any such defect would have been apparent. The fatigue had propagated circumferentially over a distance of approximately seven inches, mainly against the direction of disc rotation, and forward over approximately 80% of the section thickness. Adjacent to the primary origin, in the direction of rotation, a secondary area of fatigue cracking was present with an origin on the front face of the disc diaphragm. Overload fracture of the remaining part of the section and (generally) radial tear off in tensile rupture at both ends had then completed the fracture to release the smaller section of disc. Detailed inspection of the larger disc segment failed to find any additional cracking. The macro and microstructure of the disc material was normal and hardness was satisfactory, with measured values in the range 309-314 Vickers Hardness Value (HV) against a specification requirement of 299-334 HV. There were no signs of gross overstress, which would have been likely to result in multiple cracks. Evidence that the failure was transgranular and without creep related features, as shown by a lack of plastic deformation near the origins, indicated that a low cycle fatigue (LCF) mechanism had not been involved and that the disc had not failed due to over-temperature.

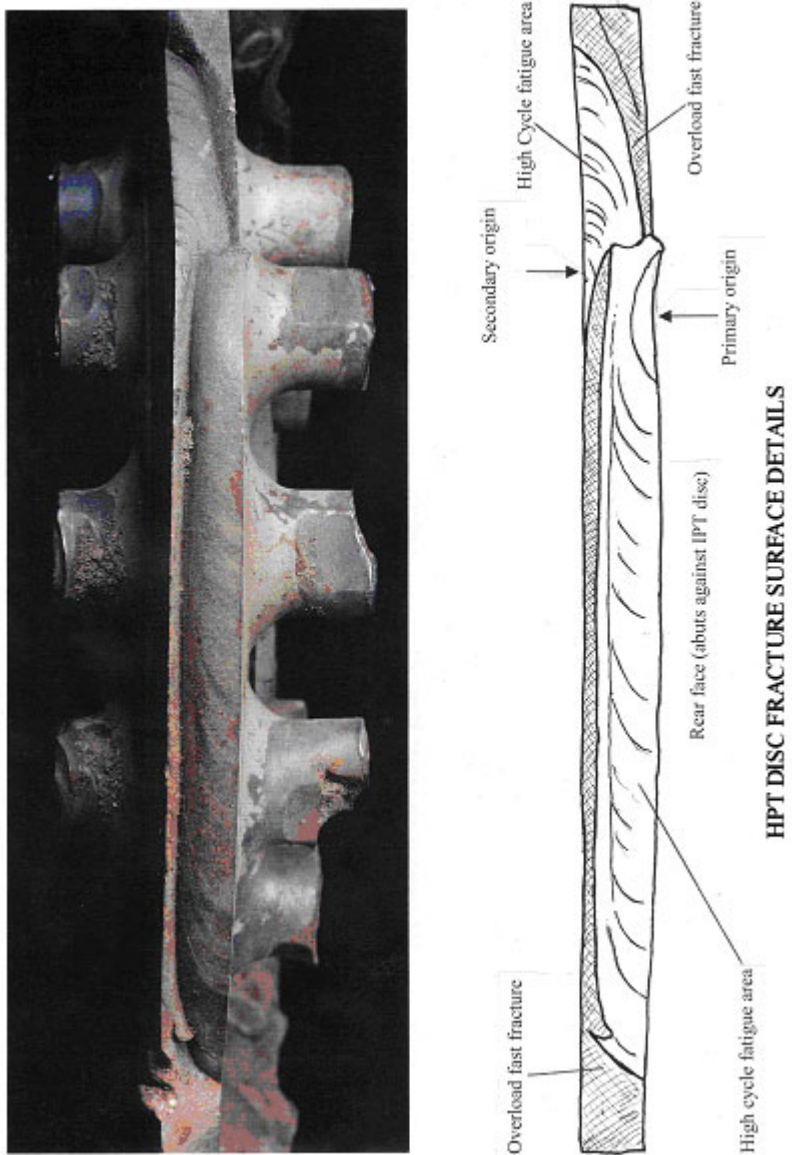
Figure 8 HPT disc fracture surface details

The main fatigue fracture surface exhibited between 35 to 50 (or possibly more) lighter coloured narrow bands, with darker regions between. It was concluded that each light region was an arrest band that represented a divider between separate periods of vibration that had been sufficient to cause crack growth in HCF during the propagation stage. It was not possible to correlate the arrest bands to flight cycles. On the strikingly similar fracture faces on the HPT from another HPT disc failure on G-OJEM (see paragraph 1.16), some indistinct striation features were evident in the HCF areas between the bands, but the available detail was insufficient to allow an accurate striation count over the fracture surface. The best estimate of striation densities, in that event, was in the order of 20,000 per millimetre, and HCF load reversal cycles involved in the propagation of the crack was estimated to be in the order of one to five million.

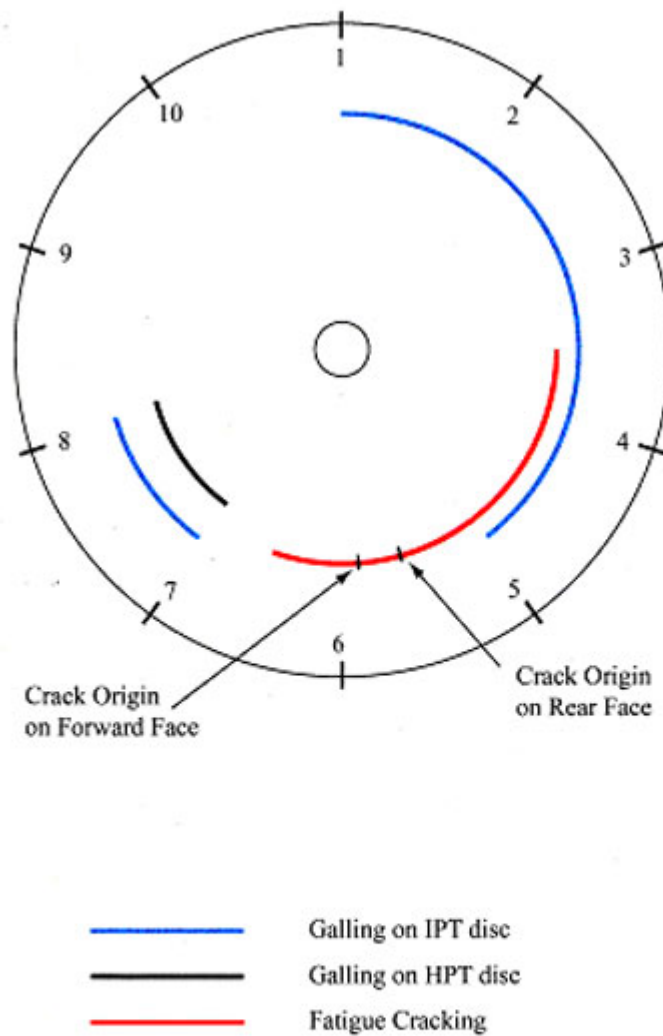
Figure 12 Relative damage locations HPT / IPT seal arm abutment faces / Fatigue Cracking

In the case of G-CEXF, evidence was found of fretting/galling on the HPT to IPT disc seal arm abutment faces, and the location of this damage relative to the fatigue crack is illustrated in Appendix C-3. The seal arm face on the IPT disc showed generally light galling, judged not to be of significance in a loss of dimension context, but this was visibly more severe over the arc between bosses 1 to 5. Light galling was also present between bosses 7 and 8 on both the HPT and IPT discs, although the loss of the smaller disc segment precluded

examination of the seal arm face between, approximately, boss locations 3 and 6. Expert examination by tribologists from the manufacturer indicated that such wear could be consistent with the results of a 'rolling contact' type of mechanism, (see paragraph 1.18.3.6). The taper bolt hole location bosses were examined to determine if any obvious wear was evident on the contact surfaces. All these contact surfaces on the forward side of the disc were free from any evidence of wear. On the rear side of the disc, five of the bosses surfaces were damaged, and this precluded comment on their pre-failure condition. Optical binocular microscopic examination of the remaining four found them to be free of evidence of significant wear, although some patchy black, thin deposits were seen on several. The thickness of the material was assessed as being less than 0.1×10^{-3} inches; analysis of this material found it to be consist of oxides of the disc material. However, residual machining marks were still clearly discernable on the boss faces, indicating that there had been little or no relative motion between the discs.
