INCIDENT REPORT

Runway Excursion Incident

Boeing 777-200 Registration 9V-SRG

AIB/AAI/CAS.016

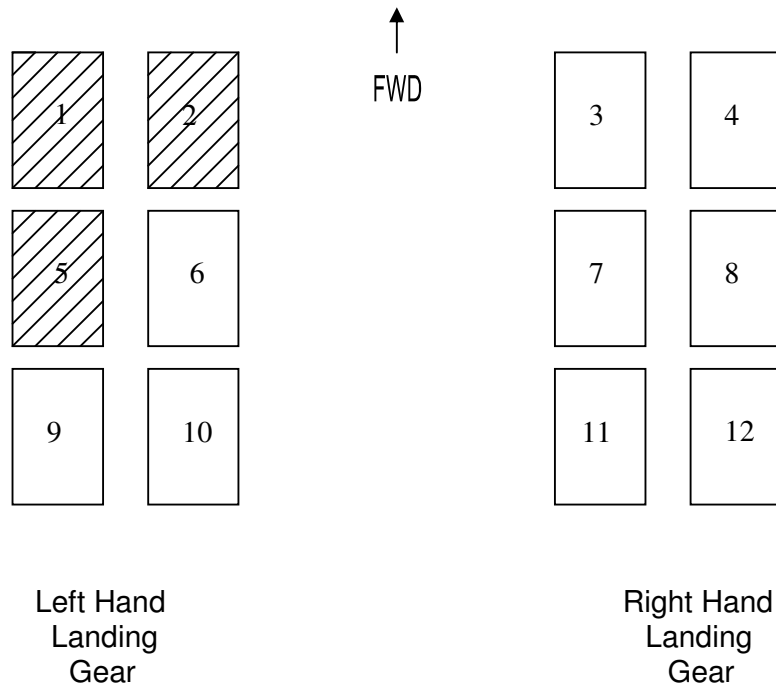
1.18.1 All six tyres on the left hand landing gear had rubber reversion⁶, indicating reverted rubber aquaplaning had occurred. Three of the six tyres at positions 1, 2 and 5 were deflated. Below is a sketch showing the layout of the main landing gear tyres of the Boeing 777 aircraft.

Notes: Number in the box is the wheel position number.
Deflated tyres are shown shaded in the sketch above.

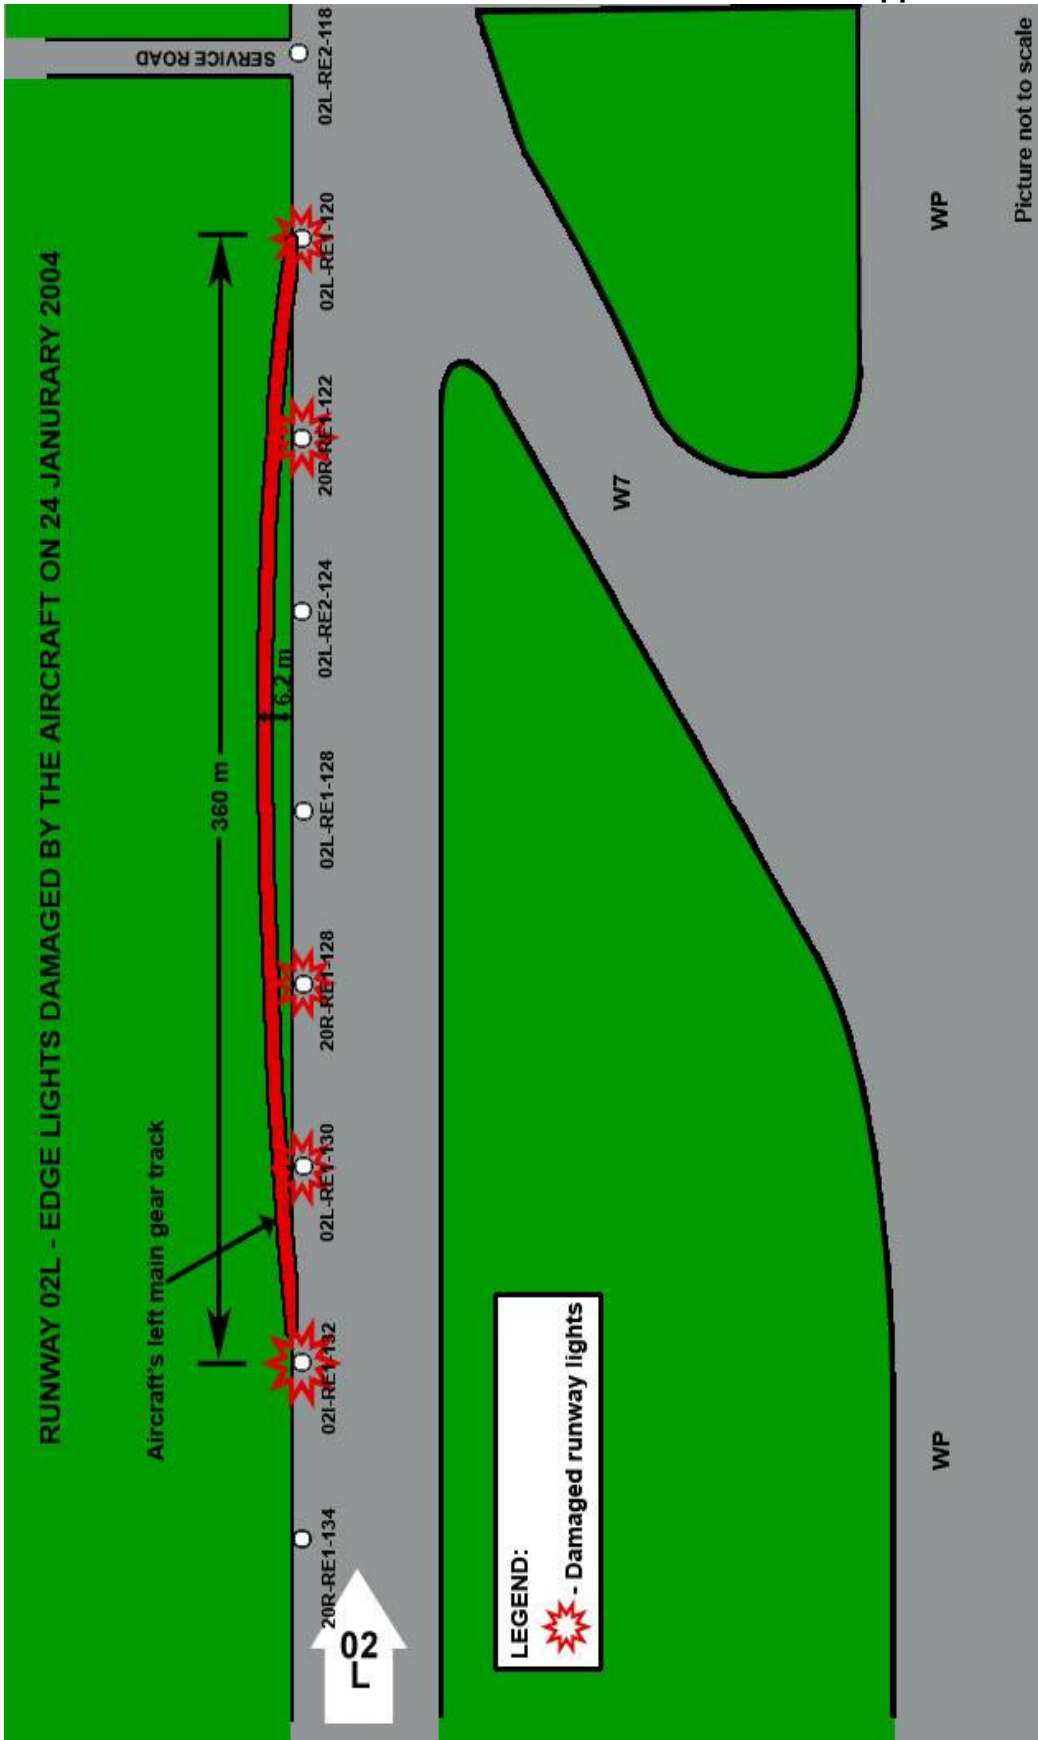
Appendix 1: Schematic of Runway 02L edge lights damaged by the aircraft

- 1.1.15 The left hand landing gear of the aircraft departed the runway for about six seconds. From the wheel tracks in the soft ground, it was determined that the left hand landing gear had rolled about 360 m on the grass verge with the maximum displacement of about 6.2m from the runway edge (see **Appendix 1**).

- 1.4.2 The wheel tracks on the soft ground started near the runway edge light No.132 which was about 700 m from the start of the threshold of Runway 02L and ended at runway edge light No.120. The wheel

tracks were about 360 m long and about 6.2 m at their furthest from the edge of the runway. Only the left landing gear had departed the runway.

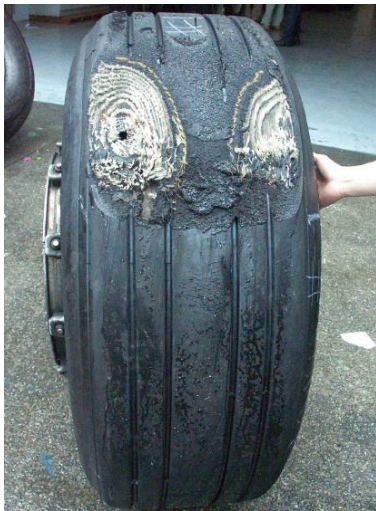
Tyre No. 1

- 1.18.2 Two tyres fitted at the No.1 and No.9 positions were sent to the tyre manufacturer, by the operator, for examination and analysis. The report from the tyre manufacturer indicated that both tyres had severe flat spotting and exposed belt plies. The damage appeared to have been initiated by reverted-rubber aquaplaning. The level of abrasion on the tyres also indicates that the tyres were blocked from rolling for some period, while in contact with the runway surface.

- 1.18.3 The report also indicated that the tread wear pattern of No.1 tyre showed an overload condition or partial or full loss of pressure, which resulted in the shoulder areas abrading more than the centre tread area. This tyre was apparently blocked from rolling for a greater distance than the No.9 tyre as the amount of tread rubber abrasion was much more.

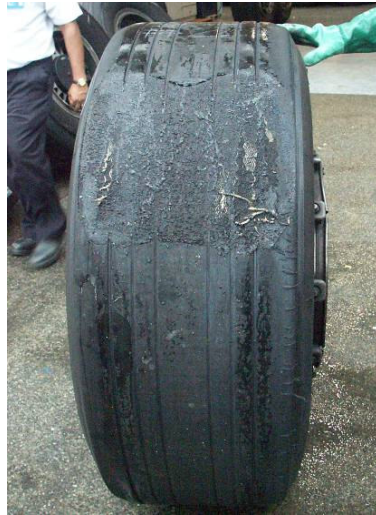
Tyre No. 2

- All six tyres on the left hand landing gear suffered rubber reversion. Tyres number 1, 2 and 5 were deflated. (See **Appendix 2**)
 - Two wing-to-body fairing panels aft of the wheel well were damaged.

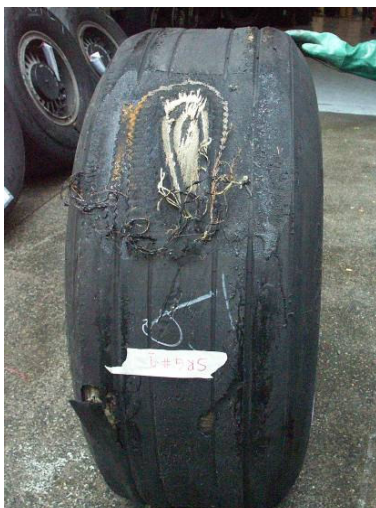
Tyre No. 9

- 1.18.4 No. 9 tyre's tread has a flat spot consistent in size with its normal load bearing, contact area. The tyre has worn in the centre rib area exposing the steel protector ply and two layers of belt ply. The wear was not sufficient to cause any loss of pressure. The slightly more central wearing (compared to the shoulders) is consistent with normal loading of that wheel.
