ATSB TRANSPORT SAFETY REPORT
Aviation Occurrence Investigation
AO-2010-081
Final

Stickshaker activation
Kalgoorlie Airport, Western Australia
13 October 2010
VH-NXD, Boeing 717-200

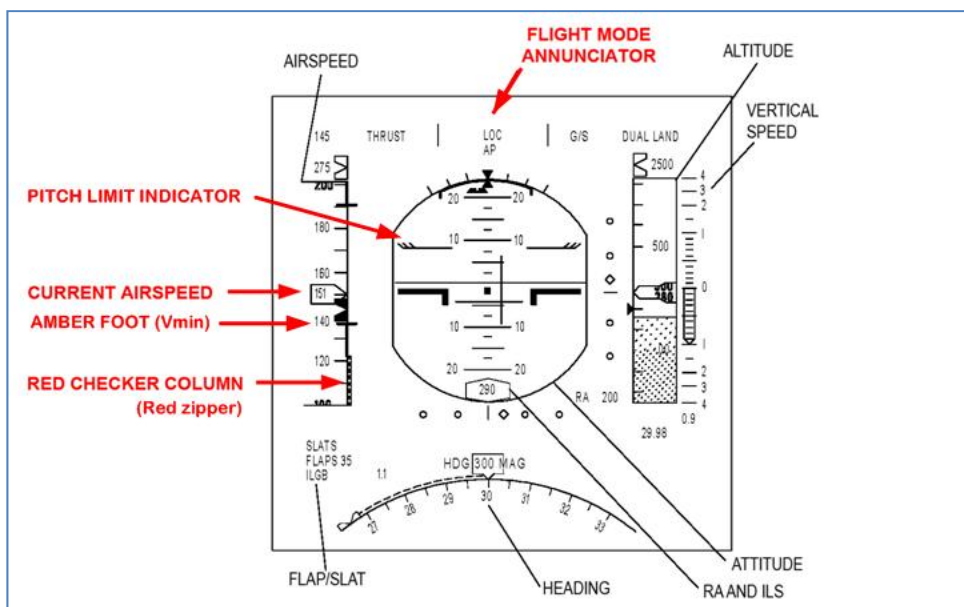
Figure 1: Primary flight display

The flight crew was provided with an indication of the aircraft's proximity to the stickshaker activation speed by the relative positions of the pitch limit indicator (PLI) and the red checker column (Red zipper) on the primary flight display. Although the flight crew noted that the positions of the PLI and Red zipper were closer to stickshaker activation than was normal, they attributed those indications to the g-loading effects induced by turbulence. Those indications were symptomatic of an inappropriate approach speed and consistent with the degraded performance and controllability experienced by the flight crew.

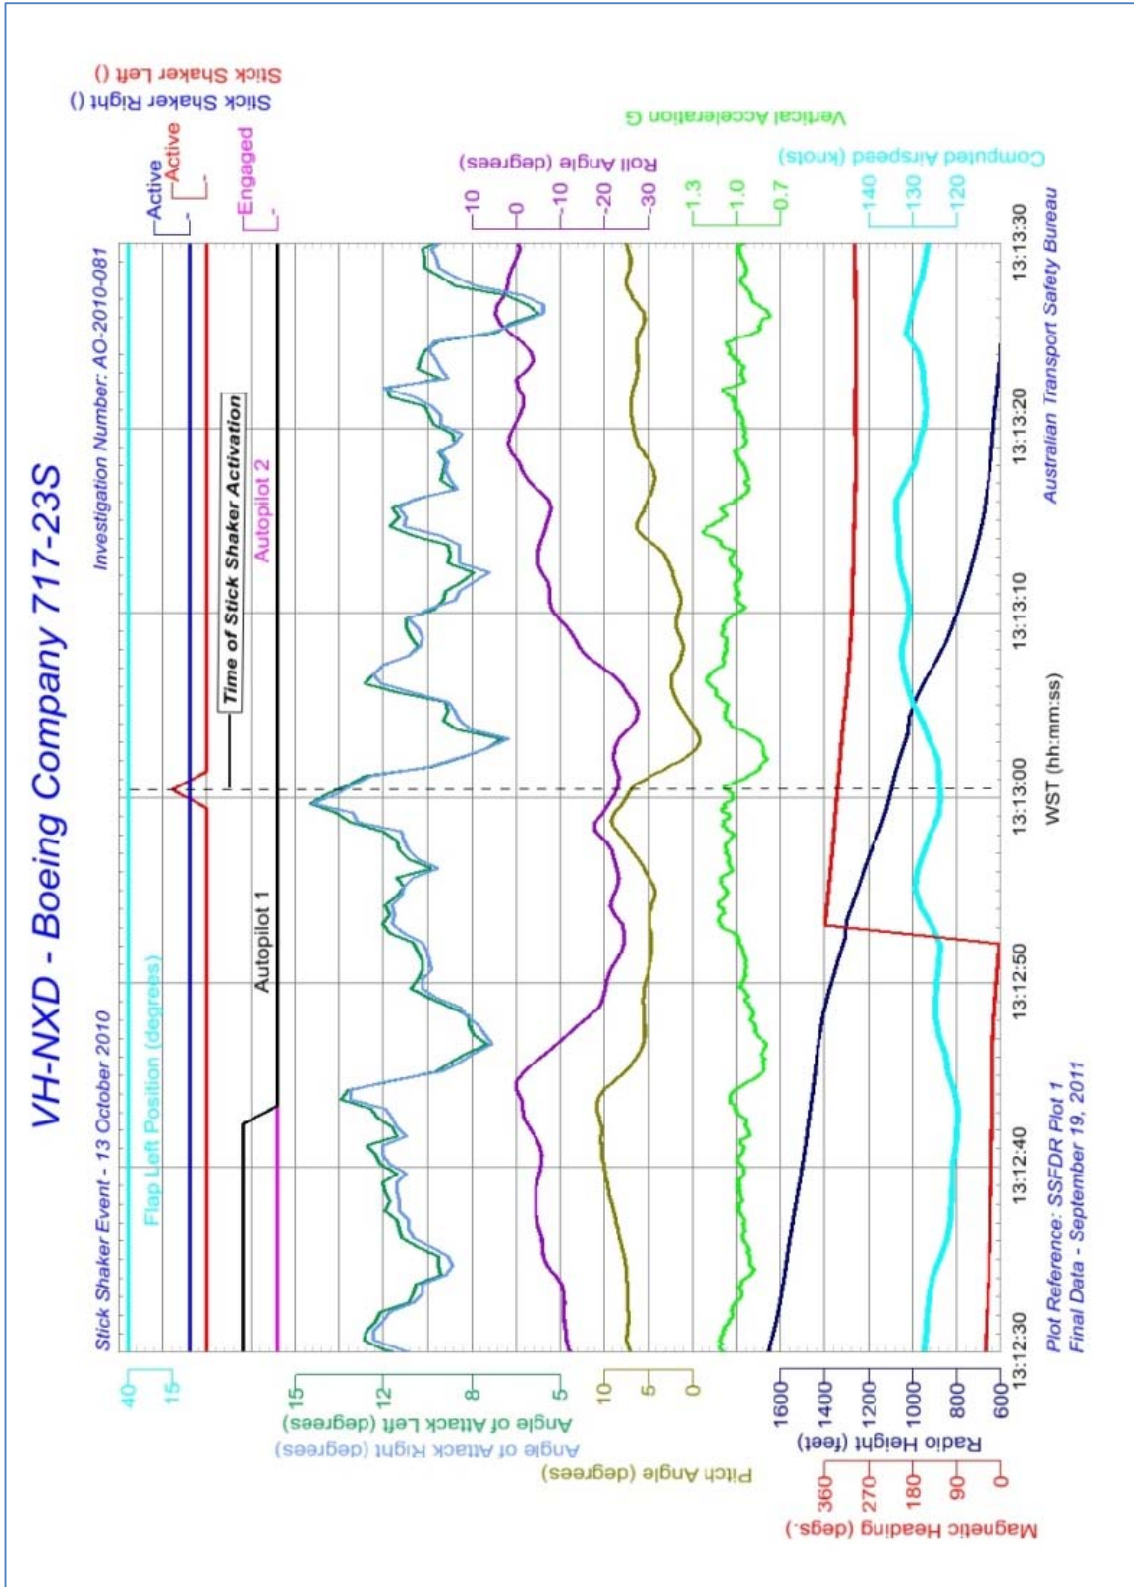
APPENDIX A: DATA PLOT - 1st STICKSHAKER EVENT

During the turn onto final approach, the aircraft's stickshaker⁷ activated momentarily. The copilot responded by reducing the aircraft's pitch attitude while continuing the turn and the approach. The copilot reported that he had considered conducting an immediate go-around but continued the approach on advice from the PIC. About a minute later, the flight crew conducted a go-around as the approach no longer met the stabilised approach criteria.

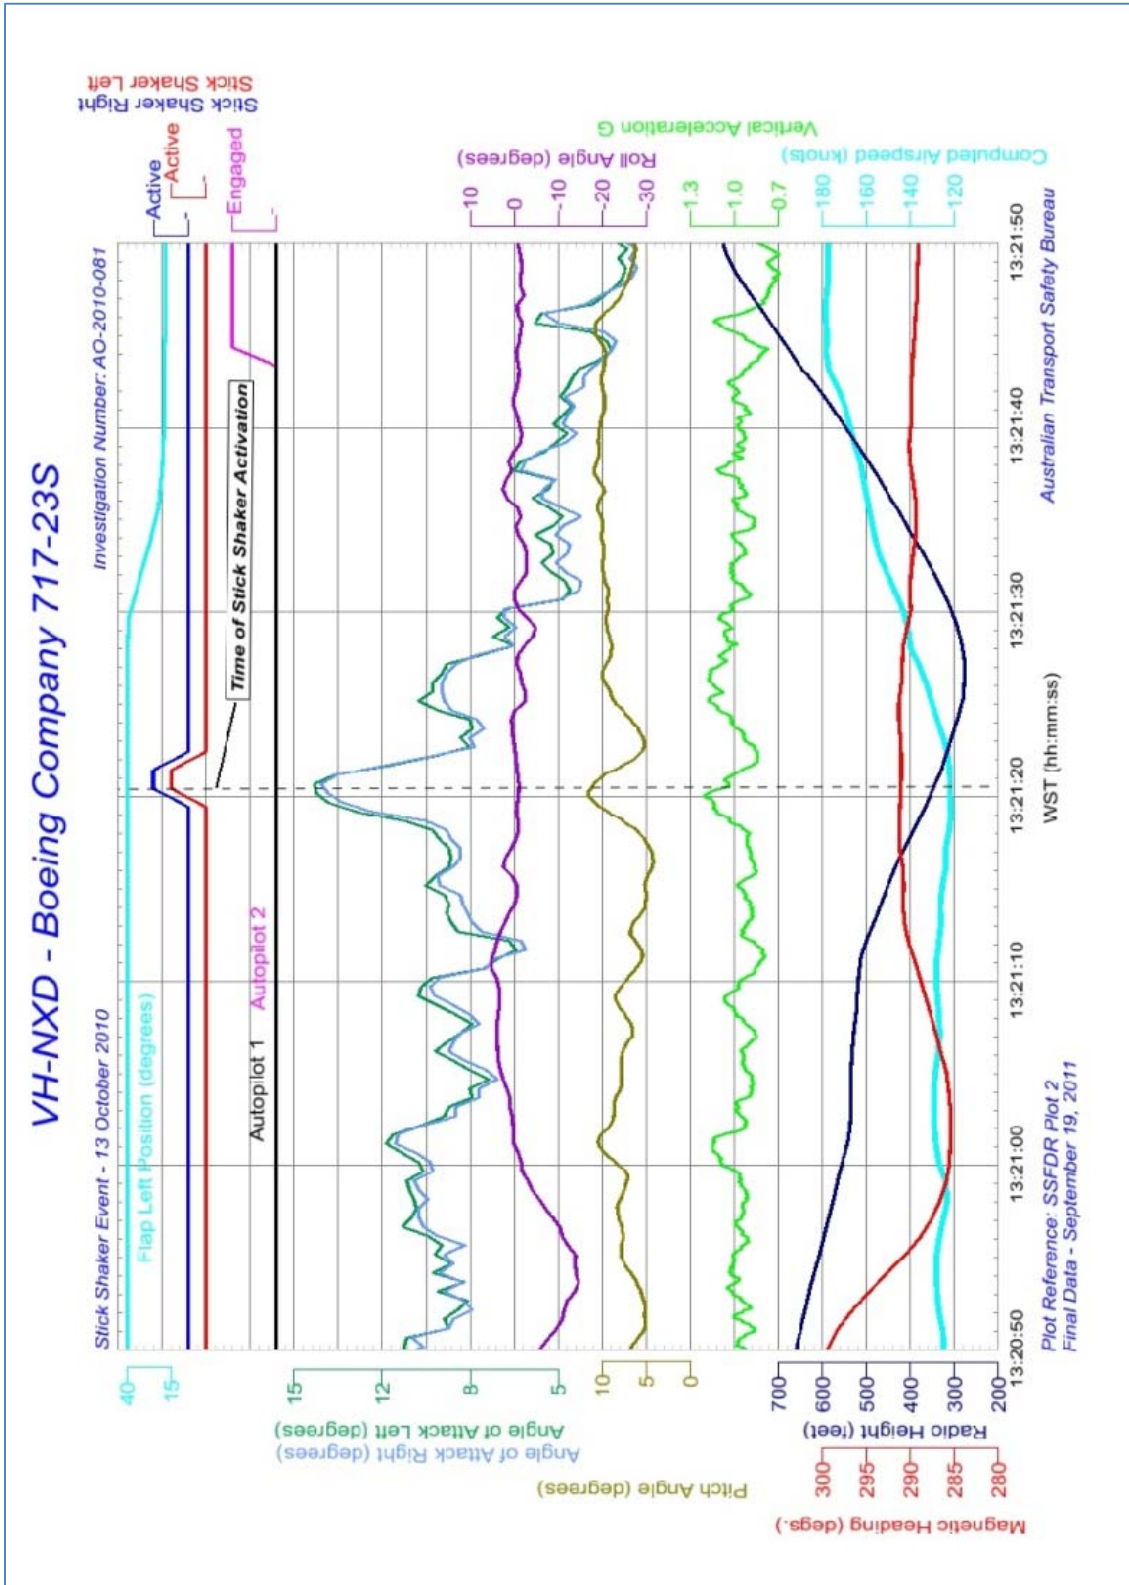
APPENDIX B: DATA PLOT - 2nd STICKSHAKER EVENT

At about 1321 and after establishing the aircraft on final approach, the copilot noted that the aircraft was below the required approach path. As the copilot increased the aircraft's pitch attitude, the stickshaker activated for about 2 seconds. Following the necessary recovery actions, the approach was no longer stabilised and a go-around was conducted.
