Accident
Investigation Board
Norway

Issued March 2010

SL 2010/05

**REPORT ON SERIOUS AVIATION INCIDENT AT
SANDEFJORD AIRPORT TORP 26 MARCH 2006
INVOLVING AIRBUS A321 OY-VKA OPERATED BY
MY TRAVEL AIRWAYS SCANDINAVIA**

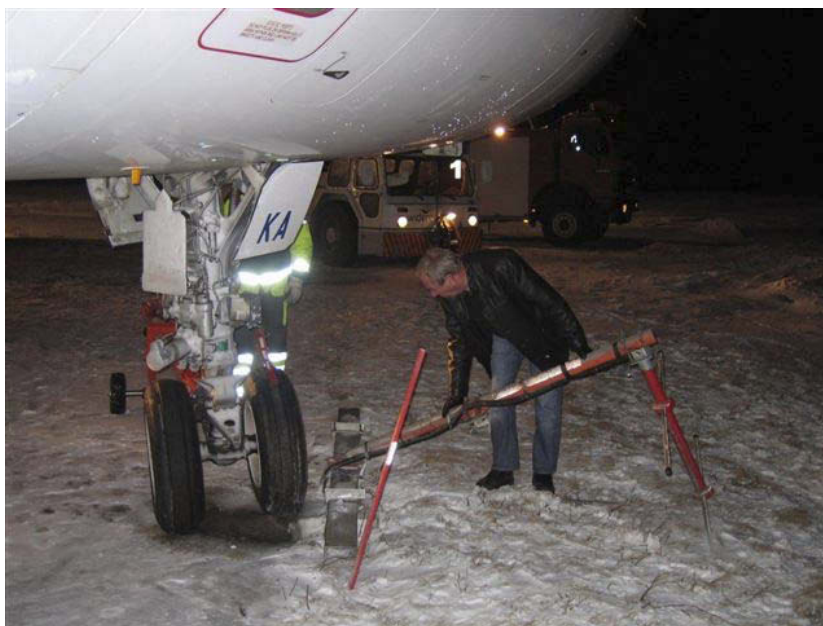
The Localizer Monitoring antenna and the base at the end of runway 18 were damaged.

Figure 1: Damaged Localizer Monitoring antenna with concrete base.

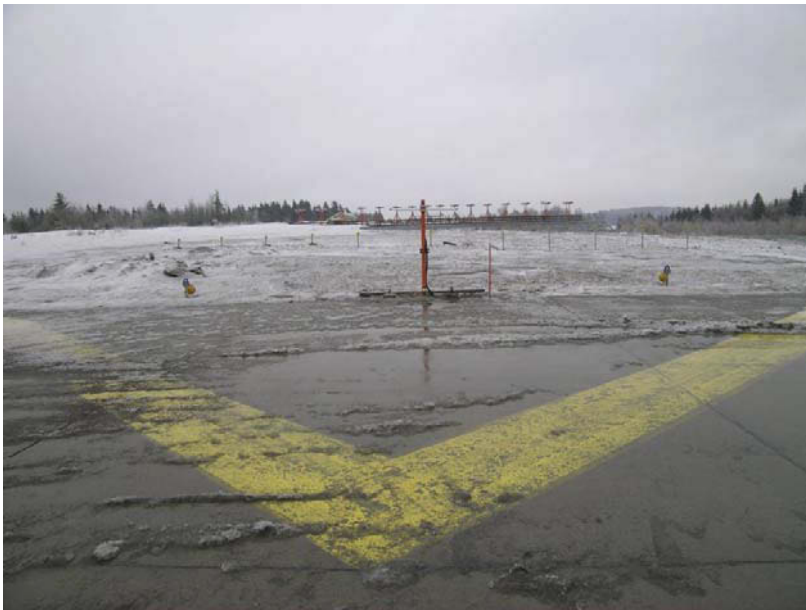
Figure 2: Repaired Localizer Monitoring antenna.

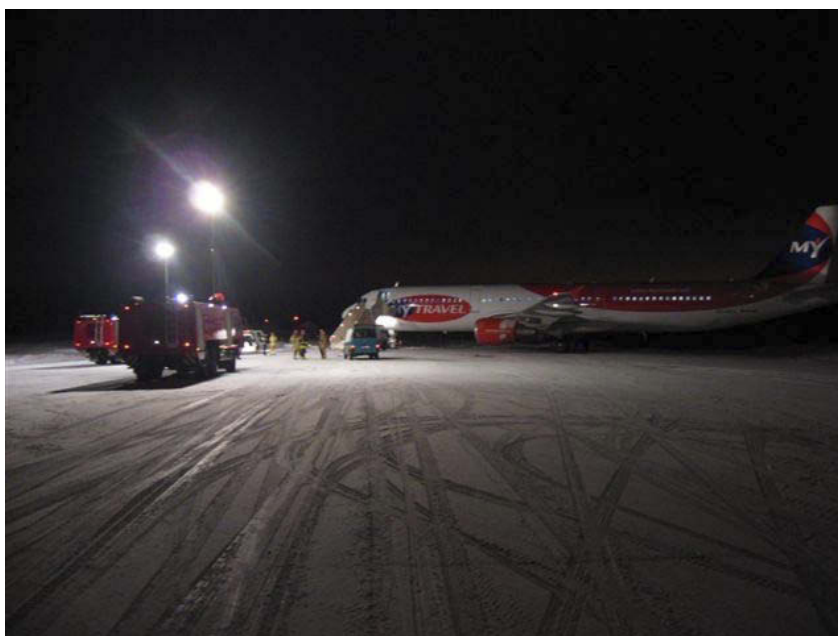
Figure 3: Reflections in frozen moisture in the vehicle tracks indicate a slippery runway.

- 2.3.5 By analysing the moisture- and temperature conditions after the event, it shows that the runway was moist before it became covered by snow (cf. item 1.7.7). The air temperature at 2 m height was measured to be - 1 °C. (Runway Report at 1451 UTC). During the afternoon the air temperature at 2 m height dropped to - 2 °C. The dew point spread was 1°C. The air temperature and dew point temperature at the runway surface may be different from those measured at 2 m. The Runway Report at 1741 UTC said that the runway was covered by 8 mm wet snow while the Runway report at 2028 UTC said that the runway was covered by 13 mm dry snow. From this AIBN conclude that the runway started out as a bare and moist runway which gradually was added moisture by snow fall. Combined with a fall in air temperature it is probable that the lower layer of moisture froze to ice at the same time as moist new snowfall was added on top. Hence, it is deducted that when OY-VKA landed the runway was covered by a thin layer of ice with fresh snow fall on top. AIBN consider this illustrates some of the uncertainty regarding decisions wheather the snow is wet or dry. The definitions for wet and dry snow is "the possibility to make a snow ball or not". In relation to the ability to support tire to ground friction these definitions may be useless (cf. Figure 3).

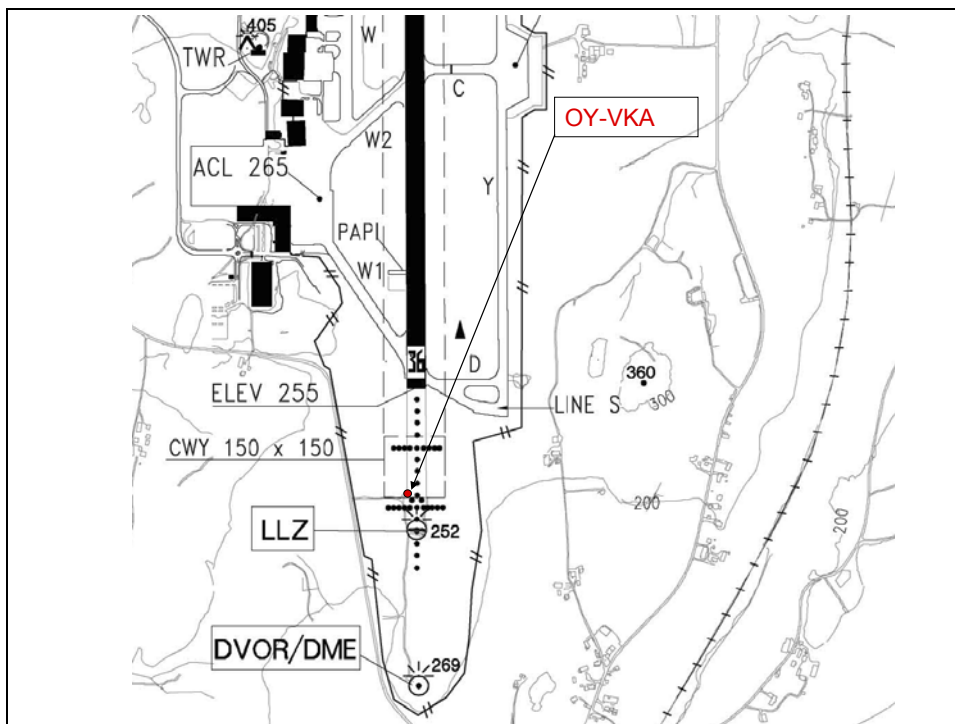
Figure 5: Stop position for OY-VKA.

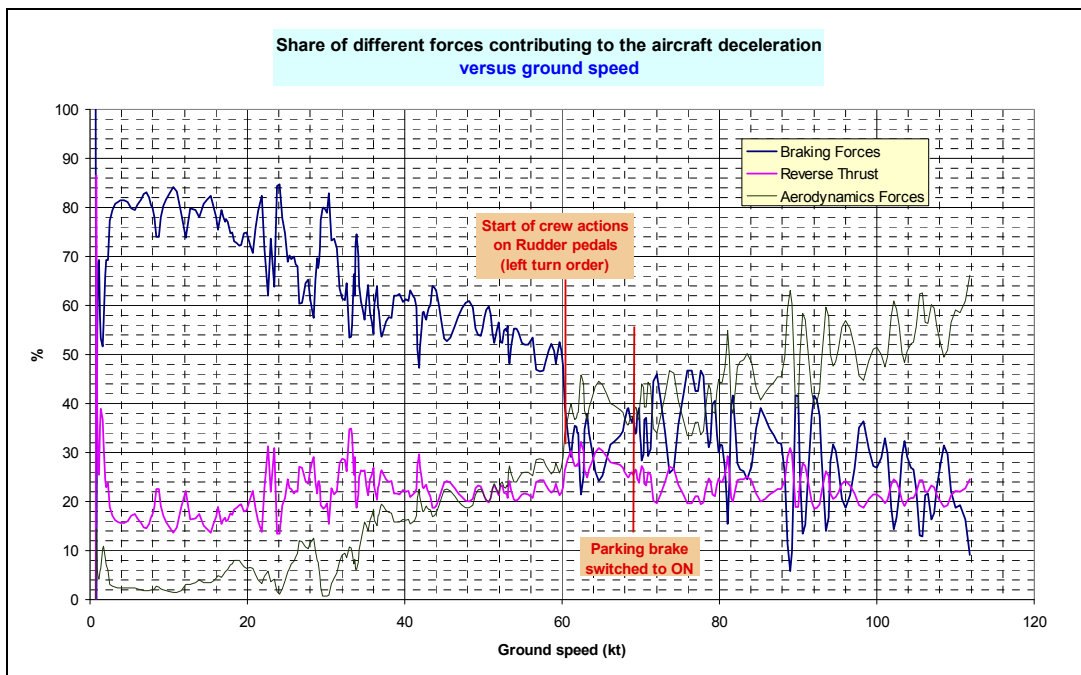
Figure 6: Graph showing the percentage distribution of braking forces from laps/spoiler, reversing and from wheel brakes.

The graph in Figure 6 shows that reversing contributed to approx. 20 % of the overall braking force and was relatively constant during most of the braking action. The graph further shows that the braking force from the wheel brakes contributed to approx. 20 % down to 60 kt. At this speed, the commander applied the parking brake and steered towards the left following advice from the first officer. The intention was to steer the aircraft towards the left side of the runway as the terrain on the left side looked better for a runway excursion. This caused the aircraft to unintentionally skid sideways while the mass velocity vector continued along the same path as before. This caused the main wheels and the nose wheels to skid sideways through the snow resulting in the retardation force from the runway surface contamination to increase to approx. 80 % of the total braking force towards the end of the braking run. The reversing continued to contribute the remaining 20 % of the total braking force down to about 20 kt.

brakes. The graph shows deceleration from 112 Knots Ground Speed (KGS), and that the drag (air resistance) varied from approx. 50 % just after touchdown, to approximately zero below 30 kt. Reversing contributed approx. 20 % of the total brake force throughout the braking course (disregarding the rolling friction which was negligible). We see that the braking friction varied a lot. This means that the conditions were very slippery and that the anti-skid system was working to the full. The average percentage from the wheel brakes shows a gradual increase from around 20 % at 110 kt to approx. 25 % at around 70 kt where the commander engaged the PB. He did this because he could not feel any effect from the wheel brakes. AIBN has found that this is a common experience for pilots who attempt to brake on a slippery surface (Braking Action POOR).

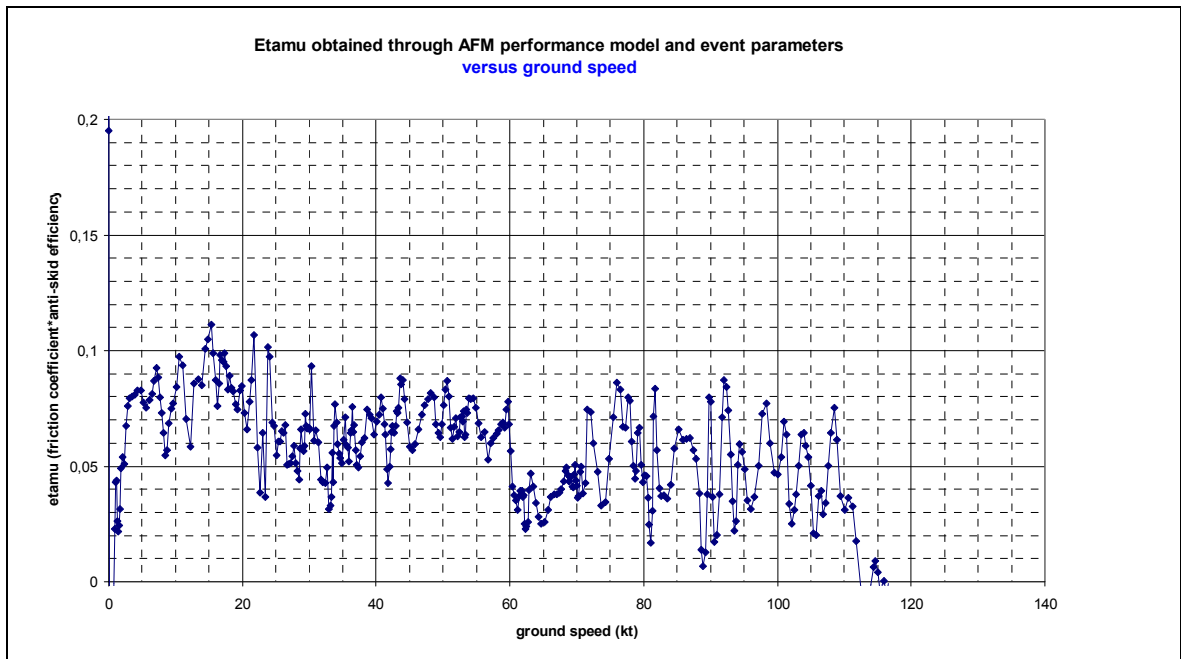
Figure 7: Graph showing the aircraft's effective brake coefficient.

The graph in Figure 7 shows that the aircraft's effective friction coefficient ("*airplane effective μ* " in the Airbus terminology, or Airplane Braking Coefficient (ABC in the Boeing terminology) was in the region of 0.05. This corresponds to POOR Braking Action.

- 2.6.4 Figure 7 shows the Airbus' computer calculation of the airplane braking coefficient" (ABC, or "*effective μ* "). The graph also shows that the average braking coefficient was approx. 0.05 from approx. 110 kt down to approx. 70 kt. That is the speed at which the commander engaged PB because he did not sense any braking actions from the wheel brakes (ref. Figure 6). Figure 7 shows that the ABC fell from approx. 0.05 to 0.04 when the PB was turned on. This is compatible with the friction theory and a result of the anti-skid system being disconnected. This caused the wheels to lock, and the friction changed over to a pure gliding friction which is lower than a slip friction. Figures 6 and 7 further show the effect of the commander's turning left by means of the nose wheel steering. Thereby the aircraft's nose turned gradually towards the left while the aircraft mass velocity vector continued along the same runway path. The friction from the main and nose wheels, which were then skidding more and more sideways along the runway direction through the snow, gradually increased up to 0.06-0.07, and up to approx. 0.08 at the end.

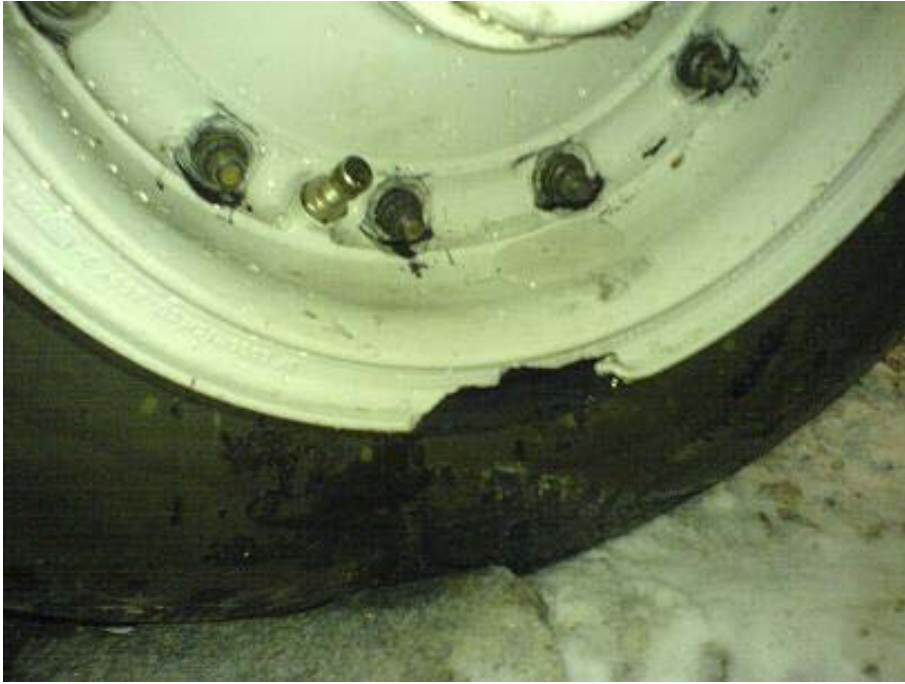
- 1.12.1.1 The aircraft sustained damage to the right-hand nosewheel rim and fuselage. The right-hand nosewheel rim was cracked by the concrete base and a bit of about 5 cm long was broken off from the rim. The right-hand nosewheel tyre was scraped on the side. Figure 8.
- 1.12.1.2 The lower fuselage sustained a small dent in the skin on the right-hand side. The damage came from the impact with the Localizer Monitoring antenna, when this was bent to the side by the fuselage. The indentation was localised between station nos. 14 and 15 and was around 10 x 14 millimetres long and approx. 1.8 millimetres deep. Figure 9.

Figure 8: Damage to the nosewheel rim.

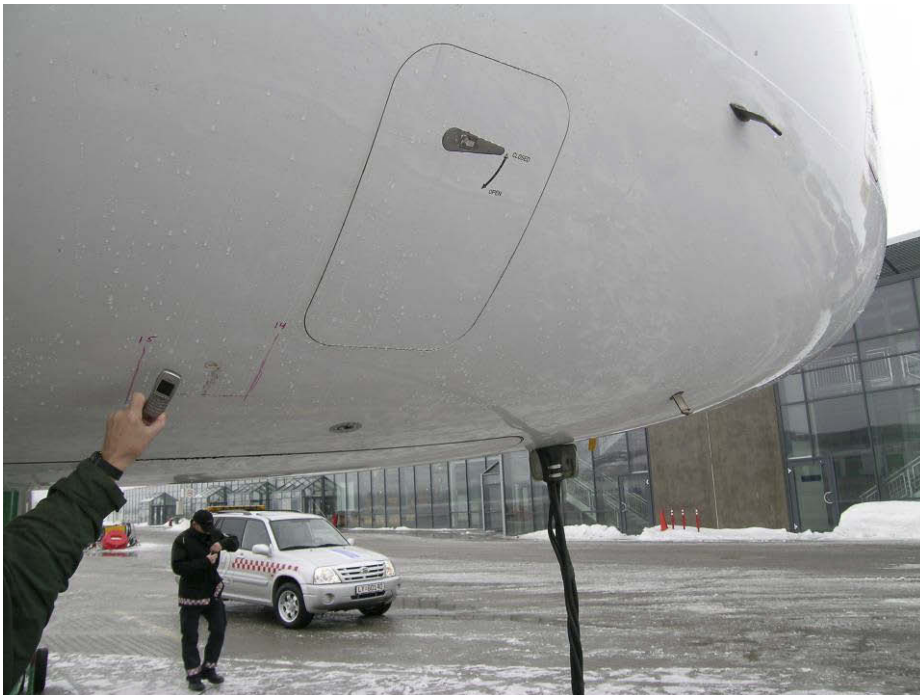
Figure 9: Minor indentation in the fuselage between stations 14 and 15.

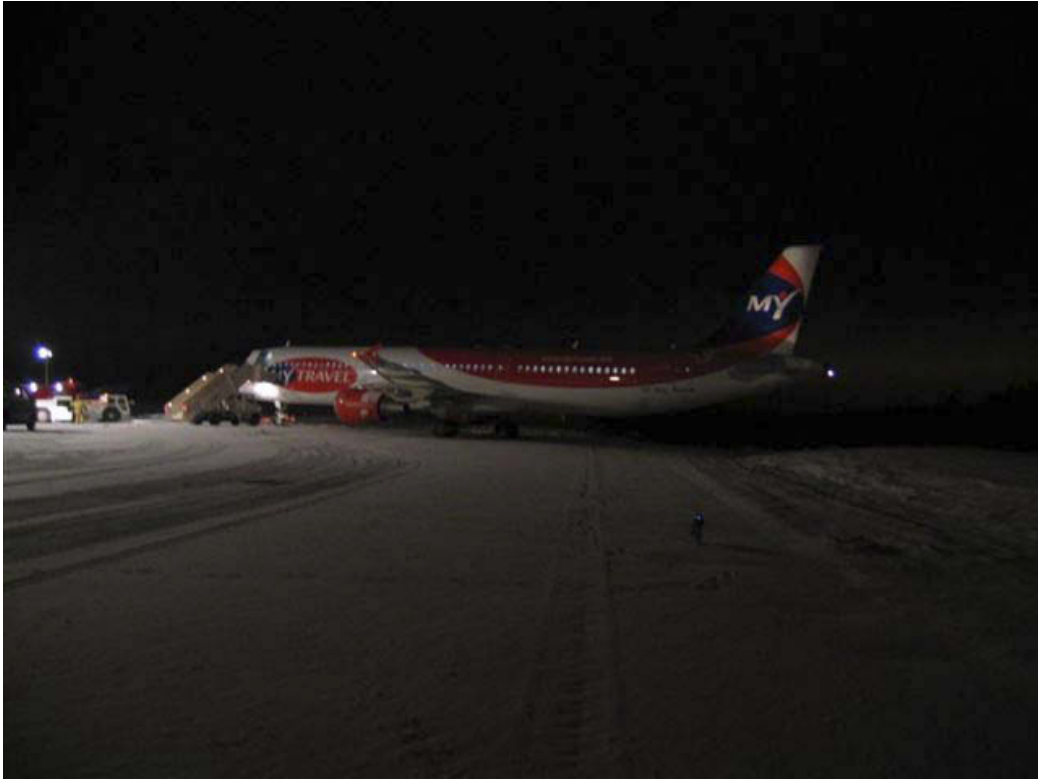
The aircraft stopped with the nosewheel perched against the concrete base of a Localizer Monitoring antenna and ended up standing across runway 18 with its nose facing approx. 65° (HDG 114°) off the runway direction, and with the right-hand side main wheel approx. 2 metres away from the end of the hard runway surface. Figures 10 and 11.

Figure 10: The aircraft stopped across runway 18 at the end of the hard surface.

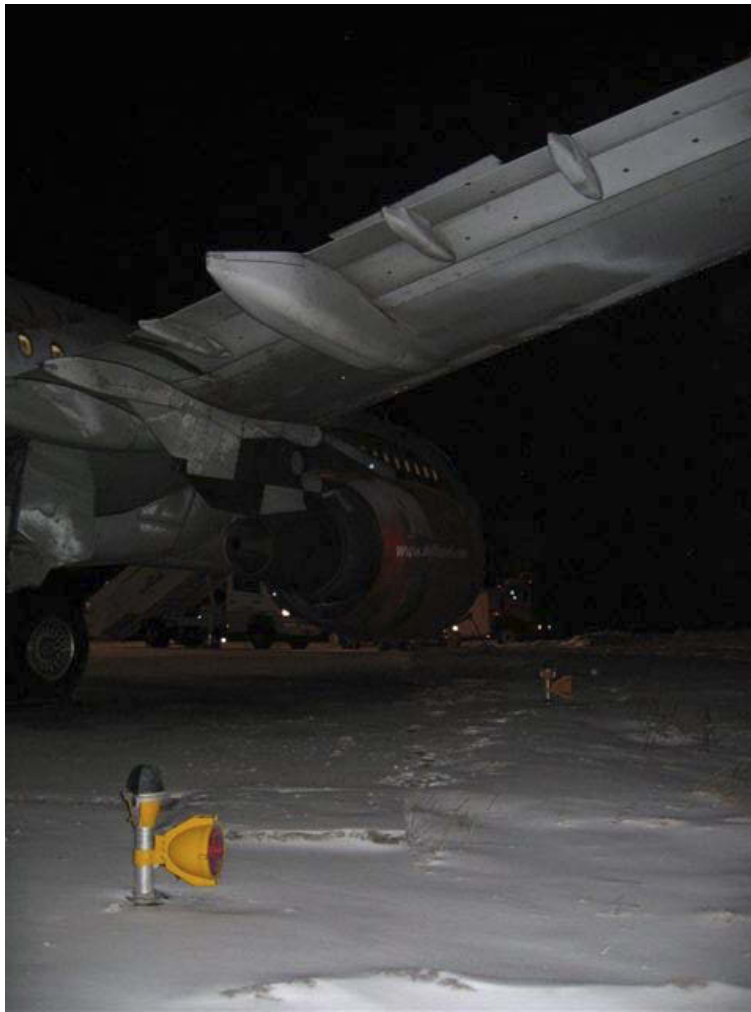
Figure 11: The right main wheel ended up approx. 2 m from the end of the runway.
