ACCIDENT

Aircraft Type and Registration:	DHC-8-402 Dash 8, G-ECOZ
No & Type of Engines:	2 Pratt & Whitney Canada PW150A turboprop engines
Year of Manufacture:	2001
Date & Time (UTC):	1 November 2009 at 0949 hrs
Location:	London Gatwick Airport
Type of Flight:	Commercial Air Transport (Passenger)
Persons on Board:	Crew - 4 Passengers - 42
Injuries:	Crew - None Passengers - None
Nature of Damage:	Tailstrike, aircraft skin abraded and fuselage frames deformed. Runway surface damaged
Commander's Licence:	Airline Transport Pilot's Licence
Commander's Age:	47 years
Commander's Flying Experience:	10,260 hours (of which 902 were on type) Last 90 days - 180 hours Last 28 days - 50 hours
Information Source:	AAIB Field Investigation

Synopsis

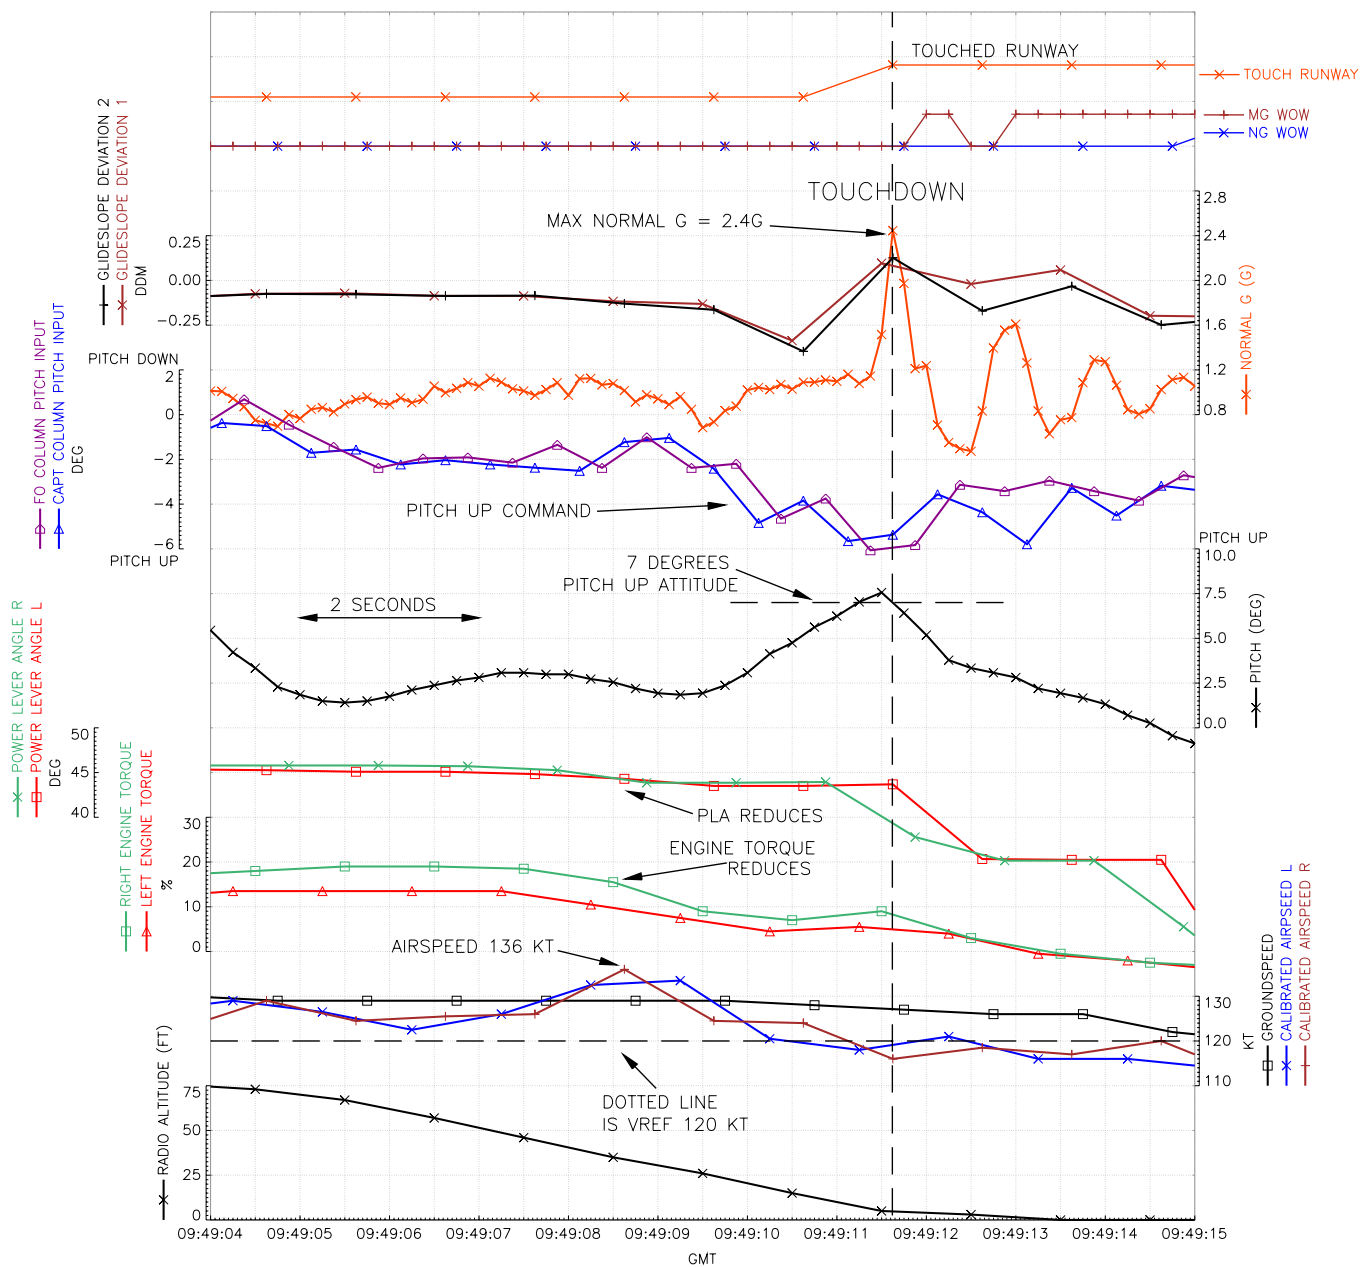
Figure 1

At about 40 ft agl the recorded data showed an indicated airspeed increase to 137 kt. The commander responded by reducing torque to 8%. The aircraft speed decreased to V_{REF} and stabilised with the rate of descent initially remaining constant at about the normal rate of 600 fpm. The aural radio altimeter counted down from 50 ft, in 10 ft increments, at a rate which sounded normal to the crew. At 25 ft agl, the commander became aware of an increasing sink rate and initiated a flare which increased the aircraft pitch from about 2.5° to 7.5° over three seconds. The FDR shows that the aircraft now had a significant tailwind with a groundspeed 10 kt greater than its airspeed. The flare did not arrest the

rate of descent and the aircraft touched down heavily on both main gear and the aft fuselage.

The aircraft was equipped with a digital flight data recorder (DFDR) and cockpit voice recorder (CVR), both of which were successfully downloaded at the AAIB. Pertinent FDR data is included in the History of the Flight section and in Figure 1.

In the turbulent conditions encountered during this accident, a large speed variation during the final few seconds, probably caused by windshear, caused the commander to reduce power. Although he subsequently flared to 7.5°, in an attempt to reduce the rate of descent, he was unable to prevent a heavy landing and consequent tailstrike.
