SERIOUS INCIDENT

Aircraft Type and Registration:	Embraer ERJ 190-200 LR (Embraer 195), G-FBEH
No & Type of Engines:	2 General Electric Co CF34-10E7 turbofan engines
Year of Manufacture:	2007
Date & Time (UTC):	1 August 2008 at 1220 hrs
Location:	40 nm NW of Wallesey, en route from Manchester to Belfast City
Type of Flight:	Commercial Air Transport (Passenger)
Persons on Board:	Crew - 5 Passengers - 90
Injuries:	Crew - 1 (Minor) Passengers - 4 (Minor)
Nature of Damage:	No 1 air cycle machine failure
Commander's Licence:	Airline Transport Pilot's Licence
Commander's Age:	48 years
Commander's Flying Experience:	6,500 hours (of which 410 were on type) Last 90 days - 147 hours Last 28 days - 65 hours
Information Source:	AAIB Field Investigation

Synopsis

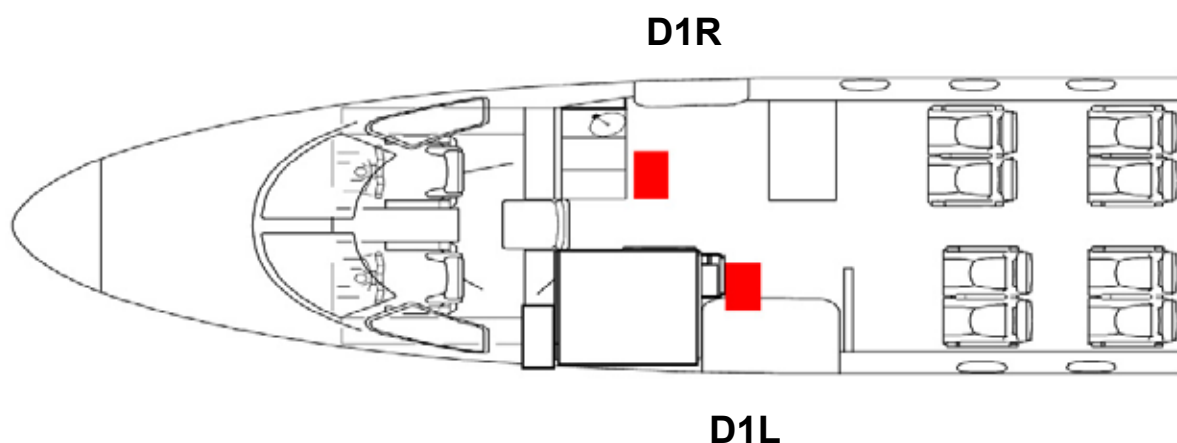
Figure 1

Forward cabin layout, showing forward exits (Doors 1 Left and Right)

None of the passengers evacuated the aircraft via D1R. This, it is considered, was influenced by the staggered layout of the front two emergency exits. In addition, there was only one crew member situated in this part of the cabin to direct and assist passengers during the evacuation and he was standing next to D1L. Passengers would have therefore had to find and use D1R at their own initiative.

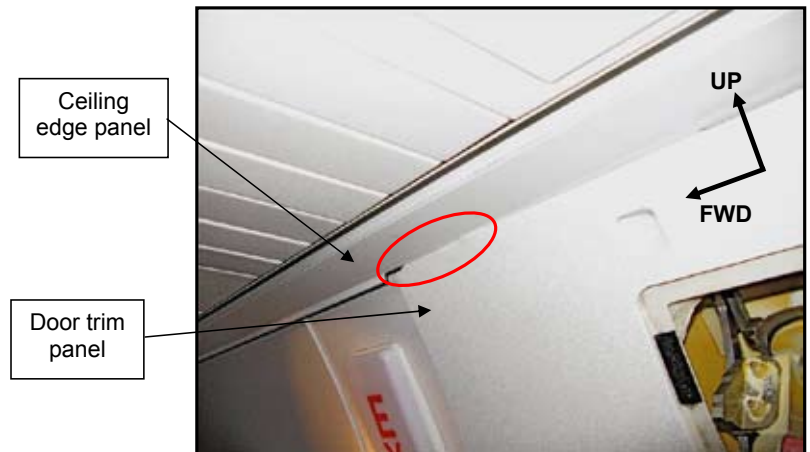
Figure 2

Right overwing emergency exit showing door trim partially jammed (circled) under ceiling edge panel

The right overwing emergency exit door was unlatched, but the forward upper corner of the door trim panel was partially jammed behind the outer edge of the ceiling-edge panel (Figure 2), preventing the exit from being opened.

Although the edge of the ceiling panel was cut back around the top edge of the overwing exit door, the resulting clearance between the door trim and ceiling edge panel was insufficient. Measurements of the right overwing exit showed that over most of its length the clearance was just sufficient to accommodate insertion of a credit card, but near the forward corner of the door, where the door trim had jammed, the clearance was only 0.003 inch.

The jamming of the right overwing exit door occurred because of insufficient clearance between the top edge of the door trim and the ceiling edge panel. To prevent fouling at this location, adequate clearance must be available in the initial stages of door movement until the door trim panel has passed fully beyond the ceiling panel. In the case of the right overwing exit on G-FBEH, there was effectively no clearance, such that the exit immediately jammed on attempting to open it.

Prior to this investigation, no clearance was specified at any location on or around the overwing exit door. After being alerted of this incident by the AAIB, the aircraft manufacturer issued Service Bulletin (SB) 190-25-0092. This required an inspection of the clearance between the overwing exit door trim and the ceiling edge panel, and replacement of the latter if the clearance was less than 2 mm. Additionally, a check was introduced during aircraft production to verify a minimum clearance of 2 mm between the door trim panel and the ceiling edge panel.

The AAIB checks demonstrated that, whilst improving the situation, the 2 mm minimum clearance specified in SB 190-25-0092 was insufficient to prevent the door liner from fouling the ceiling edge panel if the door was lifted firmly as it was unlocked, or if the door was jerked open, as might occur in an emergency. The 2 mm clearance requirement is not entirely effective in eliminating the possibility of a jam. The following Safety Recommendation is therefore made:

It is recommended that Embraer modify the overwing emergency exits on Embraer 195 aircraft, to eliminate the possibility of the exit door jamming due to interference between the door trim panel and the ceiling edge panel.

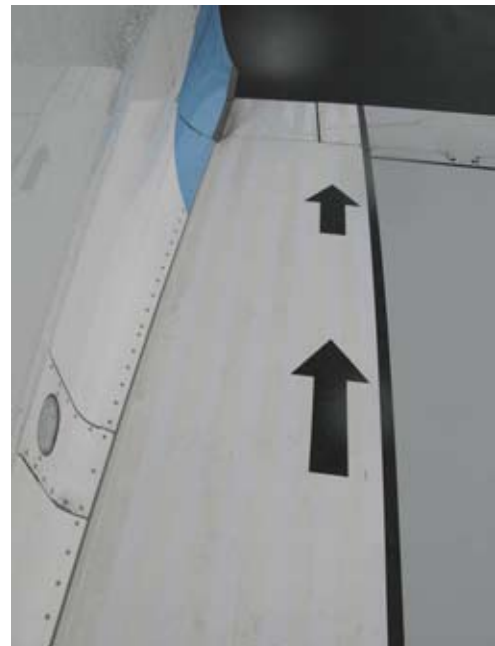
Figure 3

Passengers evacuating via the left overwing exit reported that once out on the wing, there was confusion as to how they should get off the wing down to the ground. A 61 cm-wide walkway was demarcated at the wing root in black paint, with arrows pointing towards the trailing edge (Figure 3). This was not noticed by some passengers; one passenger thought that the markings denoted an engineers' walkway, rather than an escape route. The overriding comment from passengers who evacuated onto the wing was that it was not obvious to them that they were meant to climb off the wing via the trailing edge. Although the wing flaps were lowered in accordance with the emergency evacuation checklist, there remained a considerable drop to the ground of about 1.7 metres.

Overwing exit evacuation route markings (left wing shown, view towards wing trailing edge)

It is apparent from this incident that the issue of ambiguous overwing escape route markings that resulted in AAIB Safety Recommendation 2002-42 still exists. It is therefore appropriate that this matter is re-examined. As responsibility for aircraft certification now lies with the EASA, the previous Safety Recommendation is therefore re-issued as follows:

It is recommended that the European Aviation Safety Agency review the design, contrast and conspicuity of wing surface markings associated with emergency exits on Public Transport aircraft, with the aim of ensuring that the route to be taken from wing to ground is marked unambiguously.

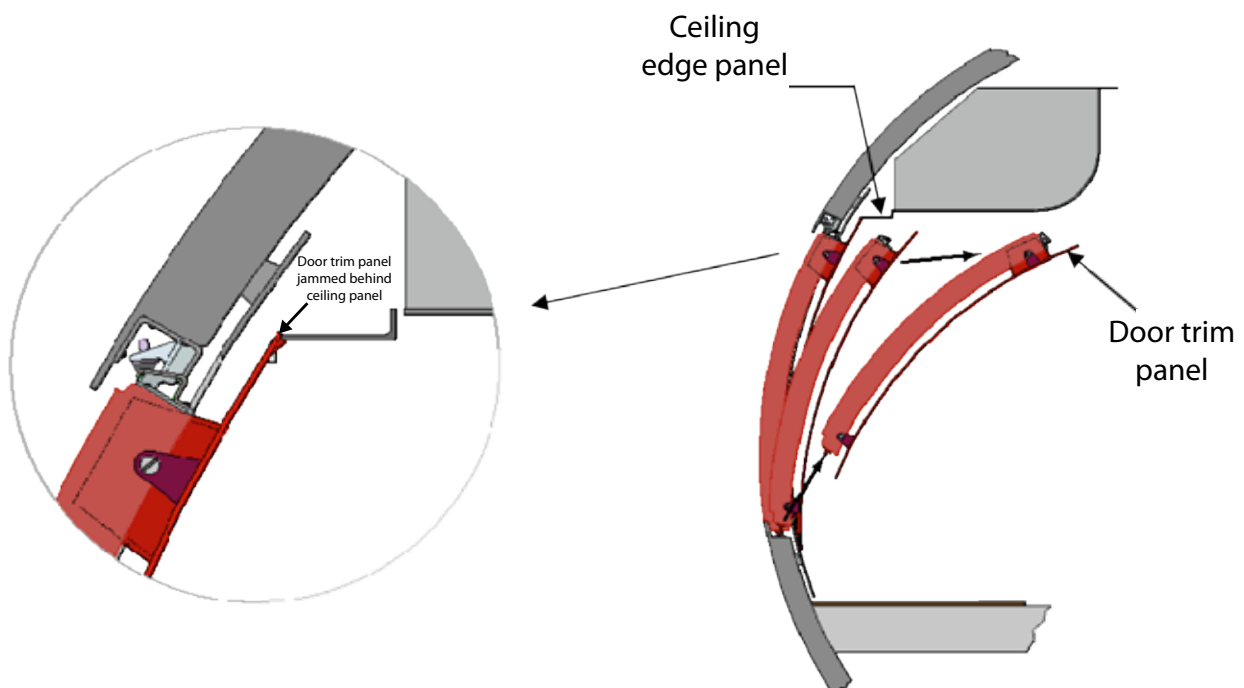
Figure 5

The overwing exit door is retained at its lower edge by spigots which engage in recesses in the bottom edge of the door aperture. Its top edge incorporates a locking mechanism operated by a handle at the top of the door, covered by a removable panel secured by Velcro strips. Pulling the operating handle disengages the lock at the top of the door and allows the door to pivot inwards about its lower edge. The spigots remain engaged until the door has pivoted inwards sufficiently for its top edge to clear the aperture, after which it is lifted clear of the aperture using a fixed handle near its base to support its weight. The door must then be thrown out of the aperture so that it does not cause an obstruction in the cabin to evacuating passengers. A compressible rubber bumper block limits the vertical displacement of the door during the initial phase of opening.

Overwing emergency exit opening, showing location of jam

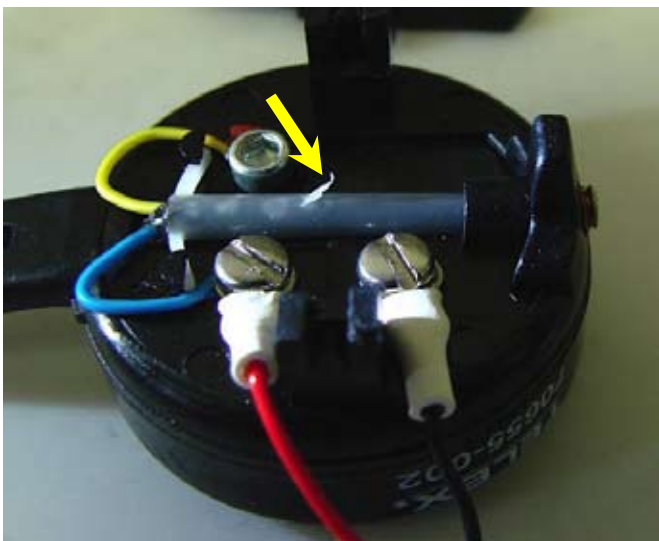
Figure 6

Disassembly of the captain's mask from the other aircraft identified a spurious whisker projecting from the plastic housing of the cut-out switch, the free end of which contacted the underside of the flow sensor pivot. The

whisker acted as a ratchet, tending to inhibit movement of the sensor vane in the direction required to reactivate the microphone, whilst leaving its motion in the direction required to cut out the microphone unaffected. Consequently, the mechanism tended to stick in the cut-out position, leaving the microphone open circuit. The whisker or spurious material appeared to be a ‘curl’ of the switch casing material (Figure 6), probably created either in the production of the switch itself, or during its assembly into the mask.

Whisker of plastic material on cut-out switch

In the light of these findings, the mask manufacturer undertook a detailed review of its design and manufacturing processes. This resulted in an improved physical location of the magnet at its attachment to the flow sensor vane, the use of adhesive to prevent movement of the switch body once its position has been adjusted to provide the required change-point, and the addition of quality checks to ensure that switch casings supplied to the company are free of burrs.
