Investigation Report

EX005-0/05
July 2010

Type of Occurrence: Serious Incident
Date: 18 July 2005
Location: Nuremberg
Aircraft: Civil Air Transport
Manufacturer / Model : Embraer / EMB 145
Injuries to Persons: None
Damage: Slight Damage to Aircraft
Other Damage: None
Source of Information: Investigation by BFU

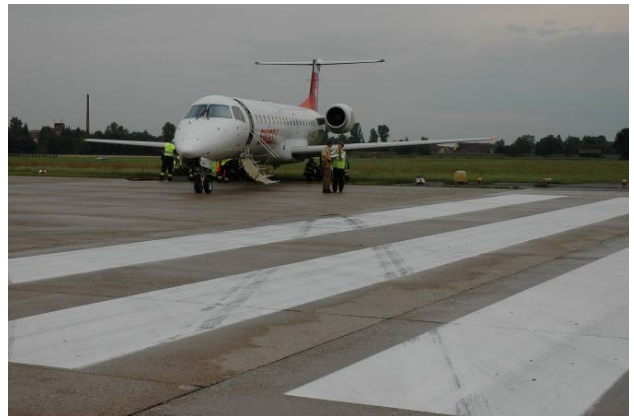
The crew reported that braking action failed to bring the aircraft to a stop before the end of the runway. The pilot-in-command was at the controls and steered the aircraft at high speed left into runway exit F, which is at 90° to runway 28. The aircraft ground looped about 200° to the left, leaving the runway tail first and coming to rest with the main landing gear units on the grass.

Aircraft position after the occurrence

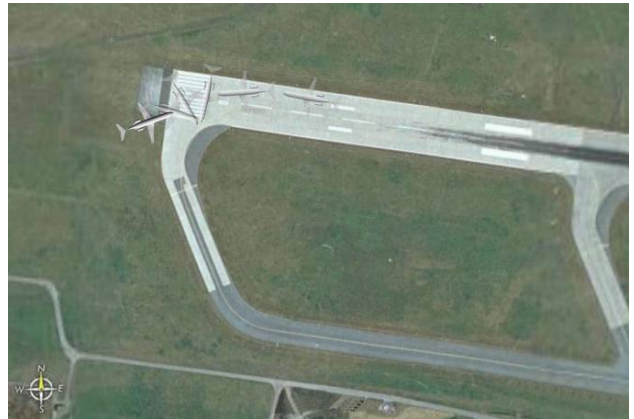
Aircraft position on coming to rest

The aircraft came to rest at the end of the runway about 30 metres south of the runway centreline with the main landing gear on the grass. The aircraft nose was pointed east, opposite to the direction of landing. The landing gear tyres were damaged. Light-coloured brake marks – which looked as if they had been formed by steam cleaning – from the main landing gear were found on the runway. In addition, a large quantity of flaked foam rubber was found on the runway.

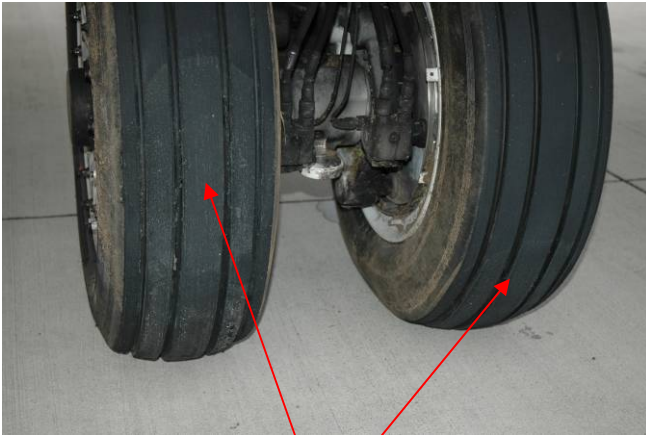
Both, the marks on the runway and the molten tyre rubber on all four wheels of the main landing gear were indicative of a rare type of aquaplaning known as Rubber Reversion Hydroplaning.

Traces of aquaplaning on the tyres

This type of aquaplaning can already happen on moist runways. If the wheel rotation should become blocked, the combination of frictional heat and moisture on the runway result in the formation of a steam cushion between the tyre and the runway surface supporting the aircraft. This can occur at speeds below the otherwise usual aquaplaning speeds.

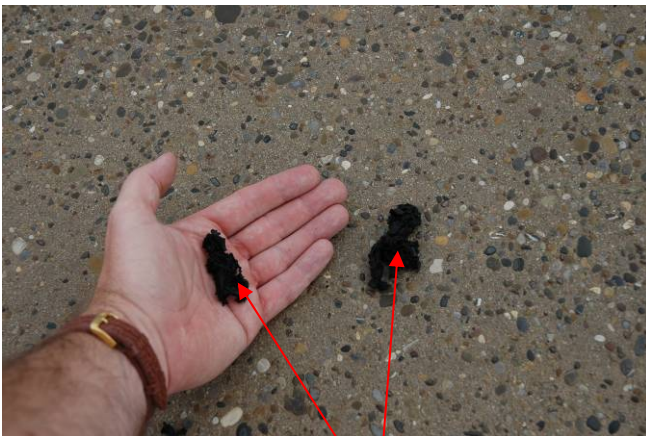
Molten rubber flakes

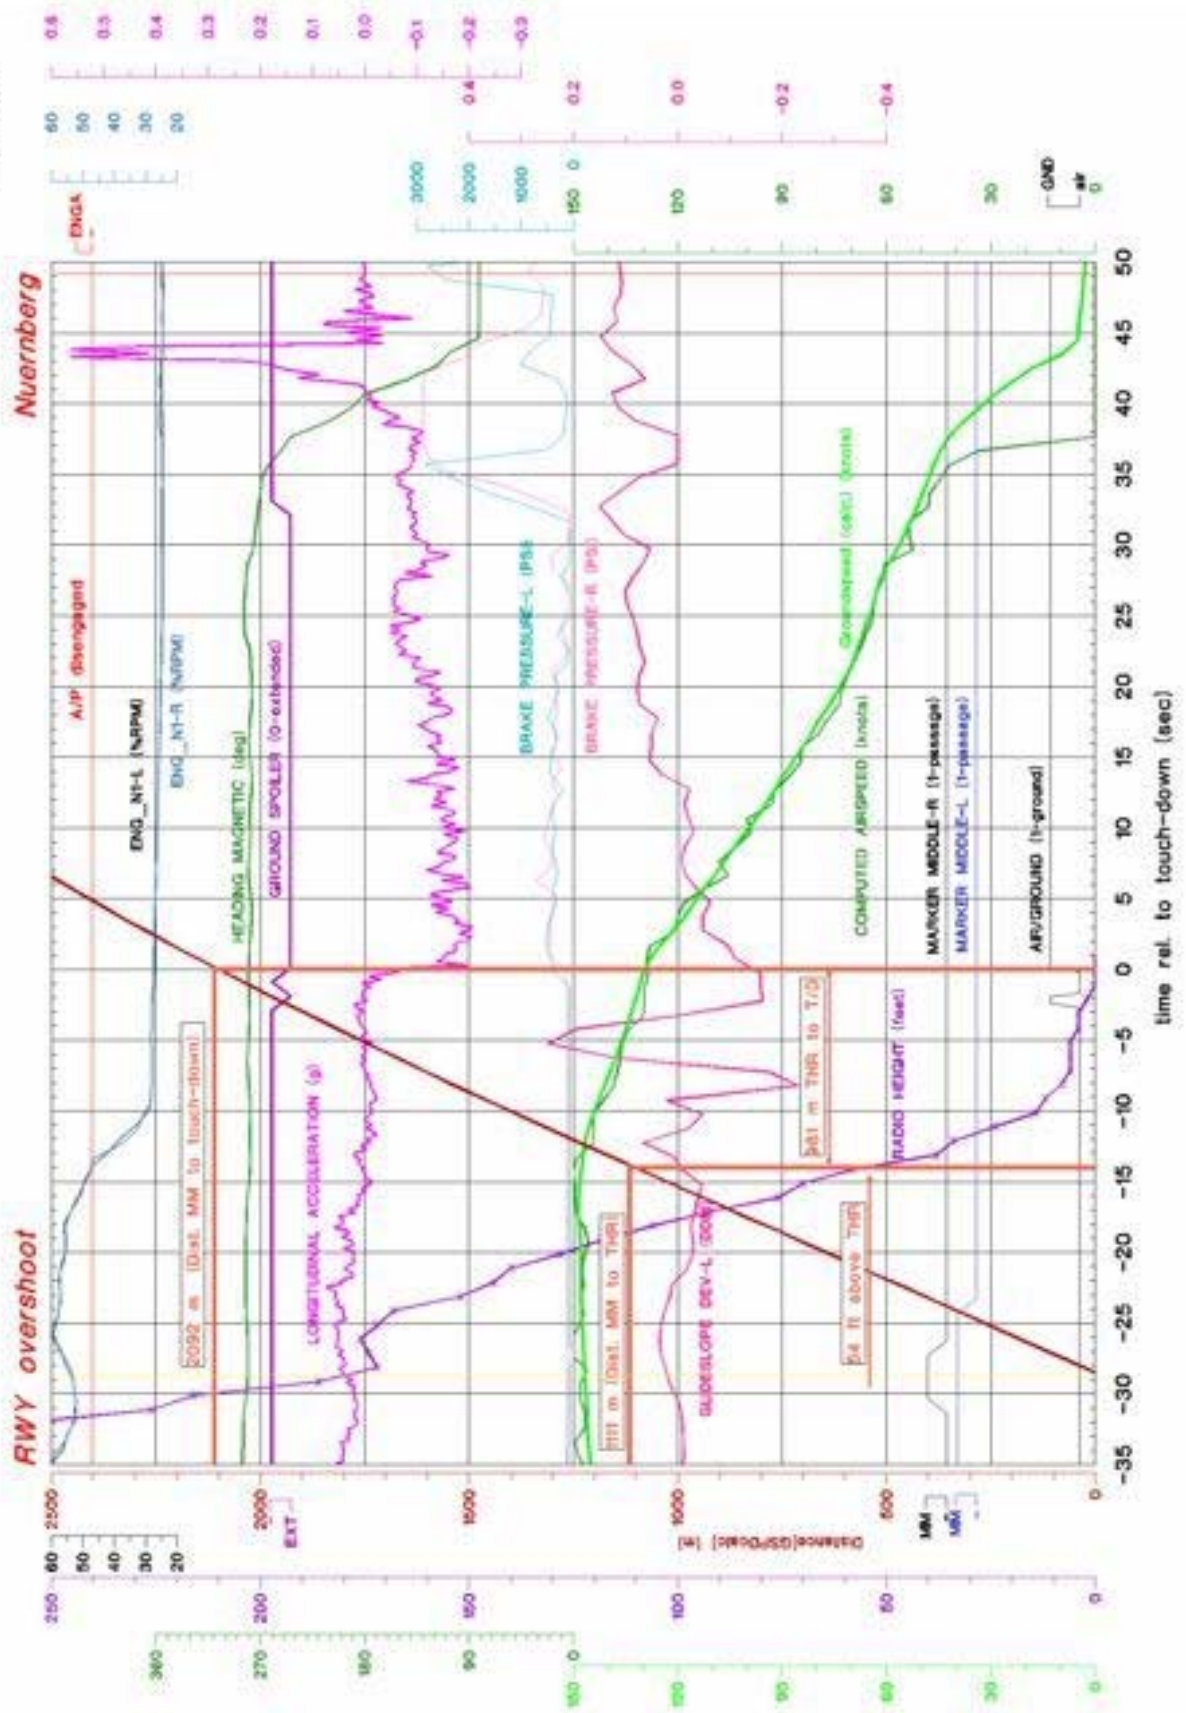
Appendix 2

The Flight Data Recorder trace showed that the approach to land was very uneven and unstable as a result of strong turbulence. There were sudden variations in speed, and the engine power (N1) required constant correction.

It was apparently quite difficult for the crew to keep the aircraft on the 3° glideslope; there was deviation from the glideslope both above and below.

The low braking action of -0.14 g (the normal value is about -0,3 g) in the first 22 seconds after the landing indicates a wet runway. Nevertheless, the friction was sufficient to impart the rotation required to deploy the ground spoilers.

22 seconds after the landing, braking action was halved to -0,07 g; in all probability, this was the moment at which aquaplaning set in.

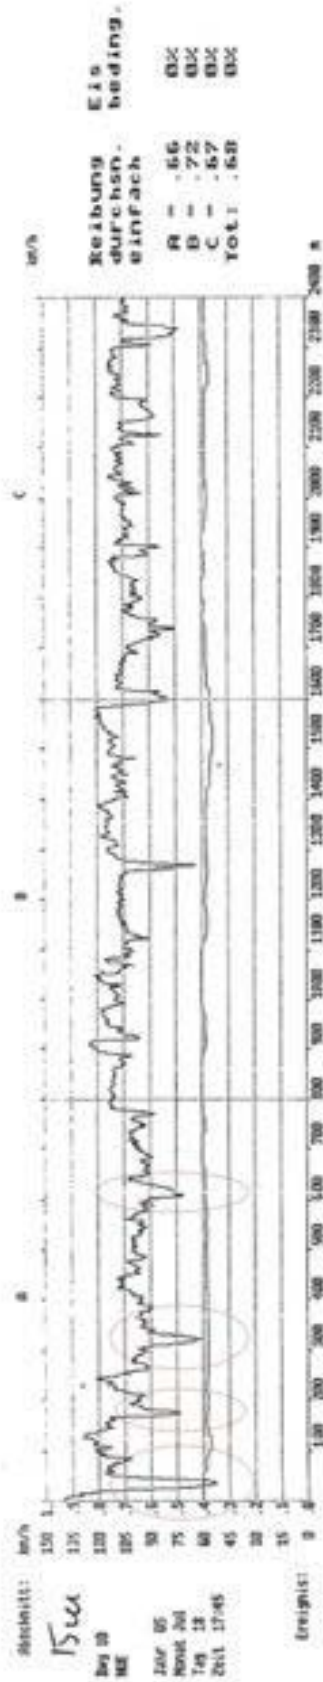
Braking Action Graph

Section A of the trace – the last one third of the runway – reveals several sudden drops in friction values. These might be the result of smooth areas on the runway. (Appendix 4).

Reduced Braking Action in Sector "A"
