## **REPORT OF THE ACCIDENT TO DORNIER 228 AIRCRAFT (9M-PEQ) AT MALE' INTERNATIONAL AIRPORT ON 18TH OCTOBER 1995**

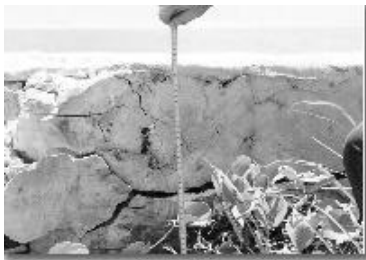
Fig 2. Sea-wall, caused the aircraft to somersault

This area, about 50m to the sea wall, was loose sand, with pebbles and covered with some grass and a lush creeper of about 6 to 8 inches in height. The sea wall was constructed with coral boulders covered with cement mortar and was about 45cm above ground. The ground (dirt surface) was uneven, at the point of impact of NLG there was a slight ramp. The aircraft struck the sea wall in a east-south-east direction nose wheel first, which collapsed rearwards (at frame 7) on impact.

- vii) The height of the sea-wall caused the aircraft to somersault into the adjacent lagoon.
- viii) The aircraft skidded banking to the starboard due to centrifugal forces.

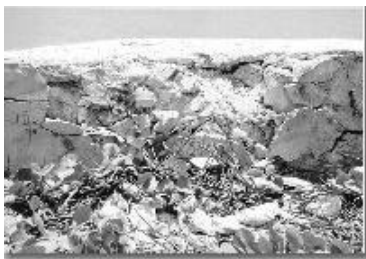
Fig 3. Point of first impact with sea-wall, NLG

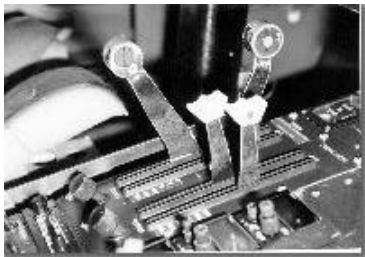
The pilots' statements state that they experienced difficulties in selecting the power levers to ground idle particularly getting them off the gates. The Captain's statement stated that the either one or both power levers were stuck.

Fig 6. Positions of power, speed levers after salvage.

However, field inspection of wreckage, immediately following salvage demonstrated that both power levers could be got off the gates and the RHS had full and free movement. The reason for the left hand side power lever and speed lever jam was because the left hand power lever cable run and pulley assembly located at the left hand leading edge wing root was severely damage during the salvage of the aircraft, thus jamming the mechanism and preventing movement forward or aft.

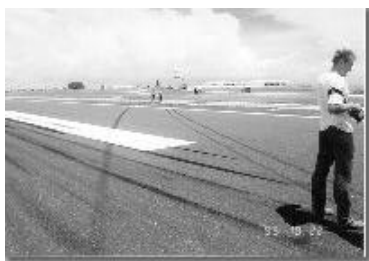
Fig 8. Tyre Marks as aircraft left runway

The tyre marks show all four tyres firmly on the ground, with more weight on the LHS due to the skid to this side. Given the terrain, which was uneven at the sea-wall the indications are consistent with the statements of the pilots, that no attempt was made to get the aircraft airborne upon leaving the runway. Additional computer simulations carried out at Dornier factory; based on field data (in view of the structural damage) does also indicate that this to be the case.

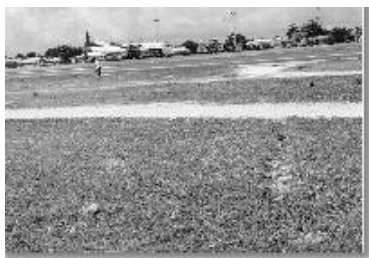
Fig 9. Wheel marks on the unpaved surface.
