**AIR ACCIDENT INVESTIGATION
& AVIATION SAFETY BOARD
(AAIASB)**

AIRCRAFT ACCIDENT REPORT

**HELIOS AIRWAYS FLIGHT HCY522
BOEING 737-31S
AT GRAMMATIKO, HELLAS
ON 14 AUGUST 2005**

Accident of the a/c 5B-DBY of Helios Airways,
Flight HCY522 on August 14, 2005,
in the area of Grammatiko, Attikis,
33 km Northwest Of Athens International Airport

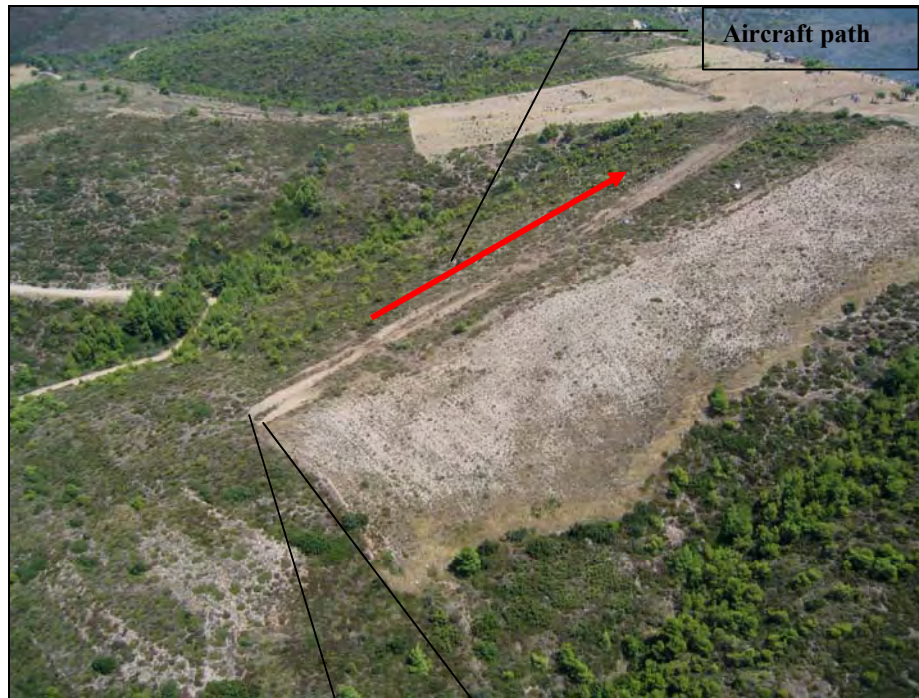
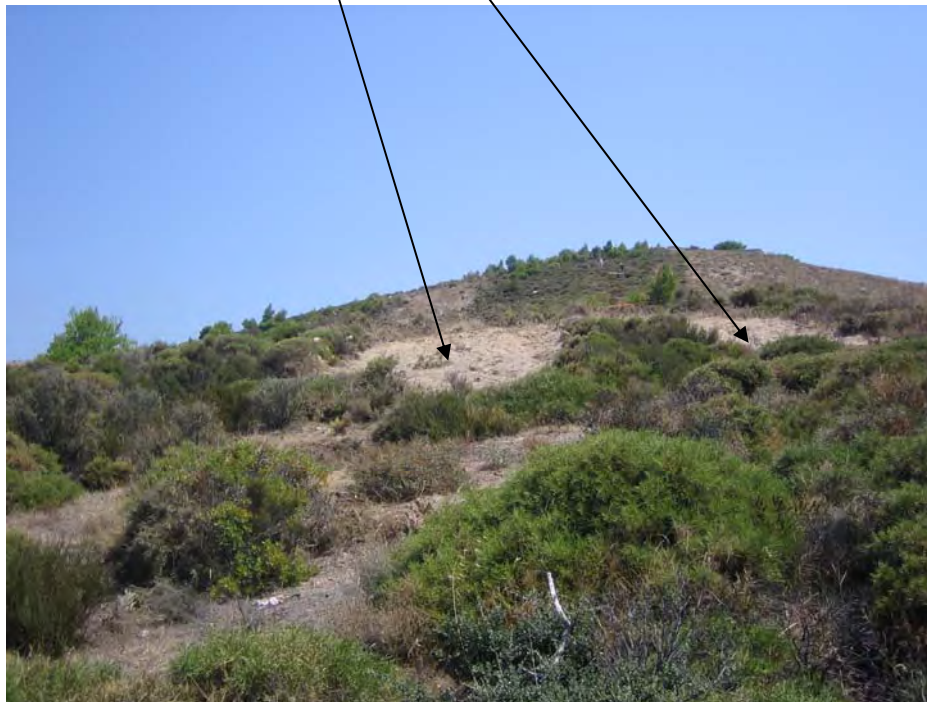
Two adjacent dirt paths (gouges) were found at the initial impact area, which matched the spacing of the fuselage to the right engine. The dirt paths passed through low vegetation on the first uphill slope (See photos on the next page). The wider path was found to be consistent with the 3.7 m width of the fuselage and the adjacent path to the right was consistent with the 2.4 m width of the engine. A third dirt path was found to the left, 10 m down-track from the initial contact of the fuselage and right engine. The location of this dirt path was consistent with the spacing of the left engine from the initial impact of the fuselage and right engine. A 35 cm wide slice through the vegetation began 9 m to the right of the fuselage centerline and 5 m down-track from the initial contact of the fuselage and right engine.

Photos – Initial impact area and first two contact paths on first uphill slope. The path with the width of the fuselage begins in the center of the photo and the path with the spacing and width of the right engine begins near the right side. The slope of the hill is visible as darkening of the path. For scale, the two people immediately beneath the peak of the hill are barely visible.

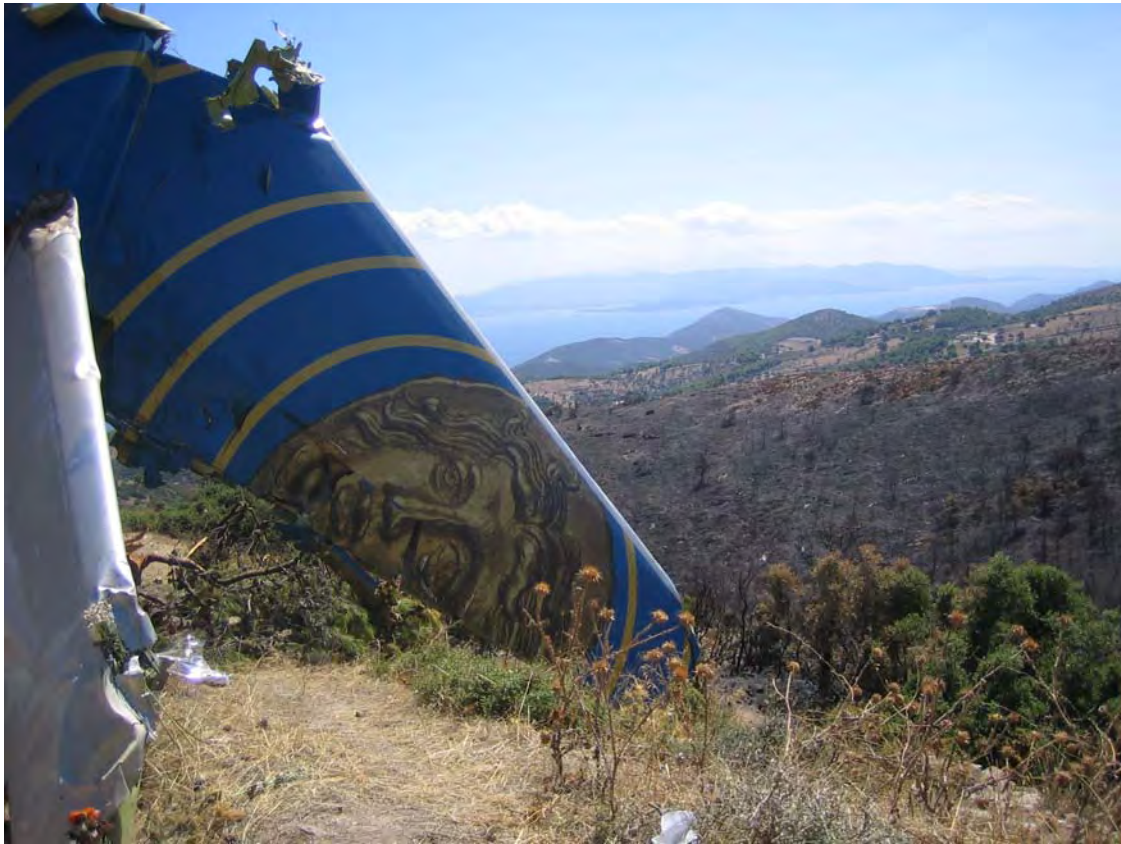
Photo – The tail assembly near the crest of the first hill, with the distant crest of the second hill in the background.

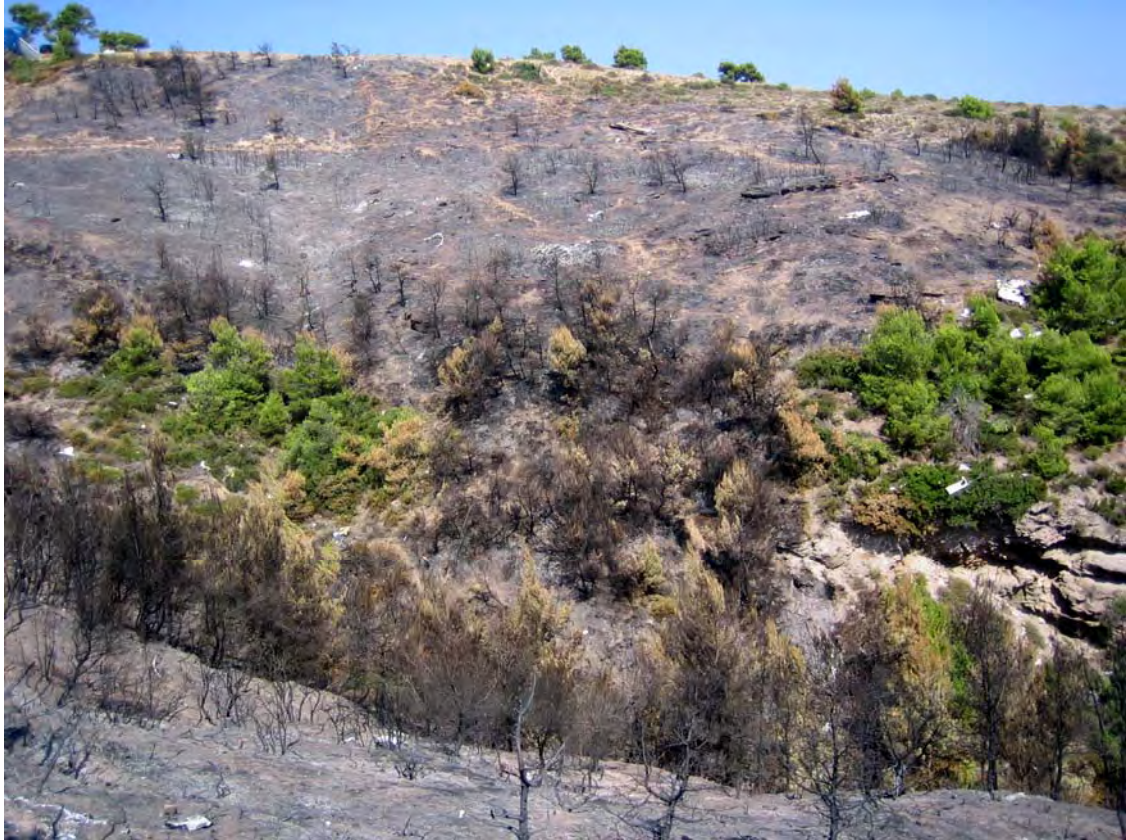
Photo – Viewed backward from the second hill, this photo looks at the downward slope of the first hill into a ravine. The tail assembly is at the extreme upper left corner, beneath the two trees. The skin of the right aft fuselage and top of fuselage is the white material at the right edge of the photo, above the green vegetation. The upper edge of the first ravine is visible along the bottom of the photo, which then drops out of sight.

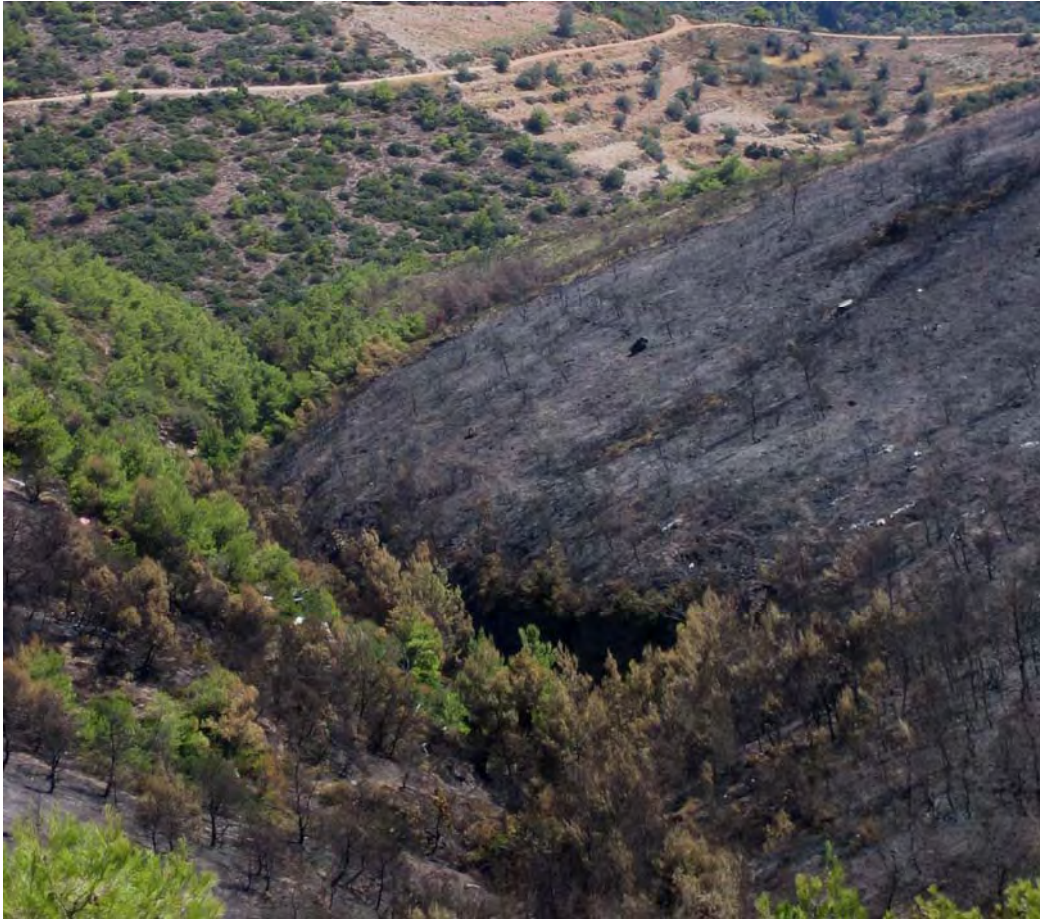
Photo – The downhill slope from the first peak is to the left and the upward slope to the peak of the second hill is to the right. The dark debris in the center of the upward slope to the right is half of the left engine.

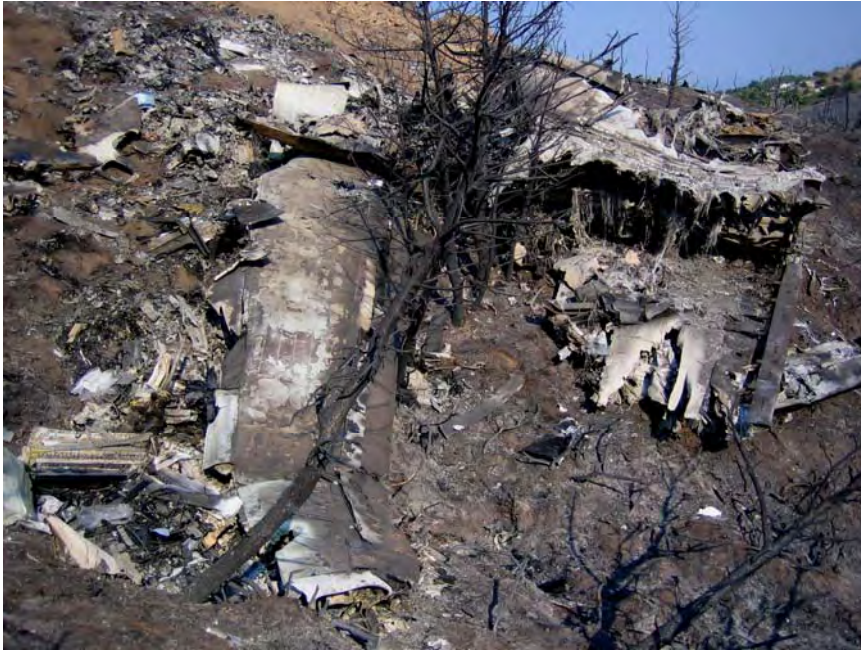
The nearly complete wings assembly was found about halfway down the second slope. The main landing gear well was burned out and was found about 12 m uphill from the wings. The wings were found folded so that the tips were downhill (See photo below).

Photo – The right wing tip is at the lower left and the left wing is at the right edge of the photo. The center section and main gear well is at top right.

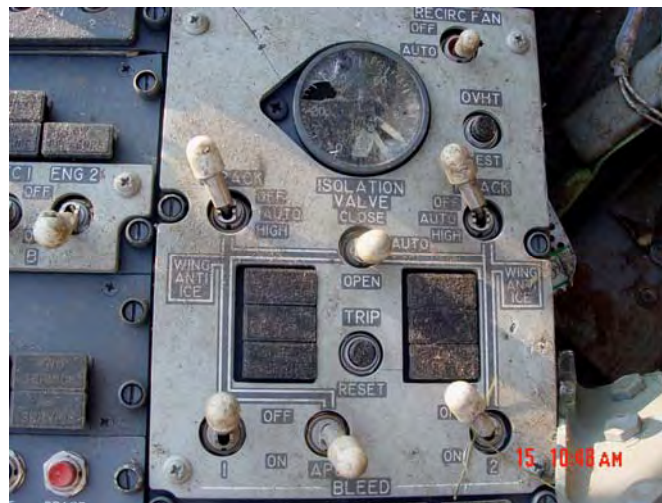
Photo – Air Conditioning Panel

The P5-10 air conditioning panel remained in the P5 overhead panel (See photo below). The panel was photographed and the positions of each toggle switch and the duct pressure indicator were documented.

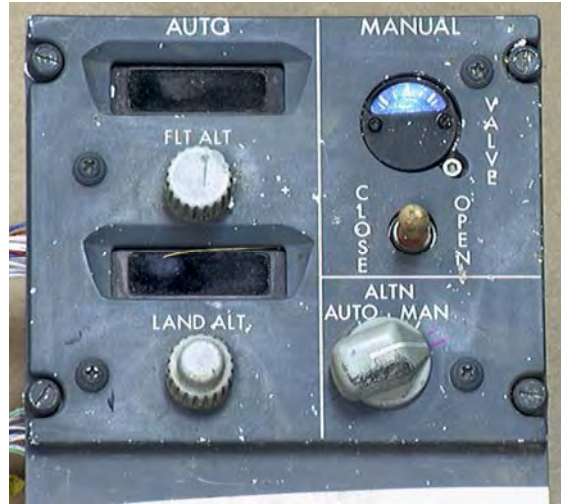
Photo – Pressurization Panel

The P5-5 cabin pressurization panel was found intact and remained in the P-5 overhead panel. The position indicator of the cabin pressure mode selector was found rotated past the MAN (manual) position (on the faceplate) by approximately 7.0 mm. It was later determined by the Boeing EQA that the damage was consistent with physical impact. The selector had an abrasion, in line with the selector line, on its right side at the lower corner. The panel face plate in the vicinity of the AUTO nomenclature had a 180 degree circular impression of the selector base. The center mark on the selector was about 10 degrees from the start of the circular impression (See photo below).

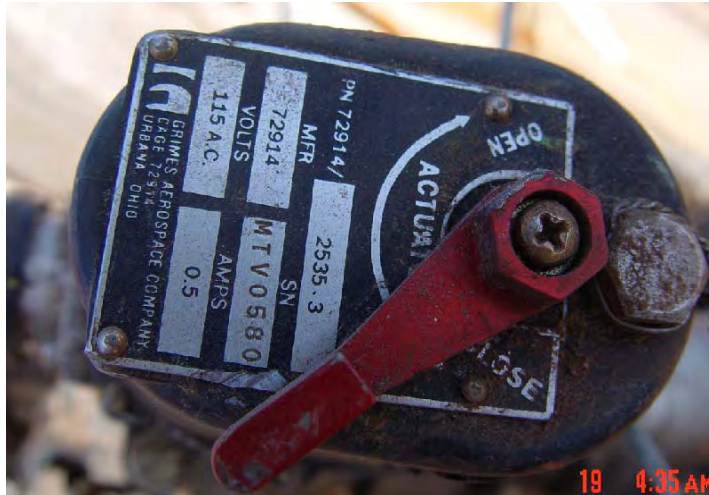
Photo - Forward Outflow Valve

The Forward Outflow Valve (photo below), manufactured by Grimes Aerospace Co., was found intact and connected to its ducting. The manufacturer Commercial and Government Entity (CAGE) code number on the actuator was 72914, which indicated that the actuator was made by Honeywell (the parent company of Grimes Aerospace Co.). The part number and serial number of the actuator were 2535-3 and MTV0580, respectively. The actuator was a subassembly of the Forward Outflow Valve, P/N 32-2684-007. The valve position indicator lever remained in the closed position, and an electrical connector remained connected to the valve assembly. A tag on the valve stated ***“installation eligibility Boeing 747-200, 747-300, 747-400.”*** According to Boeing, this valve is the ***“approved 737 forward outflow valve as verified by part number 32-2684-007 ... the part is also approved for use on the 747.”*** The butterfly valve contained within the assembly was in the closed position.

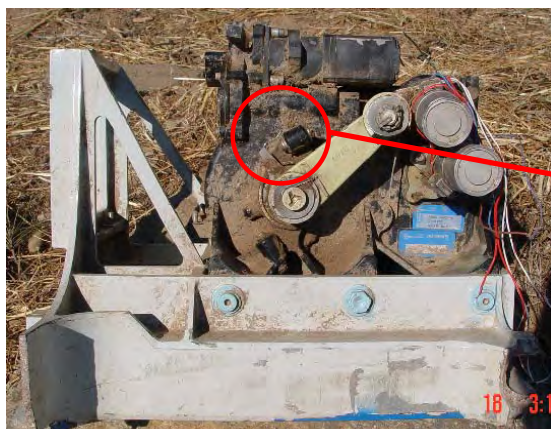
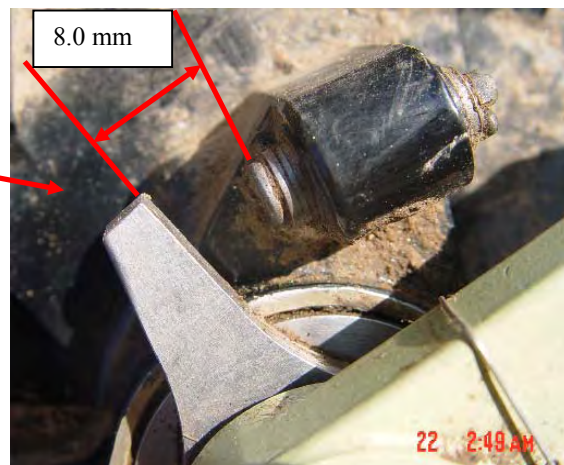
Photo - Aft Outflow Valve at accident site

The actuator/motor assembly and both the forward and aft door gates of the aft outflow valve (AOV) were found at the accident site (see diagram and photos below and next page). The actuator/motor assembly was separated from each of the door gates. The condition of the actuator/motor assembly was documented and photographed at the accident site. The control arm and position indicator remained attached to the motor assembly. Using hand pressure, a small force was applied to the control arm; it was physically locked in place and not able to rotate freely. At the storage facility, a measurement was taken between the closed position stop and the control arm position lever; the distance between the two was 8.0 mm (see photo in the next page).

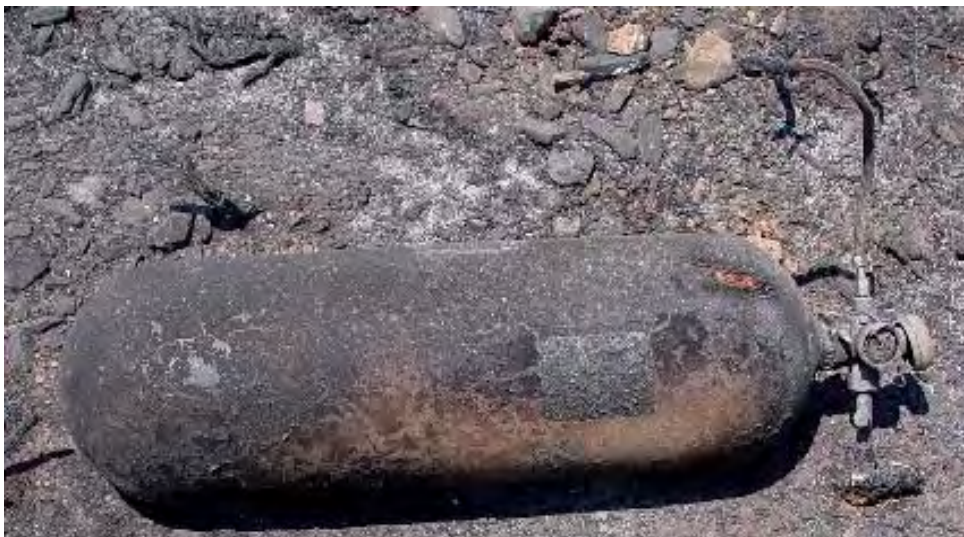
Photo - Flight deck oxygen cylinder

The flight deck oxygen cylinder was found heat damaged and the regulator was missing. (See photo - Flight deck oxygen cylinder). The shutoff valve assembly was observed to be loose on the cylinder and it could easily be rotated in the clockwise and counter-clockwise direction. At the storage facility, the cylinder was visually examined and the regulator valve was physically rotated. Using hand pressure, a force was applied to the regulator valve in the counter-clockwise (valve open) direction; the valve did not rotate. Using hand pressure, a force was applied to the regulator valve in the clockwise (valve closed) direction; the valve rotated six revolutions. The cylinder was empty. The last hydrostatic check had been carried out in September 2003 (09/03 dye stamp on cylinder neck).

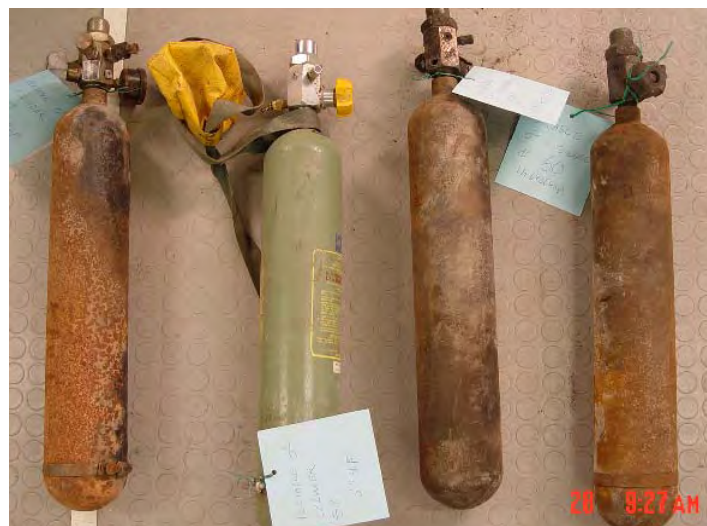
Photo – Portable Oxygen Bottles

- Bottle number 4: The bottle had been exposed to heat. The paint was missing and the exterior of the bottle appeared to be slightly rusted. The shut-off valve was rotated 1 ½ revolutions clockwise to the fully closed position.

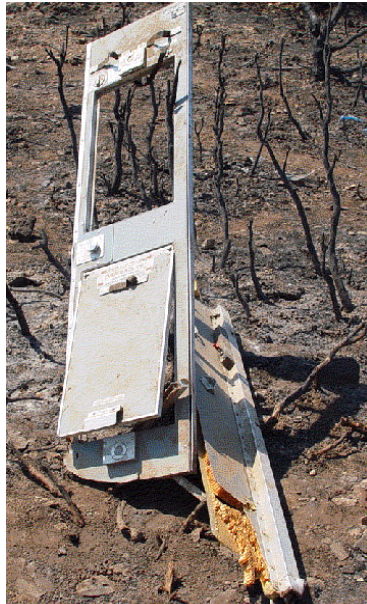
Photo – Flight deck door

on either side of flight deck door faces or lower blow out panel. The door upper blow-out panel was missing. The flight deck access system guarded switch on the door side post fragment was observed to be positioned to “NORM”. The flight deck door deadbolt was found in the “UNLOCKED” position (vertical).

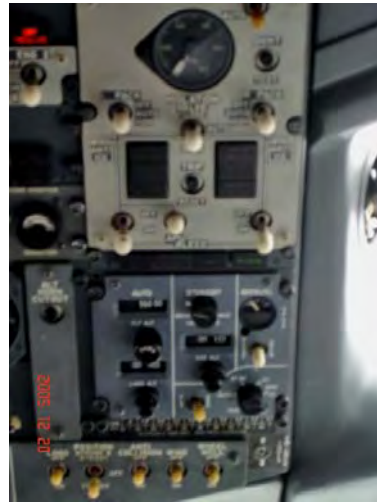
Photo - MANUAL in dim

on DIM and looking up to the overhead panel from the First Officer's seat, the green annunciation MANUAL was not particularly obvious.
