ATSB TRANSPORT SAFETY REPORT
Occurrence Investigation Report AO-2007-070
Final

Leading edge device failure
Norfolk Island
29 December 2007
VH-OBN, Boeing 737-229

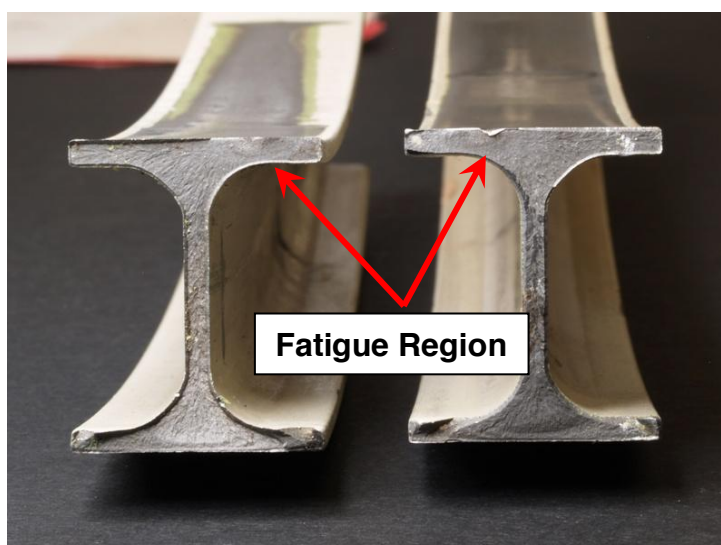
A visual examination of the fracture surfaces showed evidence of a fatigue crack that extended across a substantial portion of the lower flange¹⁵ (Figure 3). A series of machining marks were also observed on the upper and lower track surface. Those marks were considered to be associated with the manufacture of the track. Optical and scanning electron microscopy revealed that the fatigue crack origin was adjacent to the area where two of these machining marks intersected.

Figure 3: Inverted mating halves of the Slat Track fracture

The orientation of the associated fatigue region along the machining marks indicated that the marks probably acted as a local stress concentrator. The fatigue initiation point was potentially also influenced by the pitting of the rolling surface. The machining marks were a normal product of the manufacturing process, and were also evident on the aircraft's other slat tracks that did not fail.

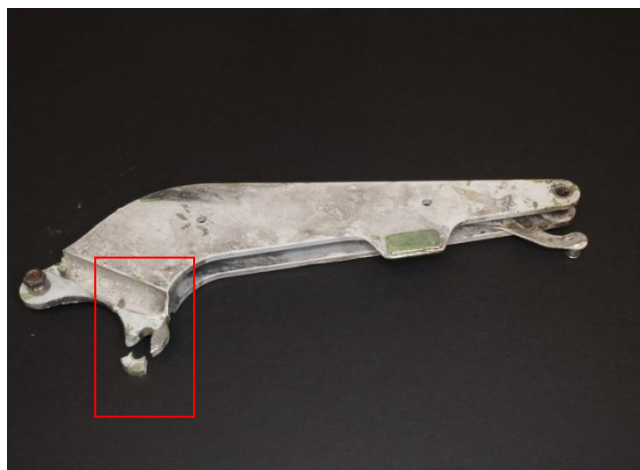
The inboard auxiliary track was found to have failed in ductile overload through one of its bolt holes. That bolt hole had also elongated in the direction of the liberated section. The material around the bolt hole was scored, consistent with the movement of the track in the support (Figure 4).

Figure 4: Inboard auxiliary track showing failed bolt hole (highlighted)

Similarly, the appearance of the inboard auxiliary track failure was consistent with a rapid overload fracture.

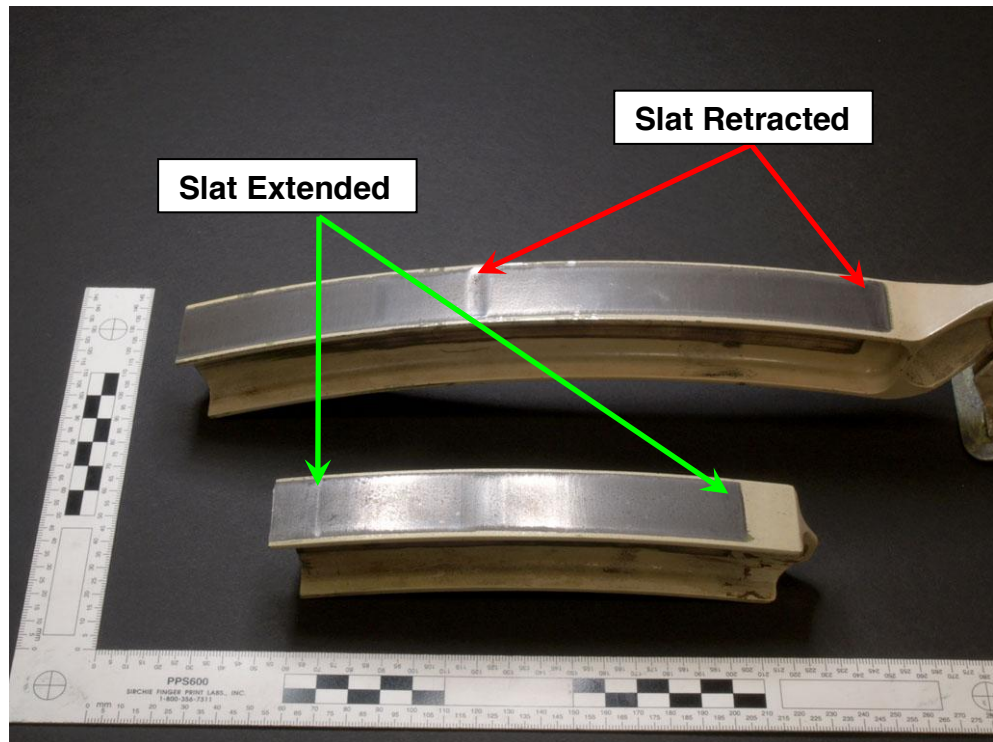
Figure 3. Main upper track roller wear marks

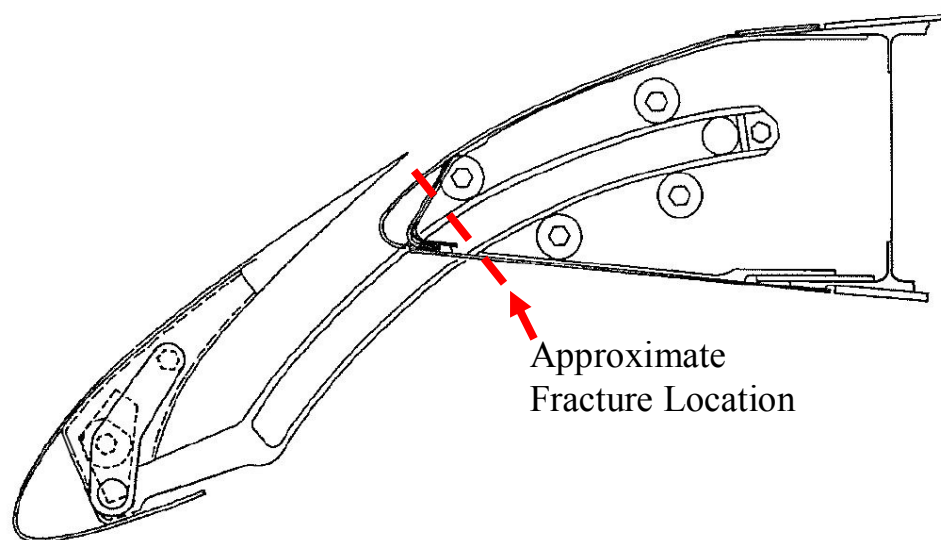
with the slat in the fully-extended position. The failure occurred at a location considered to be the maximum load point when fully extended due to the generation of lift and upward forces acting on the slat in that position.

Figure 4. Fully extended slat indicating fracture location*

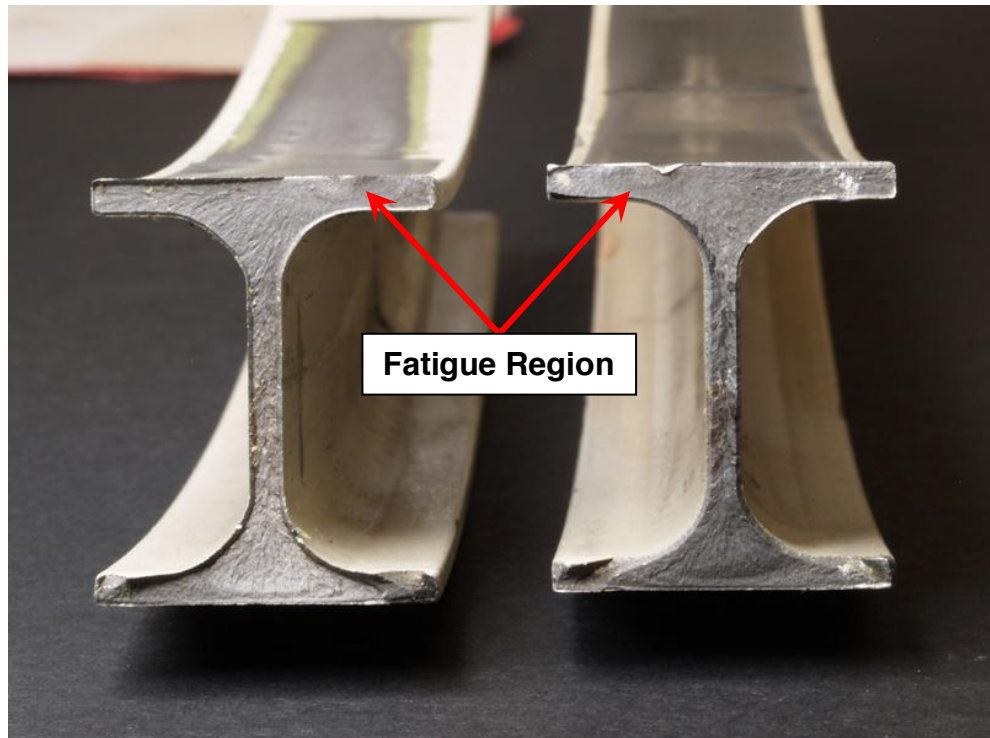
Figure 5. Mating halves of Slat Track fracture

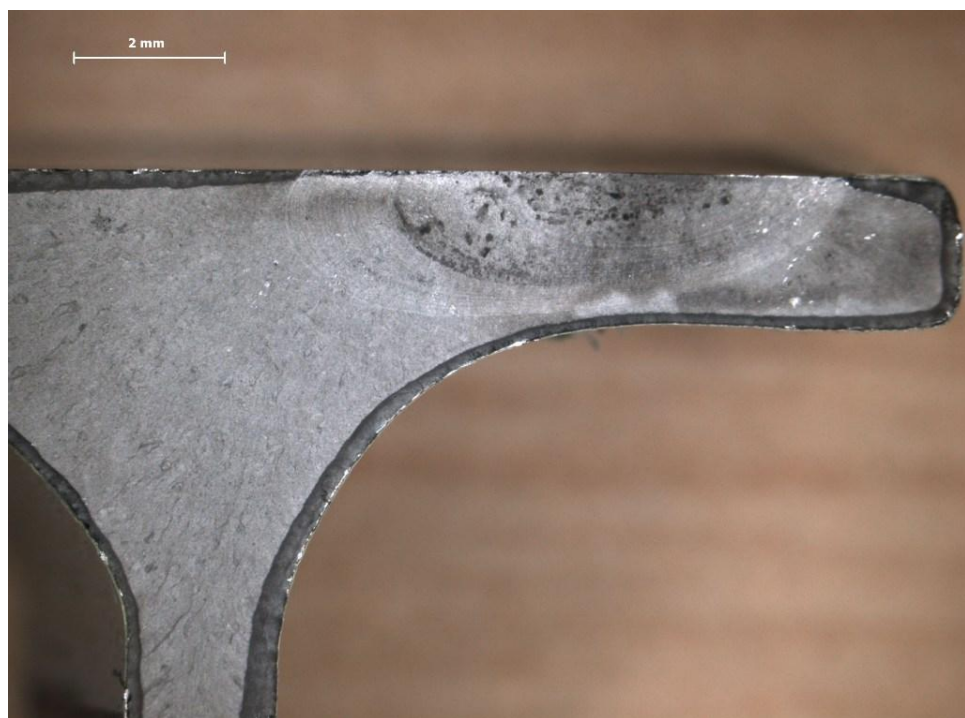
Figure 6. Fatigue region on lower flange exhibiting beach marks

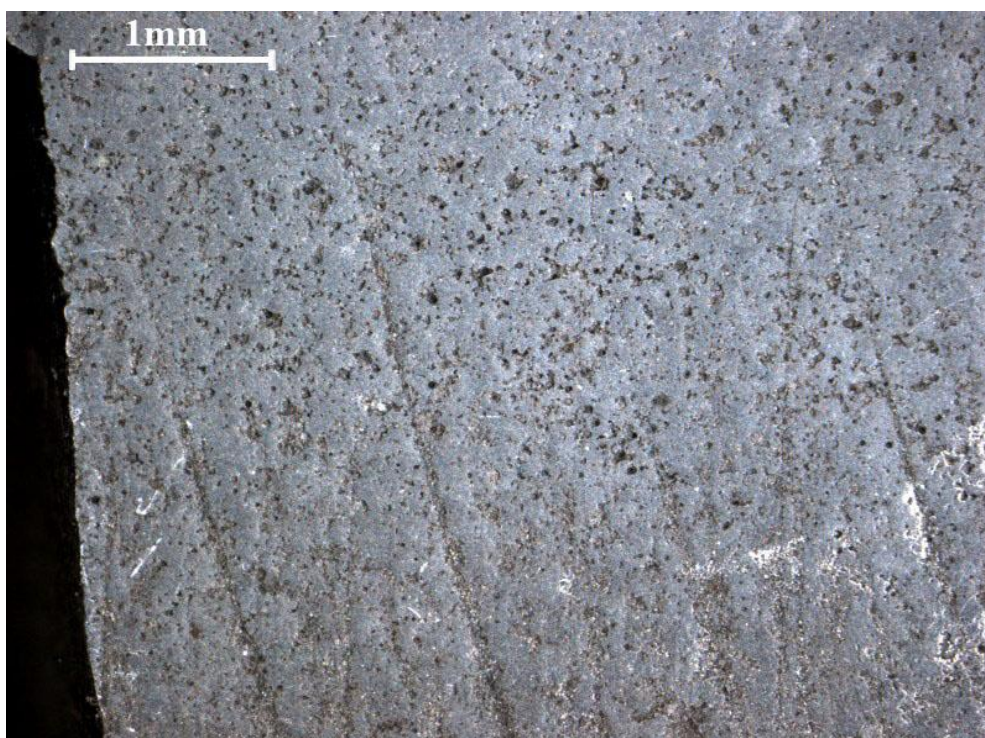
Figure 8. Pitting on the lower flange adjacent to the fracture surface

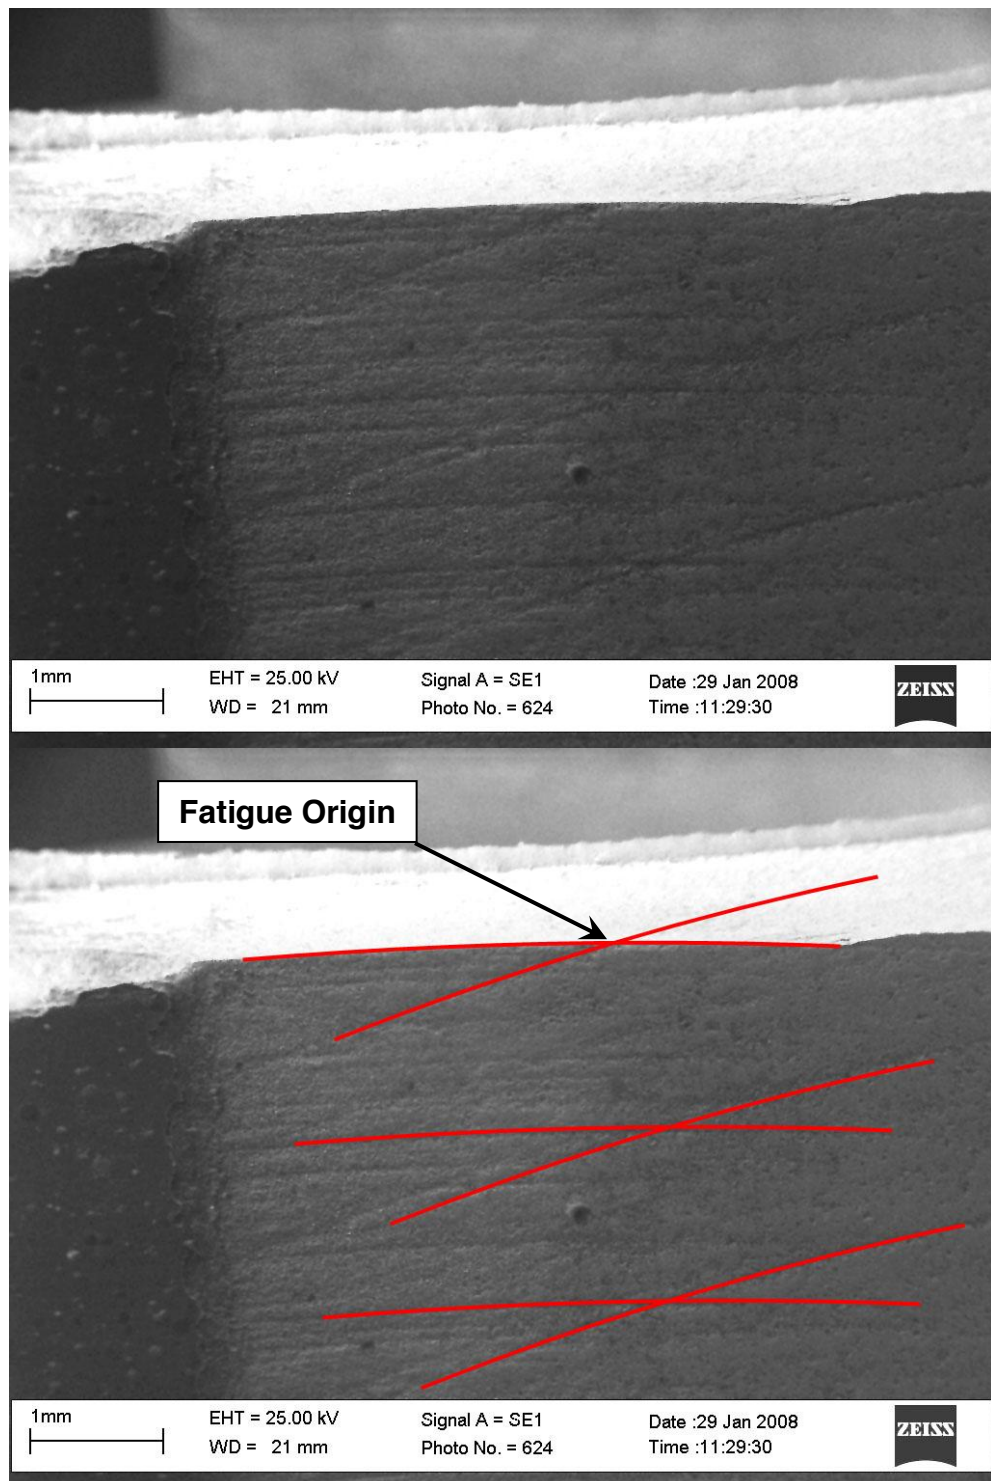
Figure 10. SEM image of machining marks adjacent to fatigue origin.

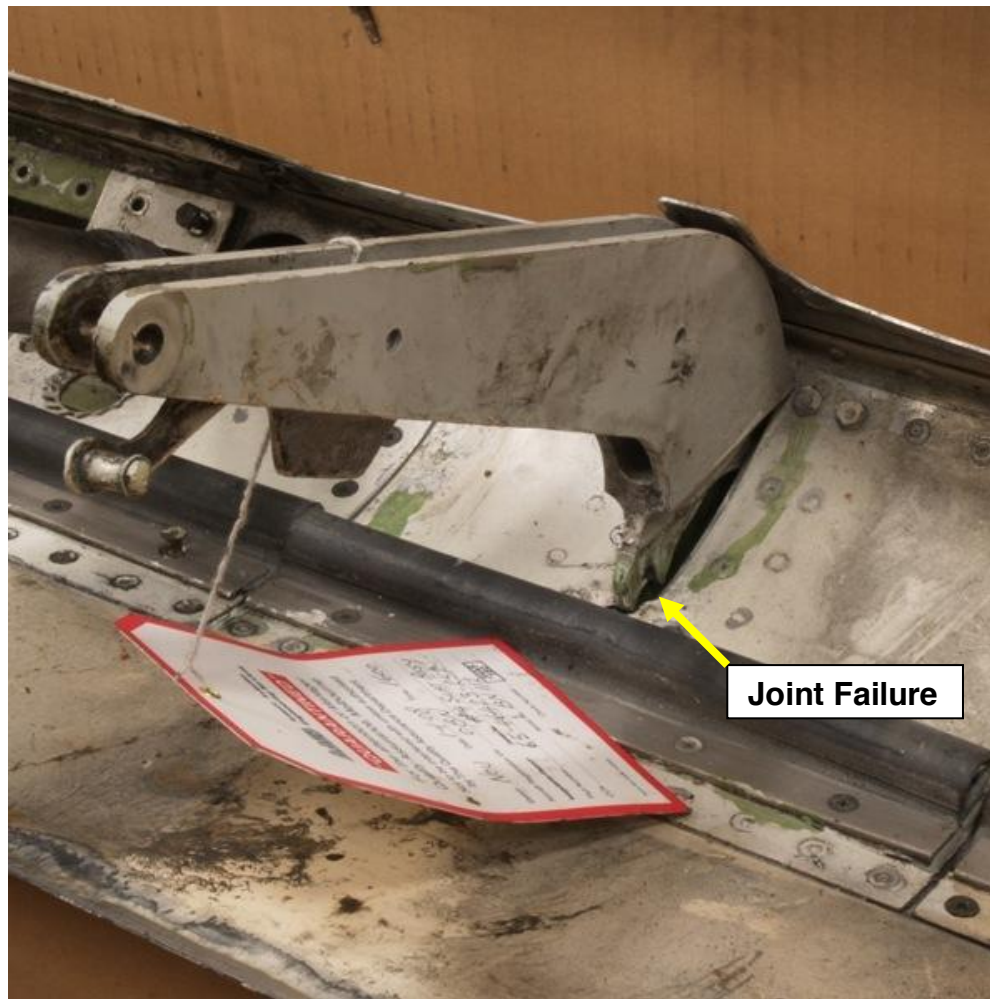
Figure 11. Inboard auxiliary track in situ

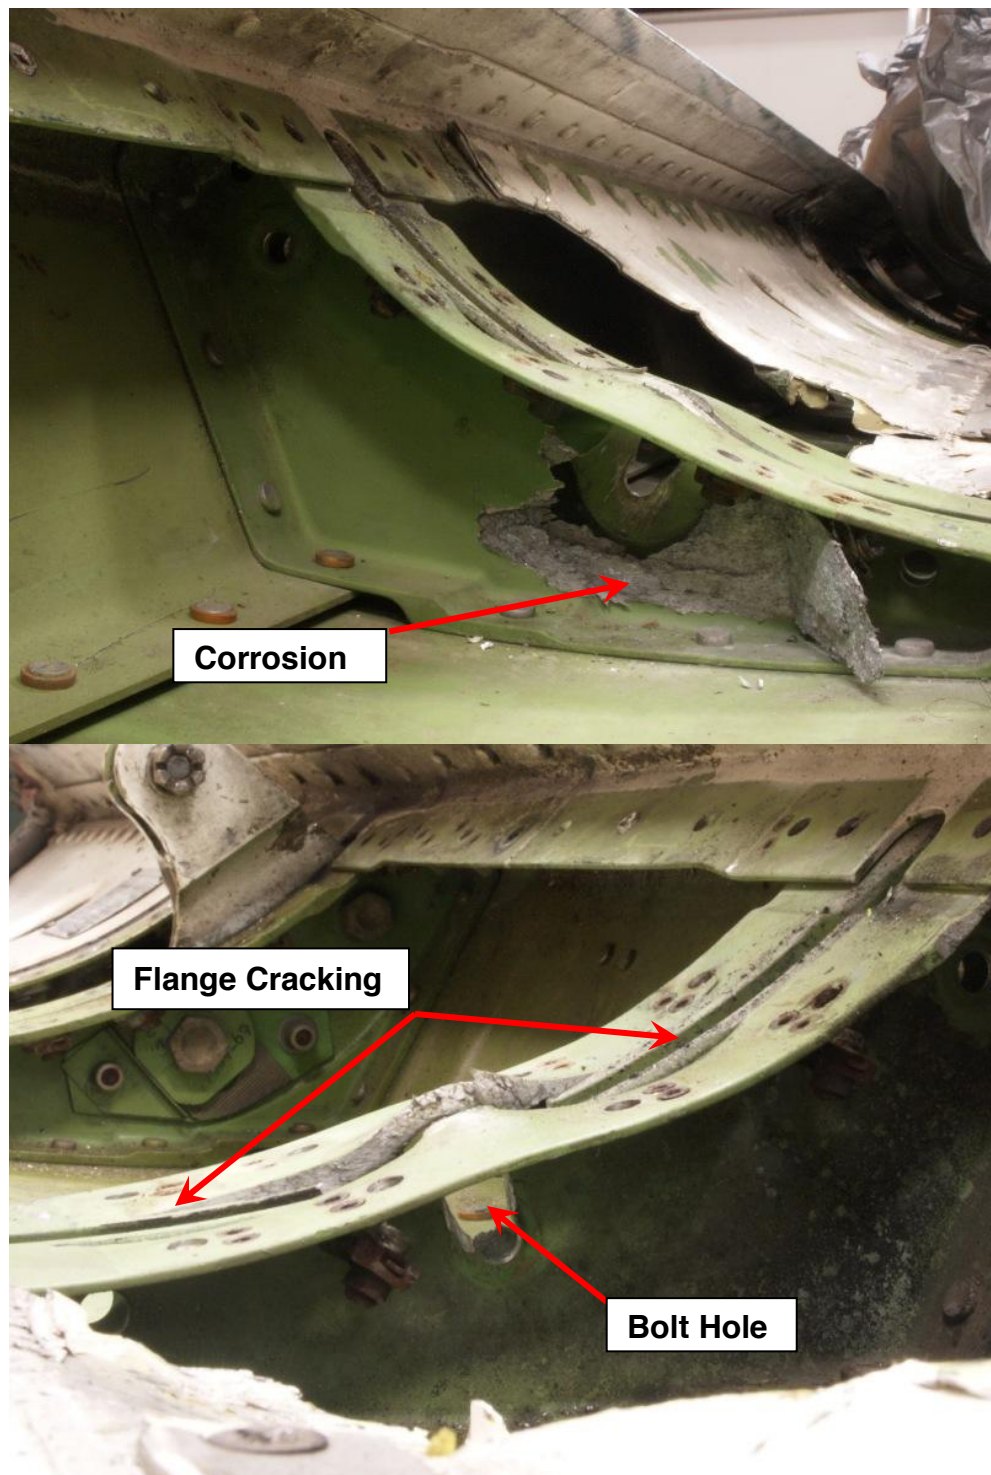
One of the aluminium support ribs for attachment of the outboard auxiliary track had failed as a result of extensive exfoliation corrosion (Figure 13). The corrosion was centred around the cadmium-plated steel bolt attaching the track to the ribs. The remaining rib failed through the bolt hole, which had fractured up to the rib flange. The flanges on both ribs had buckled outwards and were fractured along their length.

Figure 13. Outboard auxiliary track support ribs
