ATSB TRANSPORT SAFETY REPORT

Aviation Occurrence Investigation AO-2008-033

**Operational non-compliance
Perth Airport, WA
9 May 2008
PK-GEF
Boeing Company 737-8CX**

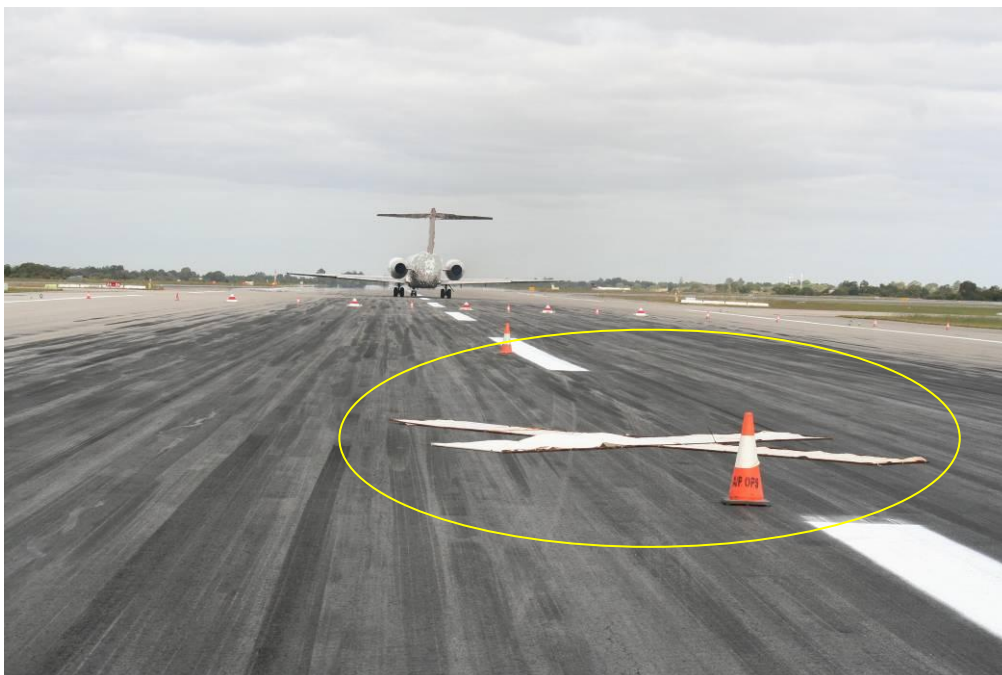
Figure 1: Runway 21 works area looking south. Note the 6m cross (circled)

The flight crew recalled that, during the first approach and subsequent go-around, they did not see the closed runway crosses and that, on the second approach, they saw the closed runway crosses ‘too late’.

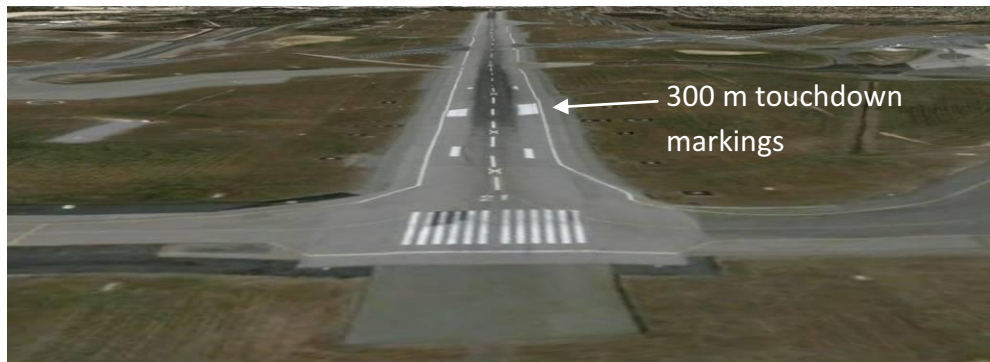
Figure 8: Closed runway 21 markings (6 m) as used at the time of the incident

- The existing runway 21 threshold and touchdown markings were not required to be obscured and were clearly visible to the flight crew. Those markings continued to provide approach and landing cues to the normal touchdown zone, which was located within the runway works area. *[Safety issue]*
- The use of the 6 m closed runway markings in lieu of the recommended 36 m markings increased the risk of a flight crew conducting a visual approach to the permanent threshold/touchdown area. *[Safety issue]*

The use of the 6 m closed runway markings in lieu of the recommended 36 m markings increased the risk of a flight crew conducting a visual approach to the permanent threshold/touchdown area.

During the development of this draft report, the ATSB met with CASA officers to discuss the possible safety benefits of the use of the International Civil Aviation Organization (ICAO)-recommended 36 m closed runway markings in Australia when the affected permanent threshold and touchdown markings were not required to be obscured.

In response to that meeting and the Directly Involved Party process (see Appendix C) CASA advised that, ‘any changes to runway marking standards will be subject to mandatory consultation with industry. The proposal for the use of the International Civil Aviation Organization (ICAO) recommended 36 m closed runway markings will be incorporated into the Part 139 amendment work program.’
