**INCIDENT**

<b>Aircraft Type and Registration:</b>	Airbus A321-231, G-MEDJ	
<b>No &amp; Type of Engines:</b>	2 International Aero Engines V2533-A5 turbofan engines	
<b>Year of Manufacture &amp; Serial No:</b>	2004, MSN 2190	
<b>Date &amp; Time (UTC):</b>	24 August 2010 at 0225 hrs	
<b>Location:</b>	At FL360 over northern Sudan	
<b>Type of Flight:</b>	Commercial Air Transport (Passenger)	
<b>Persons on Board:</b>	Crew - 7	Passengers - 42
<b>Injuries:</b>	Crew - None	Passengers - None
<b>Nature of Damage:</b>	None	
<b>Commander's Licence:</b>	Airline Transport Pilot's Licence	
<b>Commander's Age:</b>	34 years	
<b>Commander's Flying Experience:</b>	Approximately 7,500 hours (of which approximately 1,400 were on type) Last 90 days - 165 hours Last 28 days - 61 hours	
<b>Information Source:</b>	AAIB Field Investigation

**Synopsis**

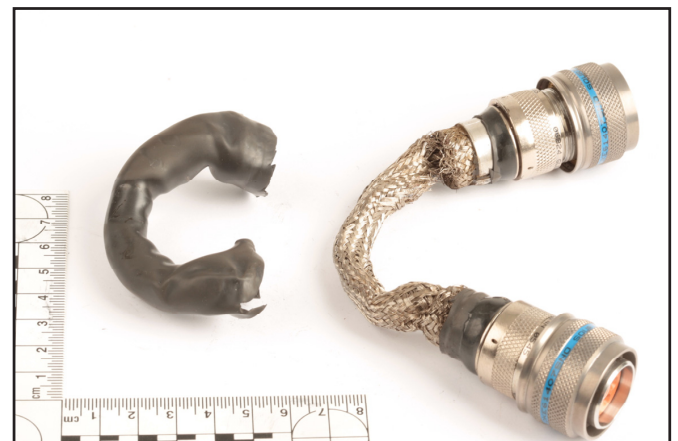
**Figure 3**

IDG1 and GCU1 were then taken to their manufacturer for further inspection. The IDG was subjected to a detailed strip examination under AAIB supervision with experienced overhaul and design specialists from the manufacturer present. The jumper lead appeared distorted (Figure 2) and when the outer cover was removed significant material damage to the wire braid was found at both ends, near the connectors (Figure 3).

Jumper lead with outer cover removed

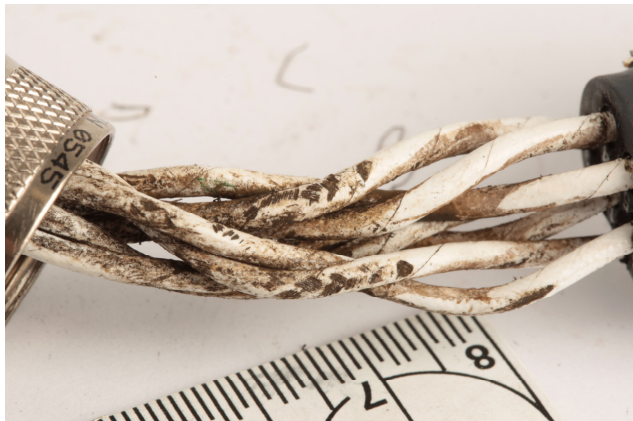
**Figure 5**

The jumper lead was taken to a forensic laboratory for examination. Evidence that the strands of wire braid had been chafing against each other was found (Figure 4). It was confirmed that wear marks made by the braid were present on the insulation of the seven wires inside

the braided outer sheath (Figure 5). The insulation was worn down on some of the cables, exposing the central conductor inside. Some cables exhibited holes in the insulation containing debris that was confirmed by an EDAX<sup>6</sup> technique as being of the same composition as the wire braid. Using a Scanning Electron Microscope (SEM), evidence of arcing was found on wire No 5 (Figure 6). Despite extensive efforts, it was not possible to positively identify arcing or a short on any of the other wires. It was concluded that the failure mechanism of

Close up of wire in jumper lead showing wear marks

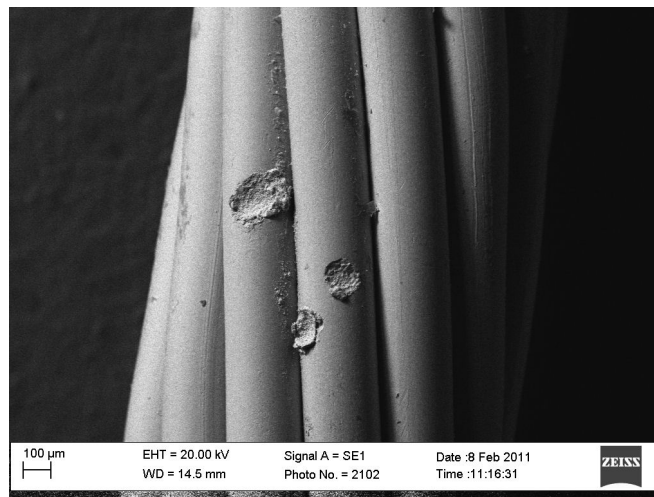
**Figure 6**

SEM image showing arcing damage on surface of strands in wire No 5
