SERIOUS INCIDENT

Aircraft Type and Registration:	Boeing 737-33A, G-CELC	
No & Type of Engines:	2 CFM56-3B2 turbofan engines	
Year of Manufacture:	1987	
Date & Time (UTC):	7 February 2010 at 1154 hrs	
Location:	On approach, Chambéry Airport, France	
Type of Flight:	Commercial Air Transport (Passenger)	
Persons on Board:	Crew - 6	Passengers - 103
Injuries:	Crew - None	Passengers - None
Nature of Damage:	None	
Commander's Licence:	Airline Transport Pilot's Licence	
Commander's Age:	43 years	
Commander's Flying Experience:	3,446 hours (of which 2,696 were on type) Last 90 days - 94 hours Last 28 days - 33 hours	
Information Source:	AAIB Field Investigation

Synopsis

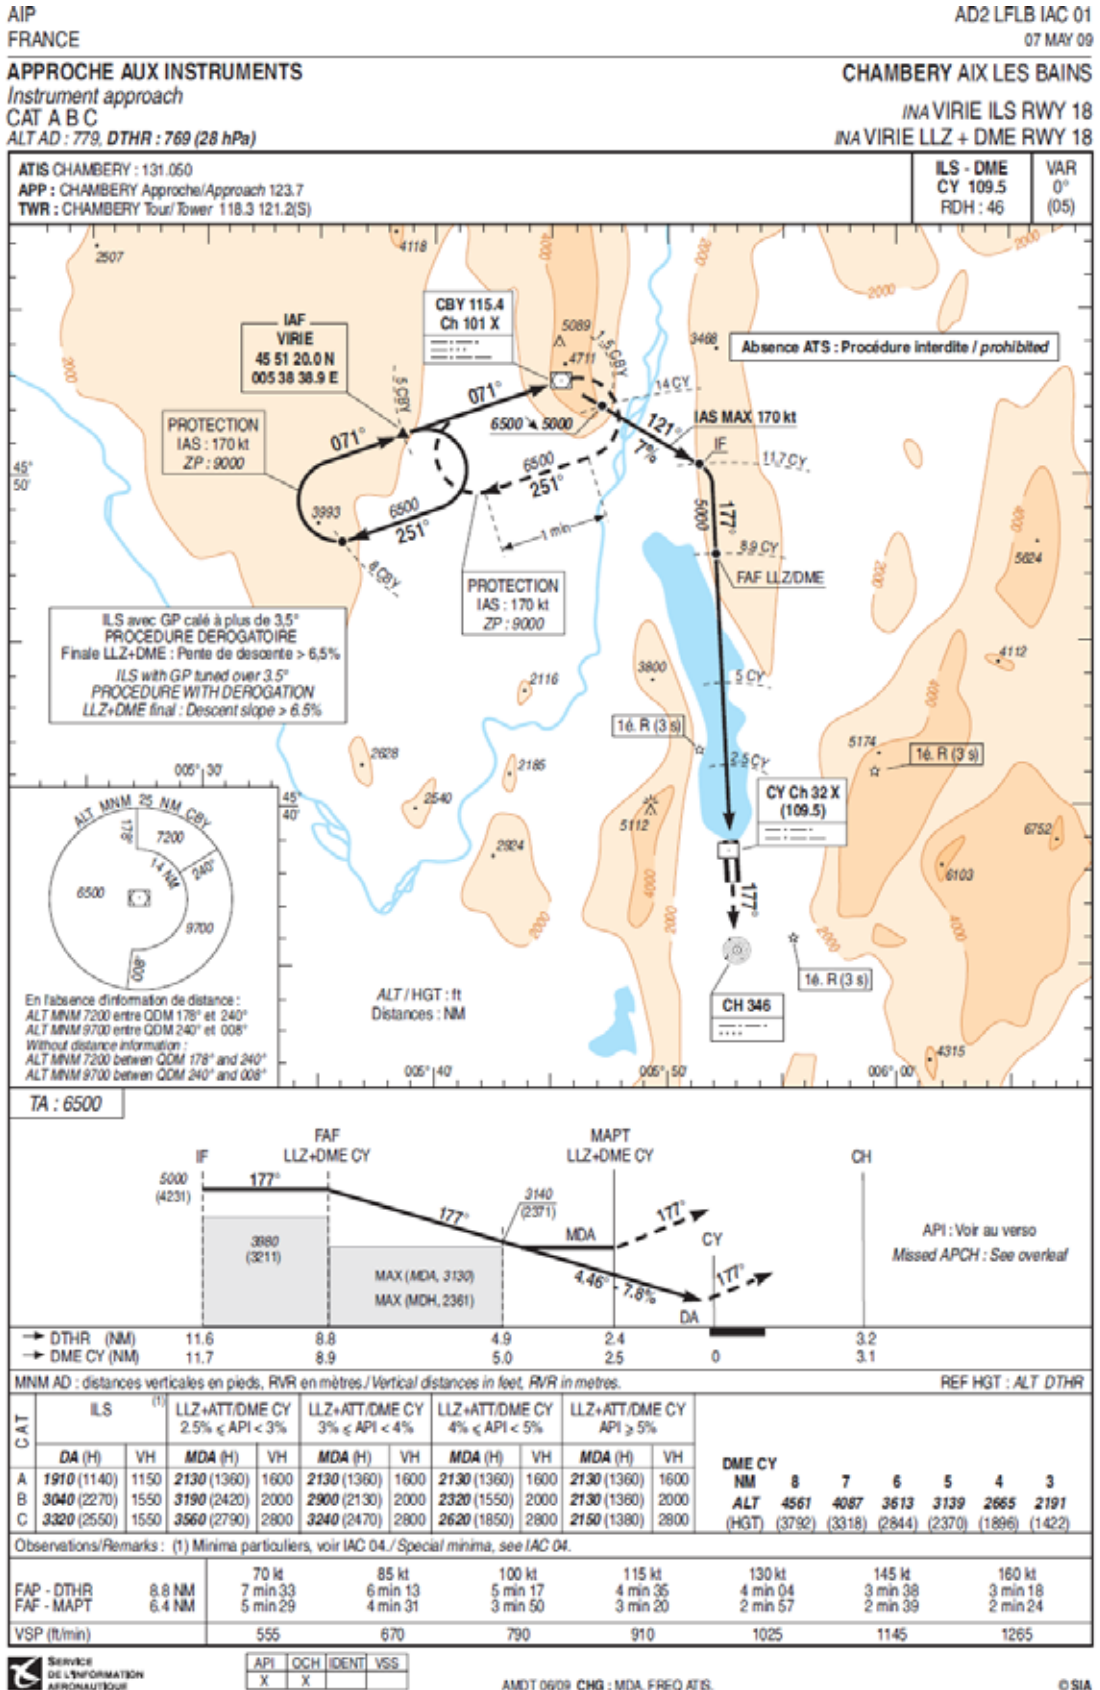
Figure 1

ILS RWY 18 approach via VIRIE

VOR beacon, with descent from an altitude of 5,000 ft commencing at 8.9 DME (nm). There is no instrument approach for Runway 36 but there is a circling procedure with prescribed flight tracks. The operator's circling minimum was 2,200 ft amsl or greater, according to the missed approach climb gradient. The airport is in a valley, with high terrain all around, and the final 8 nm of the ILS approach is over a lake. (See Figure 1.)

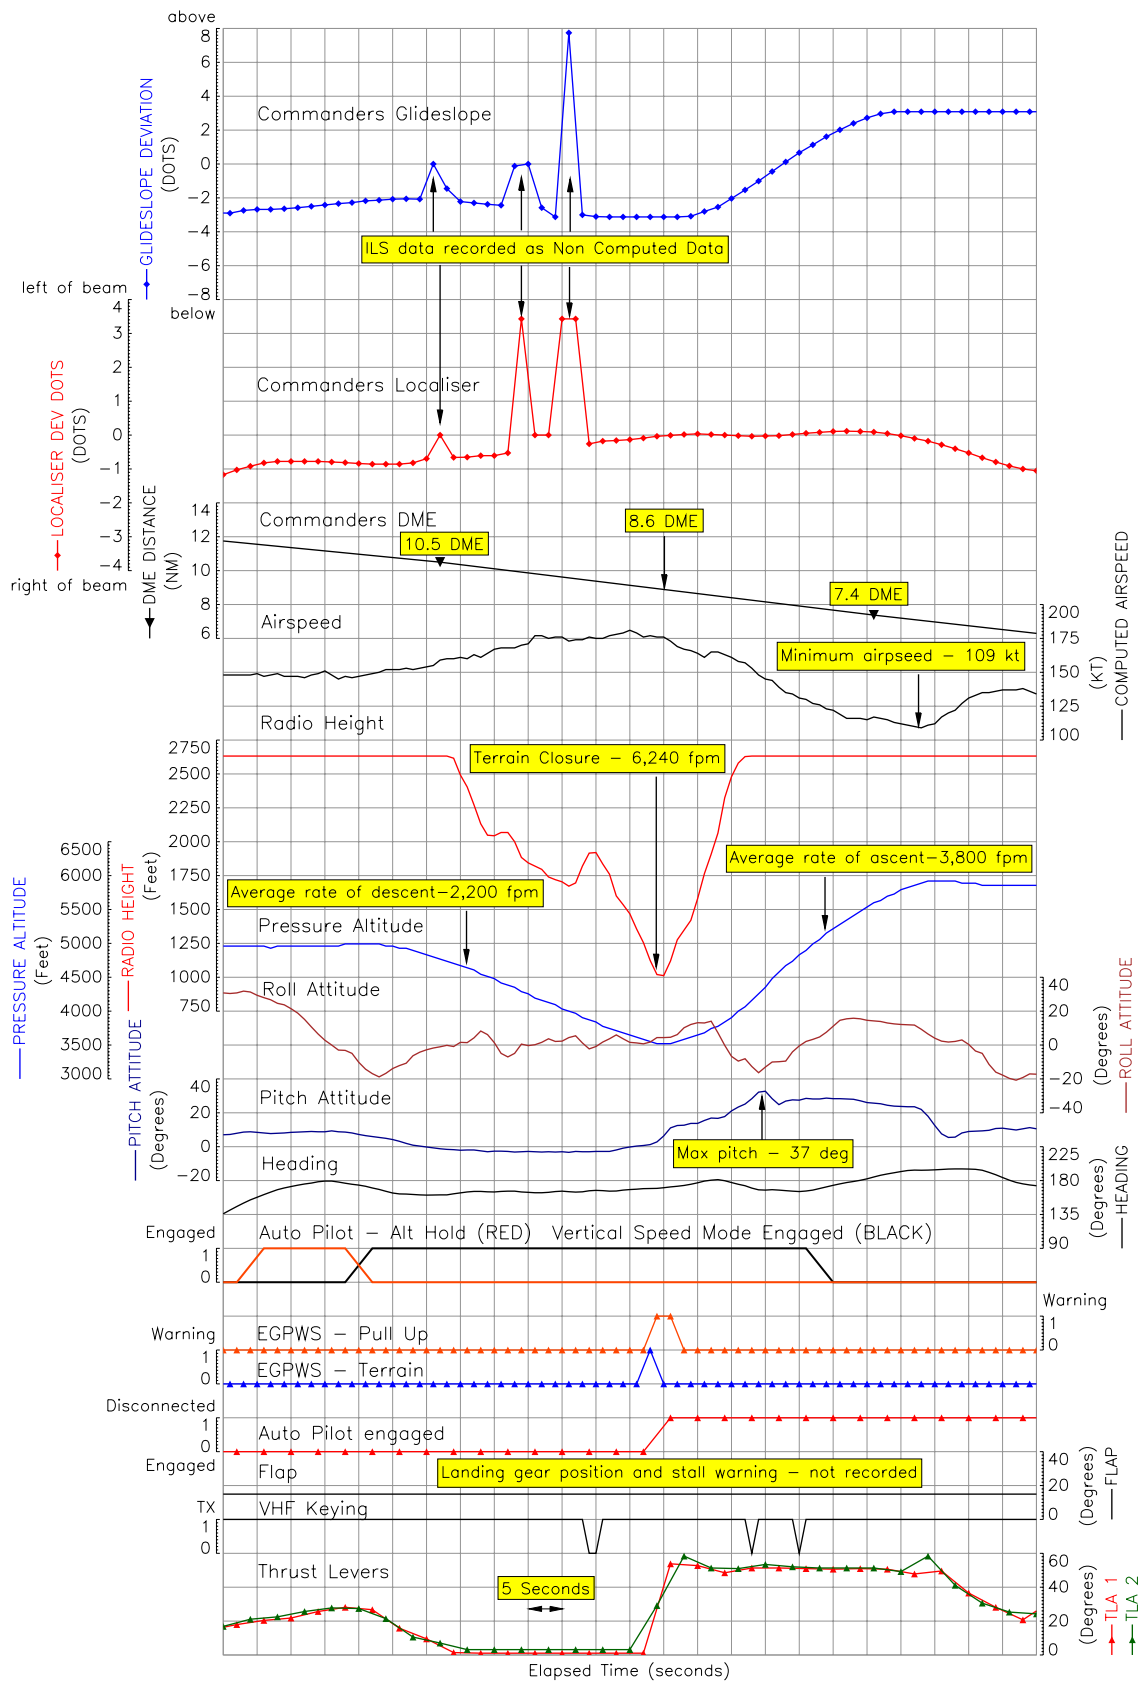
Figure 2

Approaching a range of 11 nm, the autopilot VS mode was engaged. At this stage, the aircraft was about 850 ft below the glideslope. The aircraft started to descend at about 2,200 fpm (see Figure 2). About ten seconds later, the commander's localiser and glideslope signals were both briefly recorded as non computed data (NCD) – indicative that the raw data was no longer reliable or not available. Recorded at almost the same time, the DME indicated 10.5 nm, which was accurate. Due to the low recording frequency of the DME parameter, the reliability of the data in the seconds prior to the descent could not be established. As the aircraft descended, two further recordings were made of the commander's localiser and glideslope signals temporarily being NCD.

Approaching the airport from the north, the aircraft is required to overfly a ridge of high ground to the east of Lake Bourget. As the aircraft descended, the terrain closure rate progressively increased to about 6,000 fpm. When the terrain clearance reached 1,125 ft, the EGPWS Mode 2 warning was activated. Almost simultaneously, the autopilot was disconnected and a go-around was carried out (due to the recording rates, it could not be determined if the go-around had been initiated before the EGPWS warning). The minimum terrain clearance was 1,112 ft.

Recorded FDR data for the (first) ILS approach to Chambéry Airport
