SL Report 2007/08

**REPORT ON THE SERIOUS INCIDENT AT OSLO AIRPORT GARDERMOEN ON 21
SEPTEMBER 2004 INVOLVING FLIGHT KAL520 BOEING 747-400F REGISTERED
HL7467 OPERATED BY KOREAN AIR**

SUBMITTED
March 2007

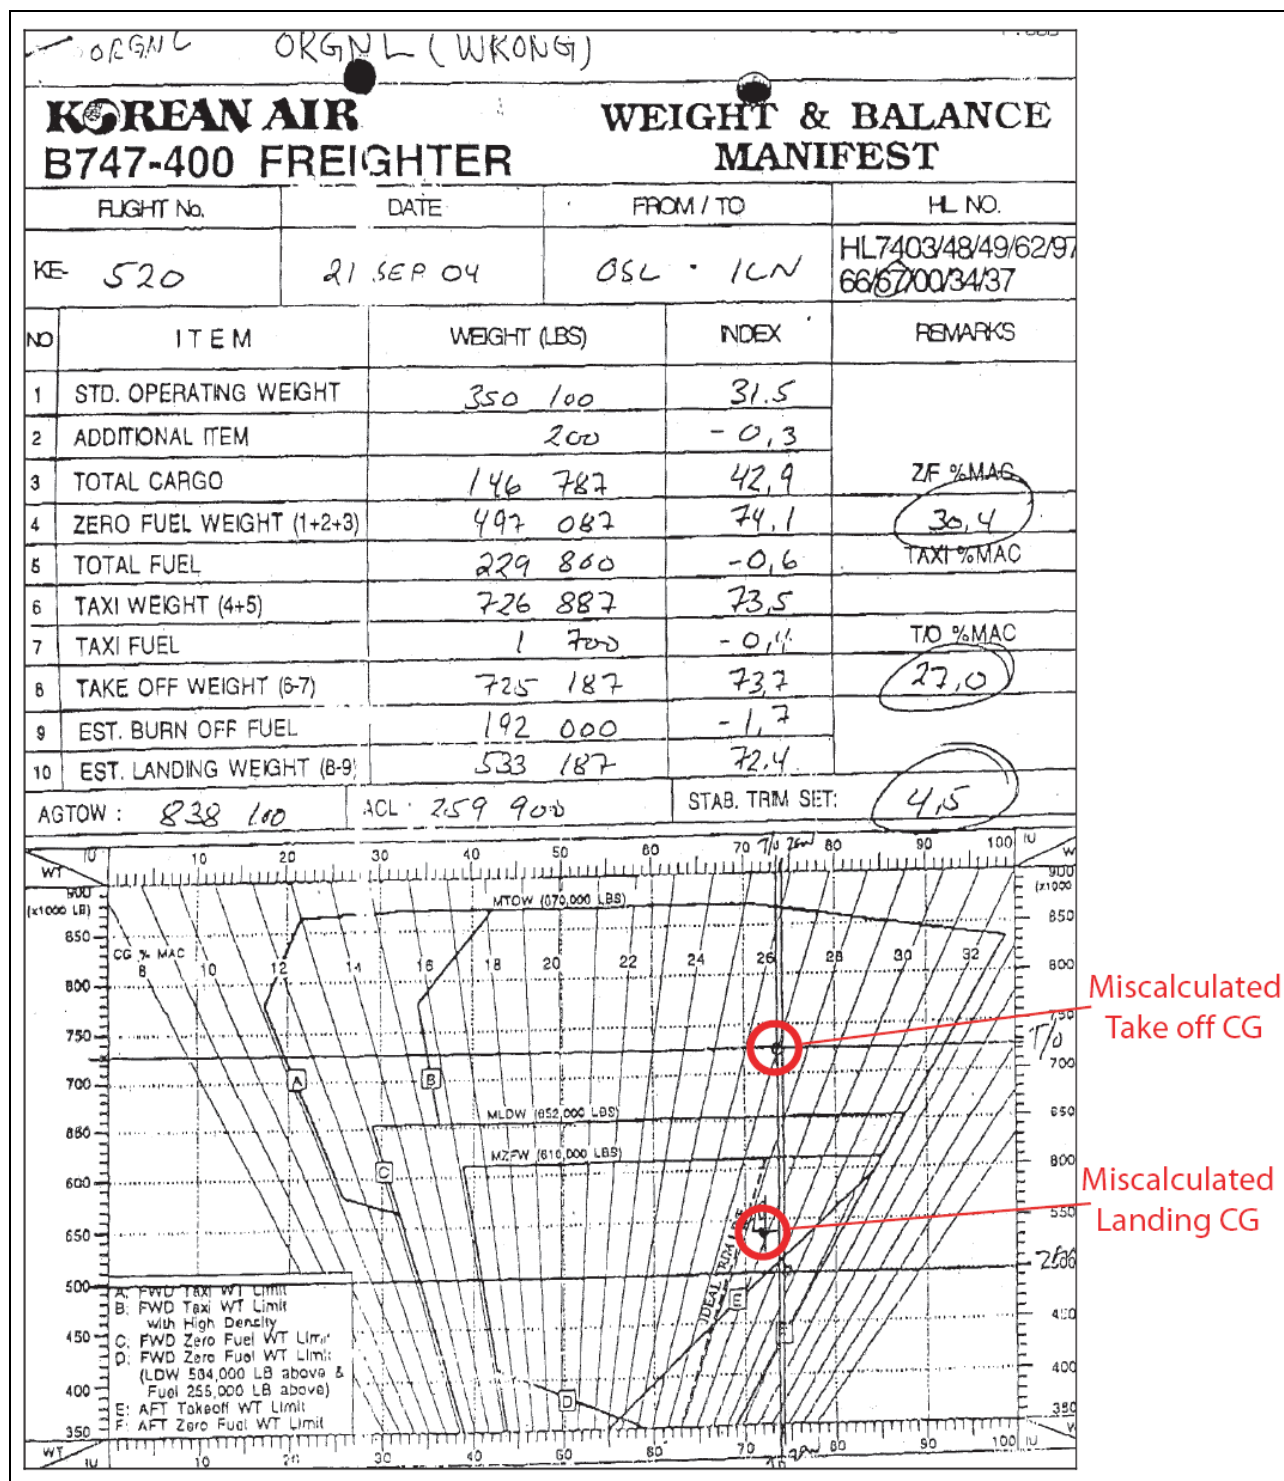
Fig. 3. M & B Manifest of 21 Sep 2004

- 1.18.1.2 After completion of the loading and balance calculations, the Load Master signed the Manifest and brought it to the visiting KAL cargo representative (ref. 1.17.1.5) who checked the loading manifest before it was brought to the Commander for review. This procedure was not always adhered to, and, in this incident, the KAL representative did not look at or reviewed the manifest. After verifying that the mass and CG was within limits, the Commander countersigned the load manifest. In this incident, the deviation was missed both by the Load Master and the Commander.

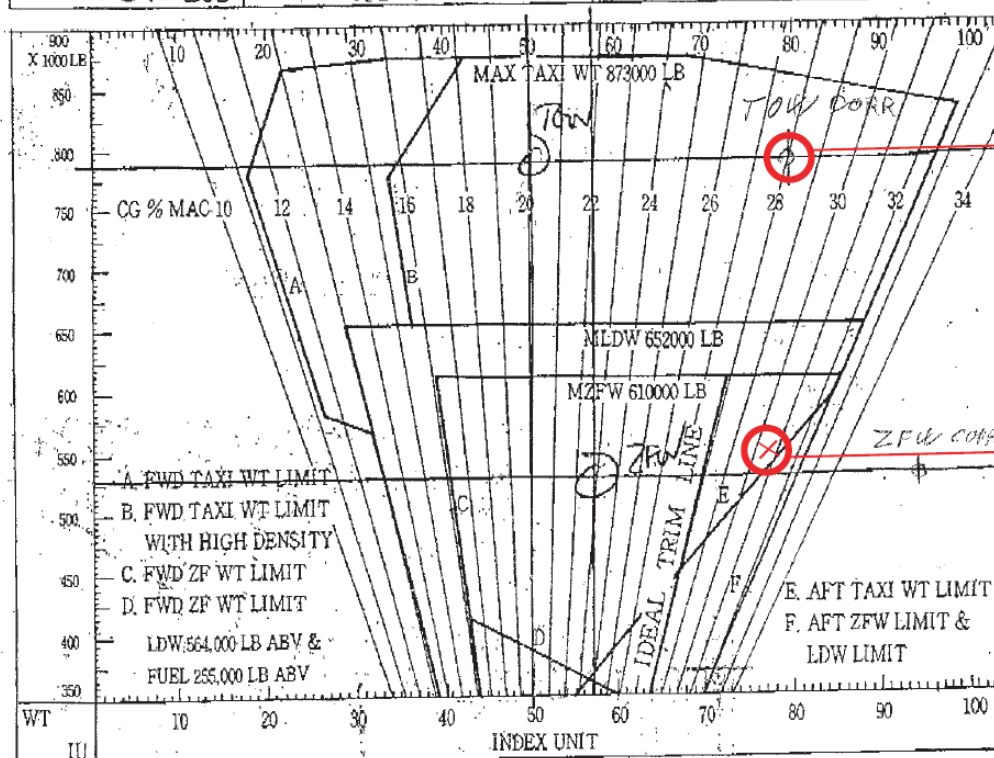
Corrected
Take off CG

Corrected
Landing CG

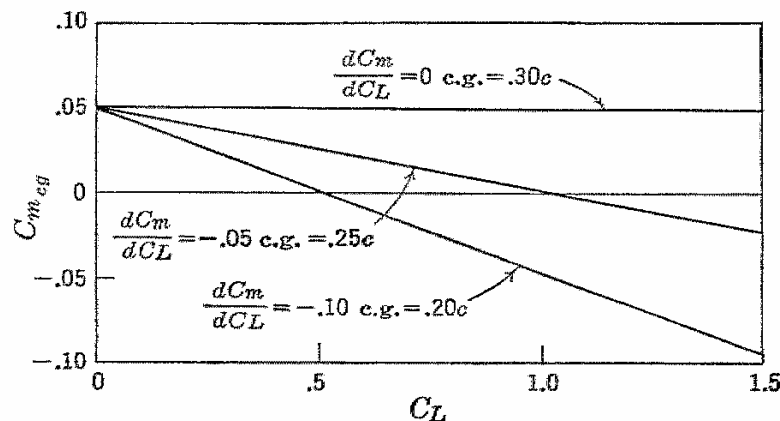
FIGURE 5-18. Typical effect of c.g. shift on pitching moments.

An examination of Figure 5-18 shows that as the c.g. is moved aft the slope of the pitching moment curve (dC_m/dC_L) for the assumed airplane becomes more positive. When a c.g. position of 30 per cent is reached, the slope becomes zero. At this point the airplane is neutrally stable ($dC_m/dC_L = 0$), and this c.g. position is called the stick-fixed neutral point and is denoted by the symbol (N_0). Equations (5-32) and (5-34) can be used to solve for this neutral point.

The neutral point gives the most aft location at which the c.g. can be placed before making the airplane unstable. It therefore places one limit on the airplane's permissible c.g. travel, for the airplane should never be balanced aft of this point if a stable airplane is desired.
