**SERIOUS INCIDENT**

<b>Aircraft Type and Registration:</b>	Airbus A300B4-605R, G-MAJS	
<b>No &amp; Type of Engines:</b>	2 General Electric CO CF6-80C2A5 turbofan engines	
<b>Year of Manufacture:</b>	1991	
<b>Date &amp; Time (UTC):</b>	26 July 2011 at 1035 hrs	
<b>Location:</b>	London Gatwick Airport	
<b>Type of Flight:</b>	Commercial Air Transport (Passenger)	
<b>Persons on Board:</b>	Crew - 12	Passengers - 335
<b>Injuries:</b>	Crew - None	Passengers - None
<b>Nature of Damage:</b>	None	
<b>Commander's Licence:</b>	Airline Transport Pilot's Licence	
<b>Commander's Age:</b>	49 years	
<b>Commander's Flying Experience:</b>	12,074 hours (of which 8,680 were on type) Last 90 days - 147 hours Last 28 days - 74 hours	
<b>Information Source:</b>	Aircraft Accident Report Form submitted by the pilot and further enquiries by the AAIB

**Synopsis**

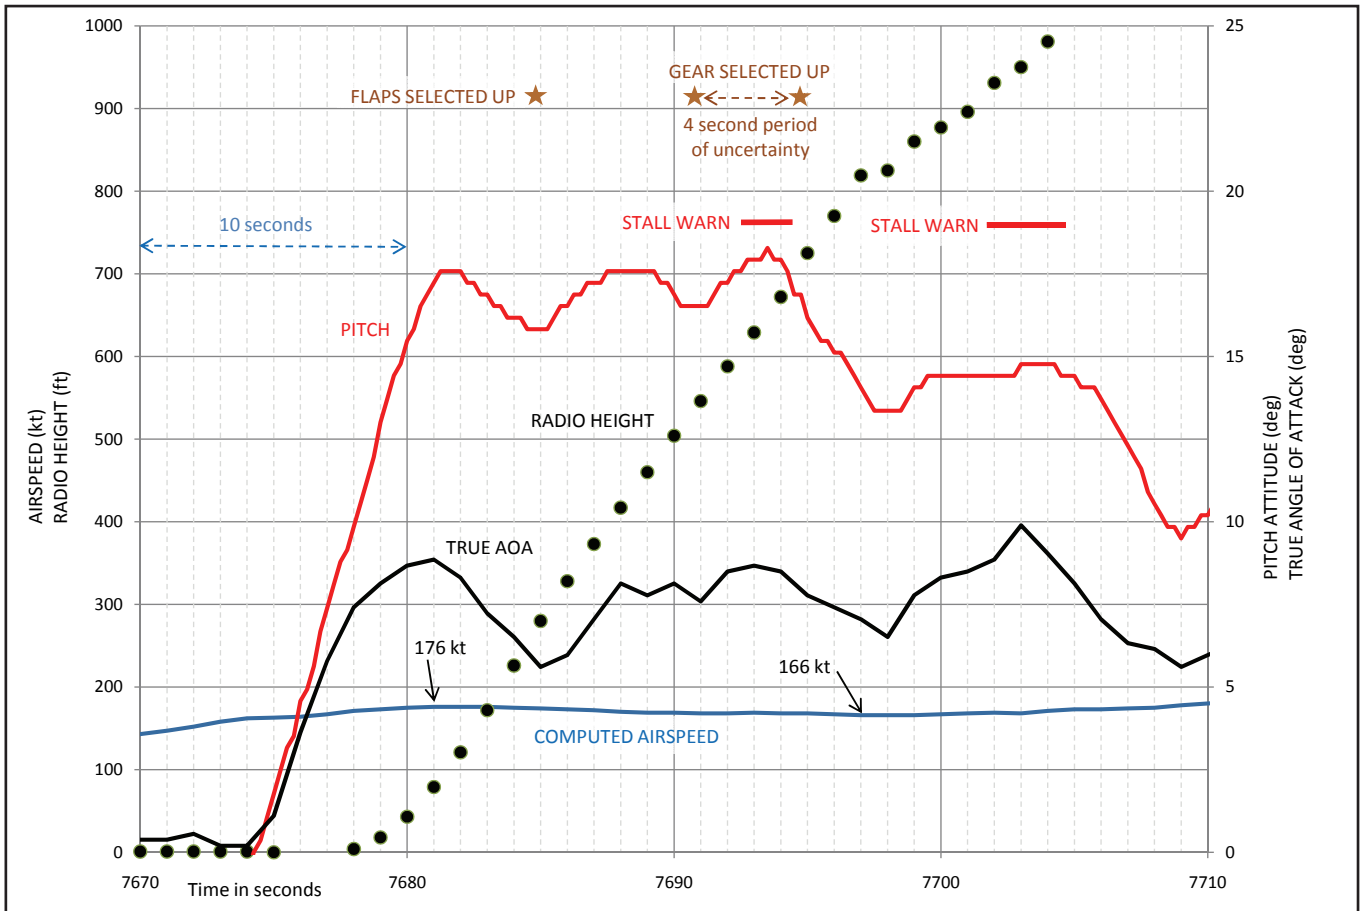
**Figure 1**  
Flight parameters

The co-pilot operated the slat/flap lever about eight seconds after takeoff and the slats and flaps started to retract. At this point the true angle of attack (TAOA) was 5.6° and the aircraft was climbing through 280 ft agl. During the following three seconds, the TAOA increased to approximately 8° and, apart from a three-second interlude, remained above 7.5° for the following 18 seconds during which time the slats and flaps fully retracted. The stall warning system operated twice during this period. The airspeed decayed from 176 KCAS to 166 KCAS during the 12 second period after the slats/flaps lever was first moved but increased thereafter. Relevant aircraft parameters are shown in Figure 1.
