Publication 19 April 2012

Incorrect aircraft configuration, VH-VWW Singapore Changi International Airport 27 May 2010

Abstract

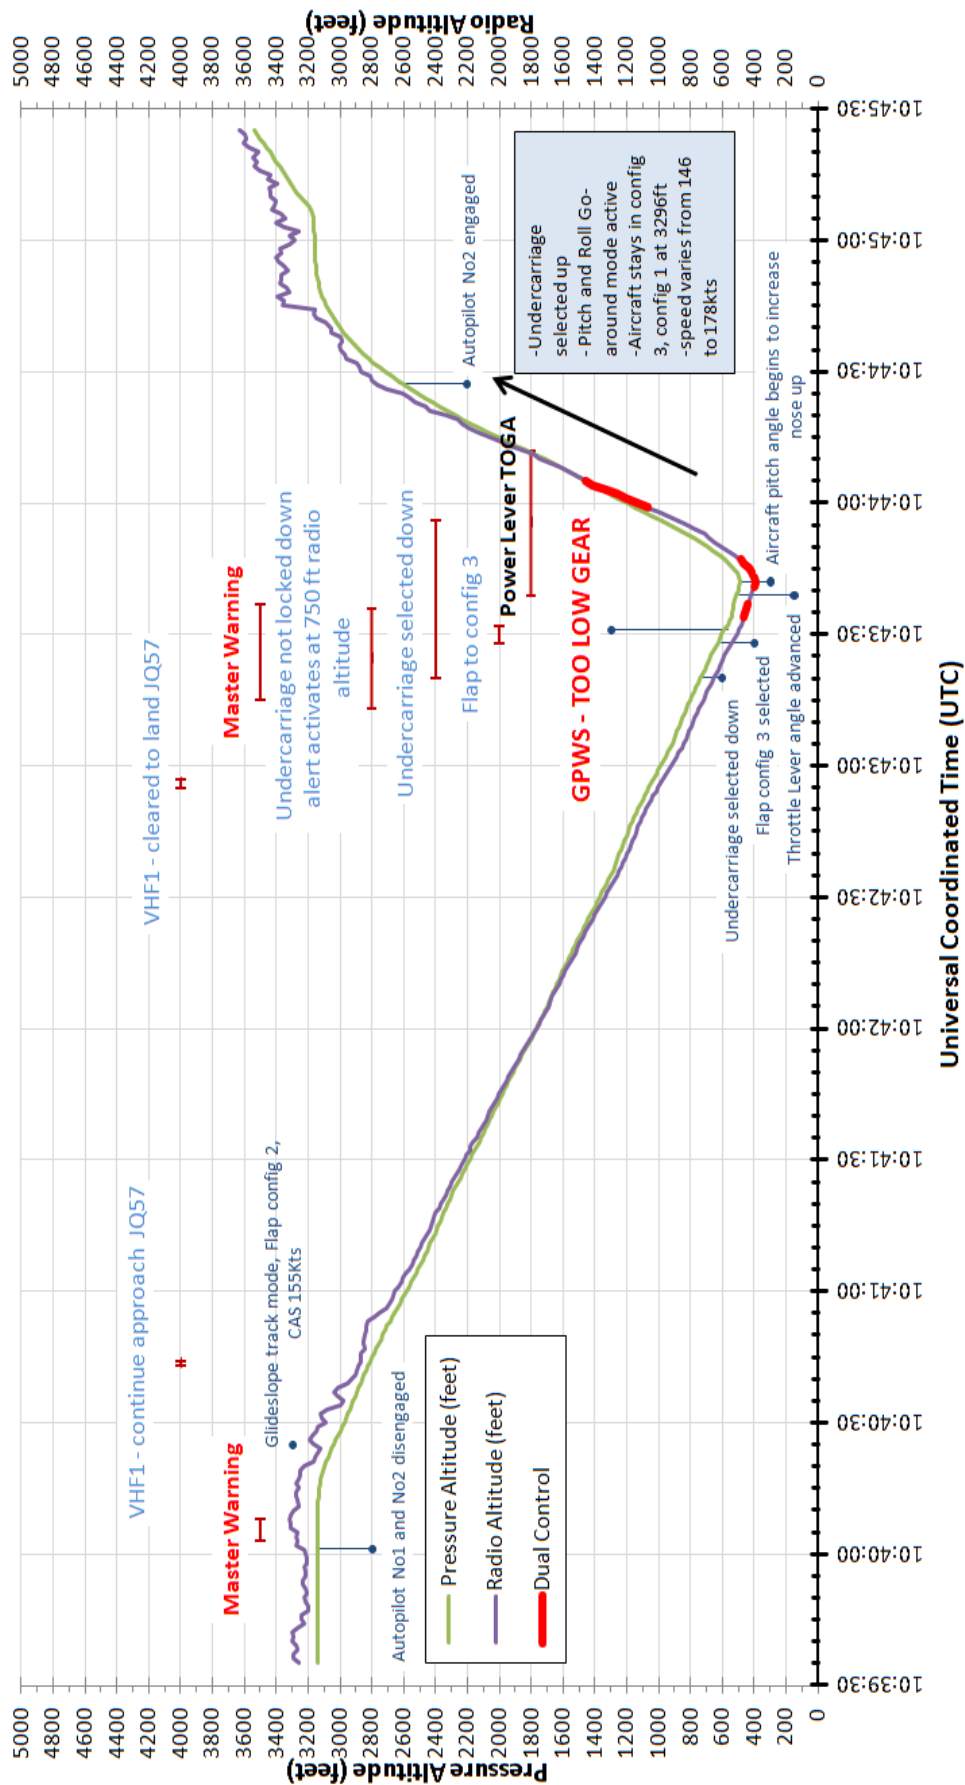
APPENDIX A: MISSED APPROACH SEQUENCE OF EVENTS

At 1,000 ft, the FO called for 'gear up', which was set by the captain. The FO engaged the autopilot at about 2,600 ft and, after a series of left turns, the aircraft was established on a second ILS approach for RWY 20R. A plot of the recorded data is at Appendix A.
