AIR ACCIDENTS INVESTIGATION  
INSTITUTE OF CZECH REPUBLIC  
Beranových 130  
199 01 PRAHA 99

**CZ-10-229**

# **FINAL REPORT**

**Air accident involving  
Airbus A321-131, registration mark D-AIRT  
And  
Boeing B737-8BK, registration mark TC-SNM,  
On 18<sup>th</sup> June 2010 at LKPR.**

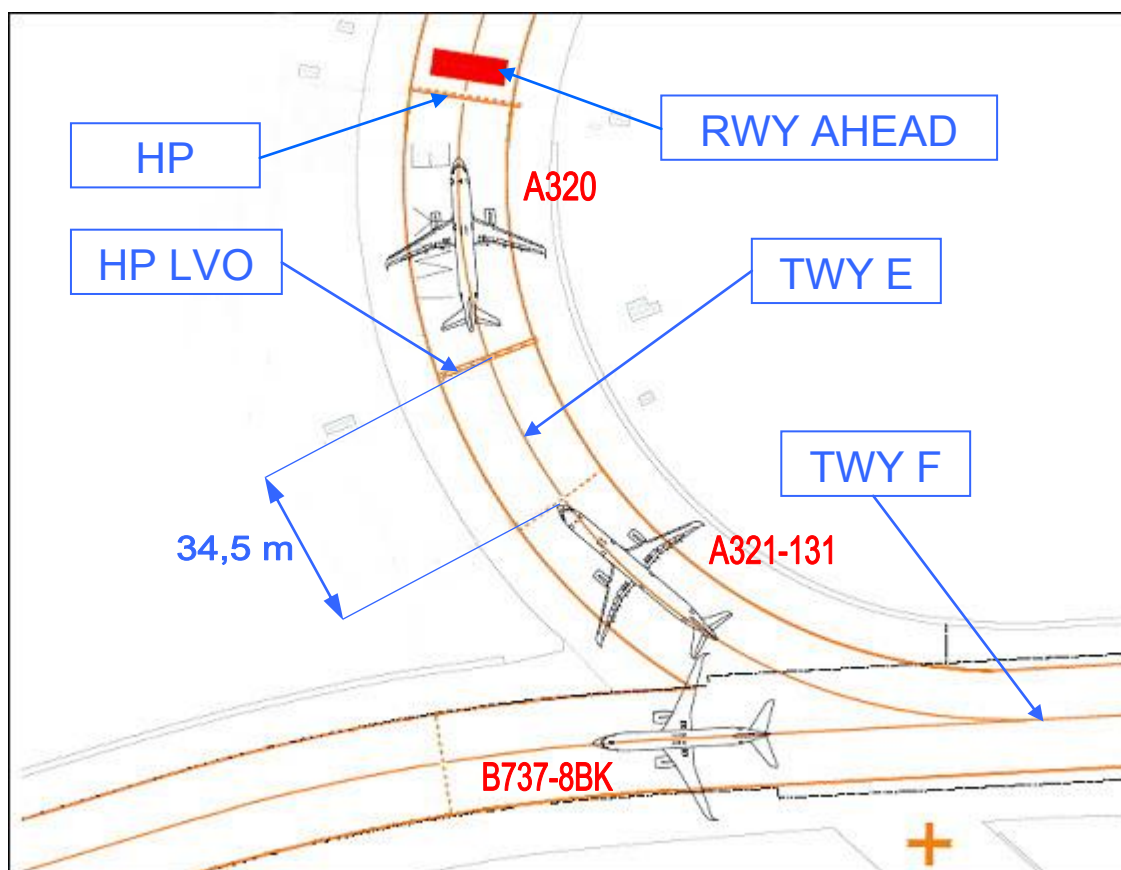
Scheme 2

At 08:37:04 the B737-8BK crew reported it could start from RWY 06 / TWY E intersection and stopped at TWY F on TWY FF level. TWR-GEC issued an instruction, for operational reasons, "continue to the end please". At 08:37:40 the B737-8BK crew continued its further taxiing on TWY F toward THR RWY 06. During this taxiing the B737-8BK right winglet struck the stabiliser of the A321-131 standing on TWY E (see Scheme 2). After the collision the B737-8BK crew stopped. At 08:38:23 the B737-8BK crew reported the event over the TWR-GEC frequency.

- At intersection where TWY E turns off TWY F, the B737-8BK crew was taxiing at a speed of 3 to 5 kt and intentionally veered off ca 0.5 m left from the TWY E centre line.

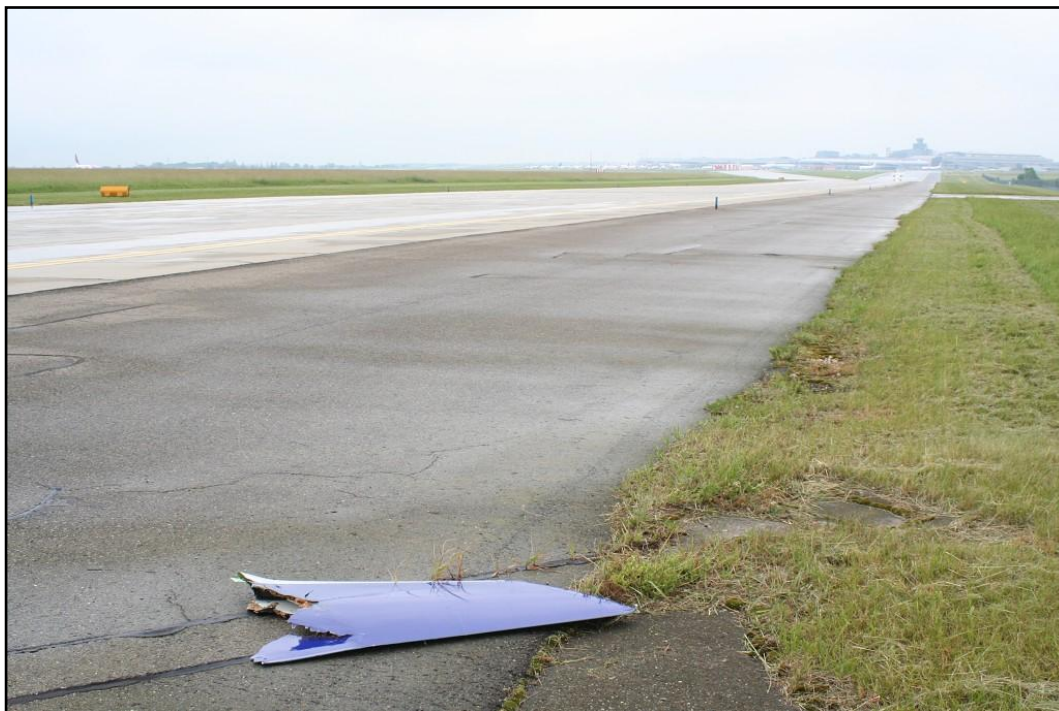
Fig. 2 Scene of the collision and a B737-8BK right wing winglet piece long approx. 1.2 m.

- At 08:47:40, an RPL dispatcher came to the TWY F / TWY E intersection and removed a piece of the B737-8BK winglet about 1.2 m long.
- At 08:58:22, RPL checked RWY 06/24 for clearance after the damaged B737-8BK had passed, and reported RWY 06/24 serviceability to TWR.

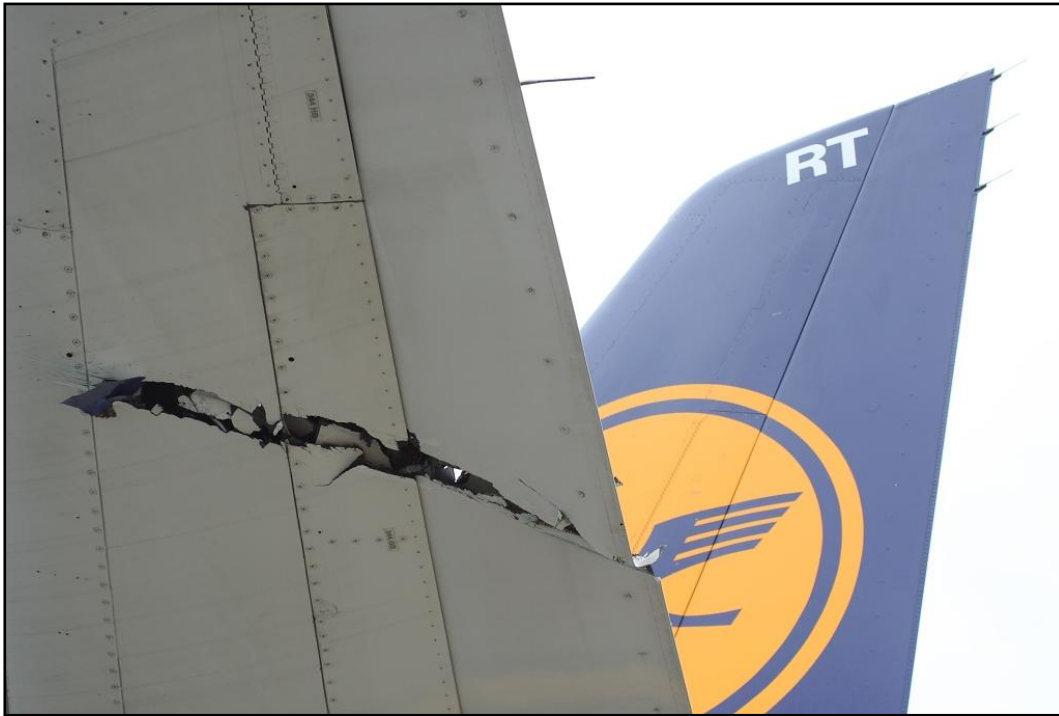
The A321-131 - Left stabiliser and left elevator damaged.  
The B737-8BK - Right winglet damaged.

Fig. 3 Damage to A321-131 left rudder and stabiliser.

- At 08:38:07 there was a collision as the B737-8BK right winglet hit the A321-131 left elevator and left stabiliser.
- At 08:38:18 the B737-8BK stopped on TWY F behind the intersection with TWY E.

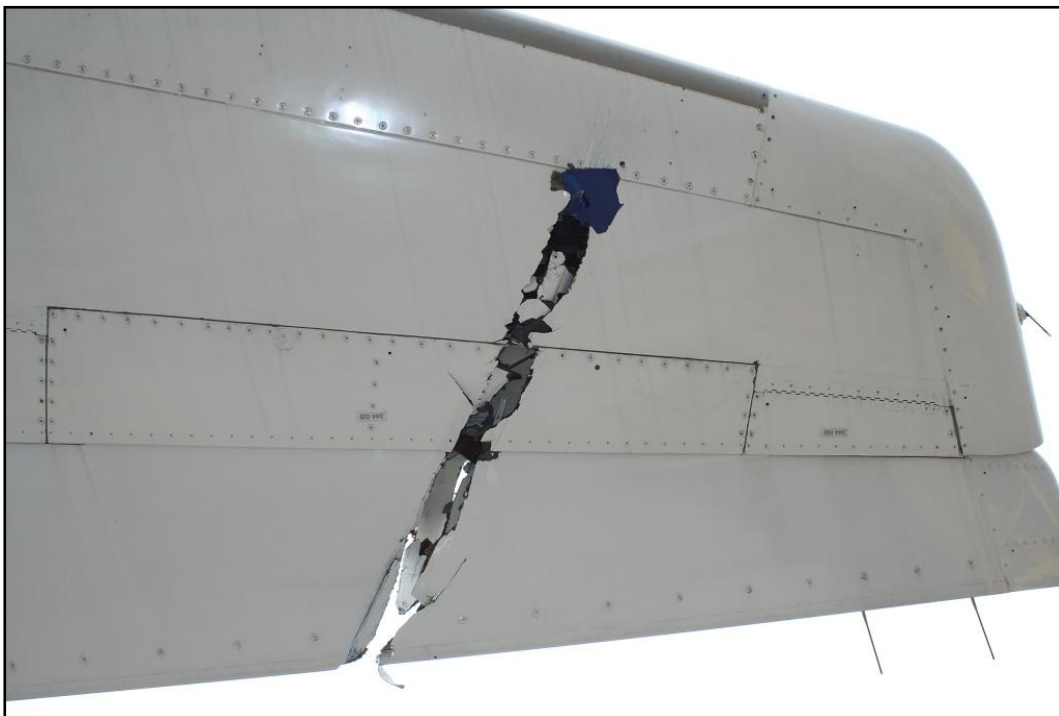
Fig. 4 Damage detail of A321-131 left rudder and stabiliser.

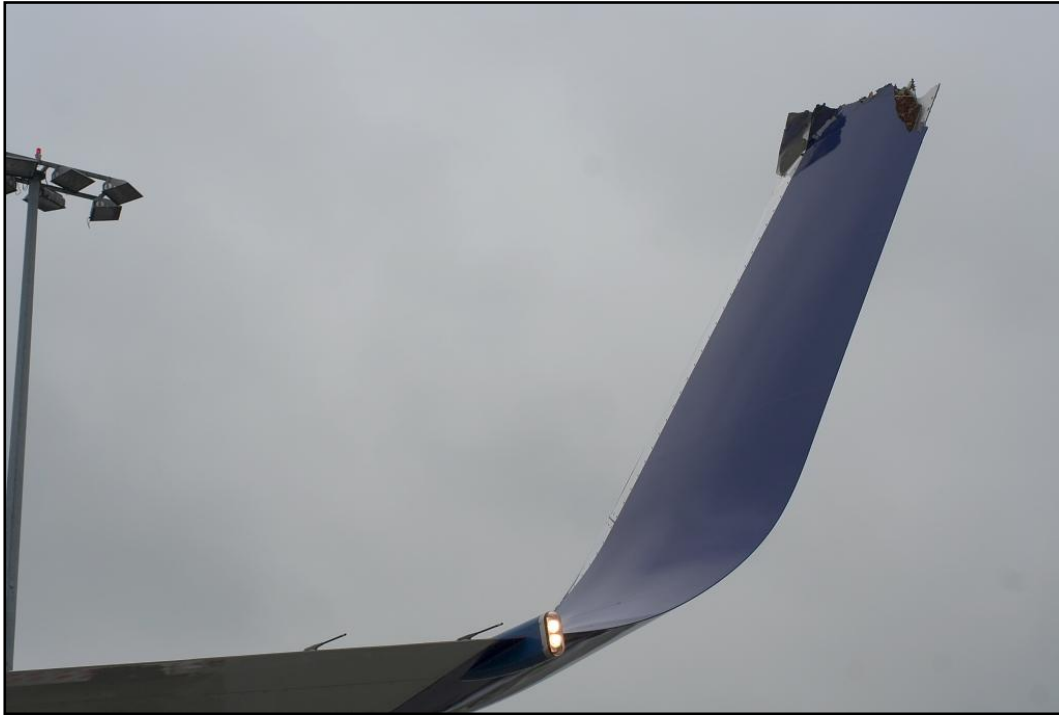
Fig. 5 Damage to B737-8BK right wing winglet.

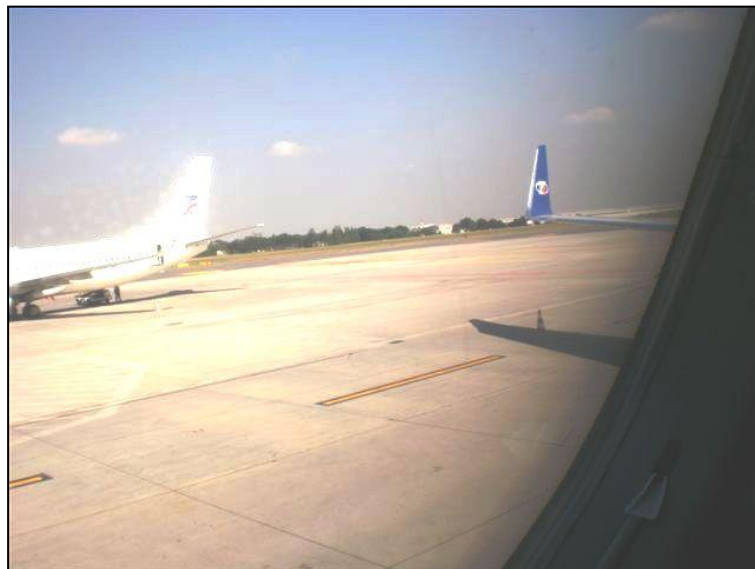
FO confirmed this information. The reality whether FO could have seen end of wing from his seat was check experimentally.

Fig. 6. View from the right seat of cockpit to end of right halves of wing B737-800

- The PIC relied on FO's information on the clearance between the wing and the second airplane, the piece of information FO was not able to determine uniquely from his position.

- The B737-8BK crew did not make good assessment of the distance between their right wing tip and the A321-131. FO was not able to tell the distance uniquely.
- Both of the crews did not make good judgement of the gravity of the situation, did not ask for the damage scope assessment on the scene, and taxied with their damaged aircraft back to the apron.
- The TWR shift leader decided not to put HZS on the alert Air Accident since he had not enough information available at that time.
