**ACCIDENT**

| <b>Aircraft Type and Registration:</b> | Airbus A319-111, G-EZFV |
| <b>Date &amp; Time (UTC):</b> | 14 February 2012 at 1359 hrs |
| <b>Location:</b> | London Luton Airport |

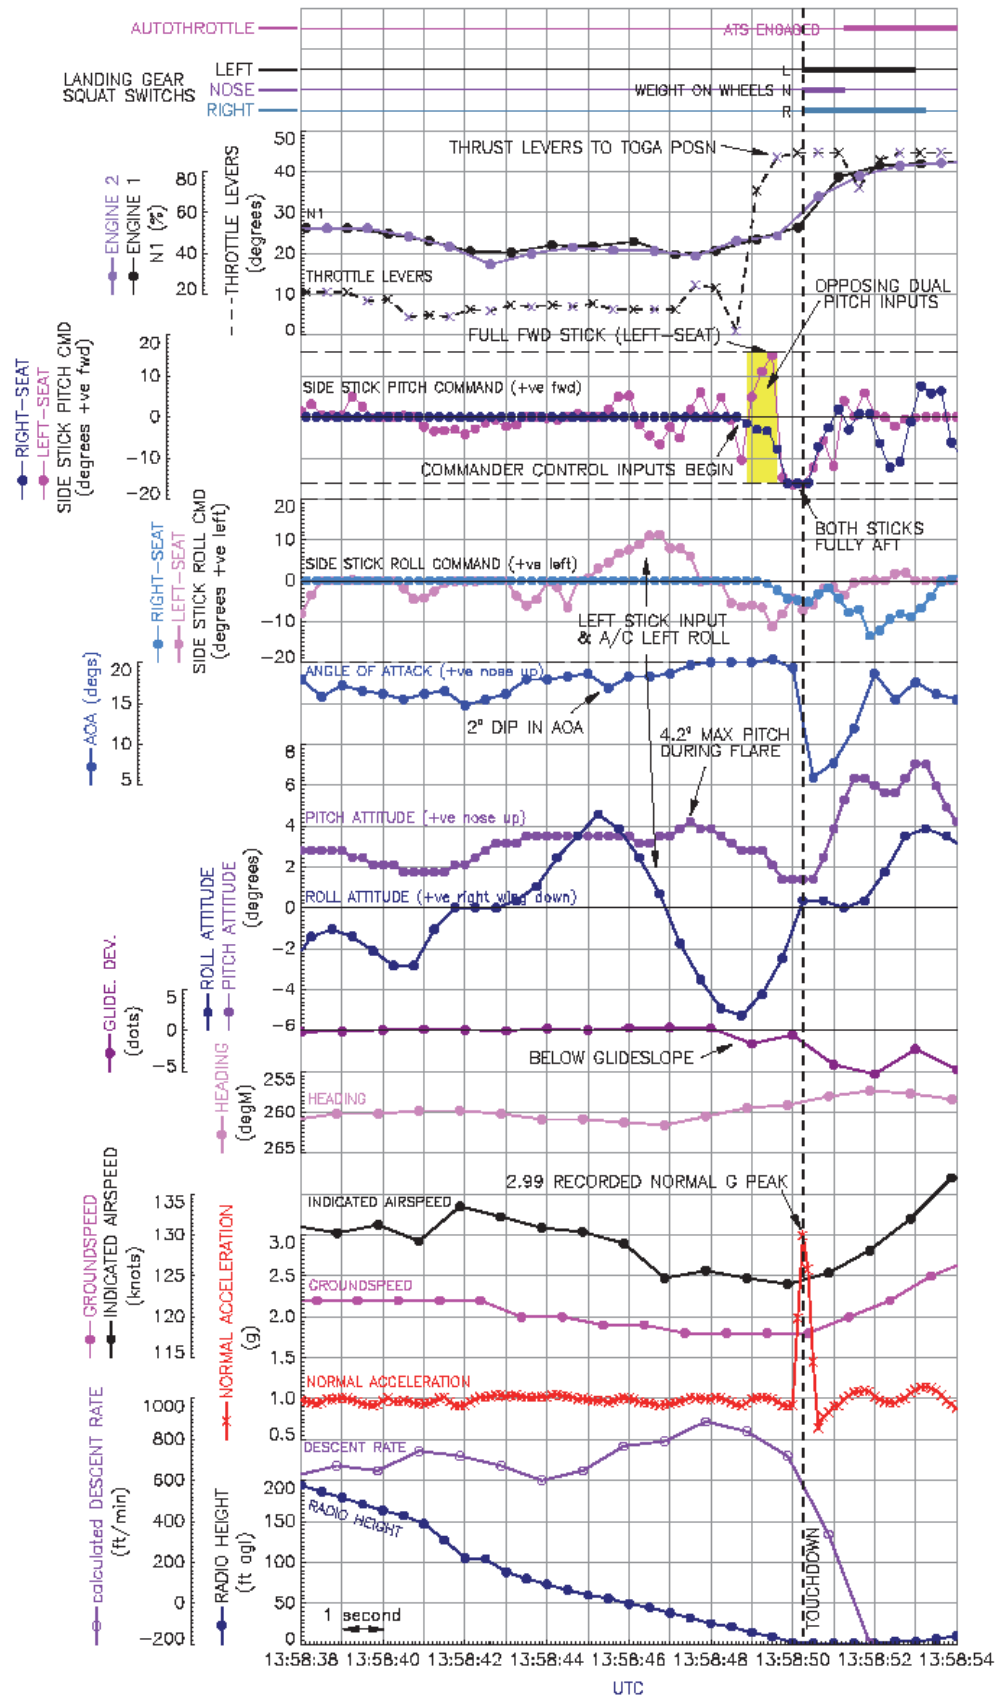
Figure 1 shows the salient recorded parameters approaching the touchdown. The data illustrated starts at 1358:38 hrs, with the aircraft at 200 ft agl, 130 kt indicated airspeed and descending at 625 ft/min. At this point the aircraft's attitude was 3° nose-up and 2° left wing low. Left-seat sidestick control inputs were made which resulted in the aircraft rolling wings level as it descended through 100 ft agl. The wings remained level for just over one second before further inputs rolled the aircraft right (to 4.5° at 60 ft agl), then left (to 5.5° at 21 ft agl), then back to wings level at touchdown.

As the aircraft descended through 60 ft agl, at 1358:46 hrs, a momentary 2° reduction in angle of attack was recorded while the pitch attitude remained steady at 3.5° nose-up. A maximum pitch attitude of 4.2° occurred at 32 ft agl, 2.5 seconds before touchdown. This was followed by some pitch-down control inputs (from the left seat) which resulted in a decreasing pitch attitude, the descent rate peaking at just under 900 ft/min, and the aircraft descended below the nominal glideslope. The left-seat pilot then applied an aft sidestick control input of 10° (out of a maximum of 16°) which was coincident with a small aft-stick input by the commander. Both thrust levers were then advanced to the TOGA position. However, there was also a simultaneous forward sidestick input of 15° from the left seat pilot, which was countered by an aft input of 8° by the commander (ie a net input of 7° forward). Both sidesticks were then moved to the fully aft position. Half a second later the aircraft touched

down on all three landing gear simultaneously, during which a normal acceleration of 2.99 g was recorded. The aircraft then lifted off, completed a go-around and returned for an uneventful landing.

Salient FDR parameters for incident touchdown at Luton
