Crash During Approach to Landing  
Empire Airlines Flight 8284  
Avions de Transport Régional  
Aérospatiale Alenia ATR 42-320, N902FX  
Lubbock, Texas  
January 27, 2009

**NTSB/AAR-11/02  
PB2011-910402**

# Aircraft Accident Report

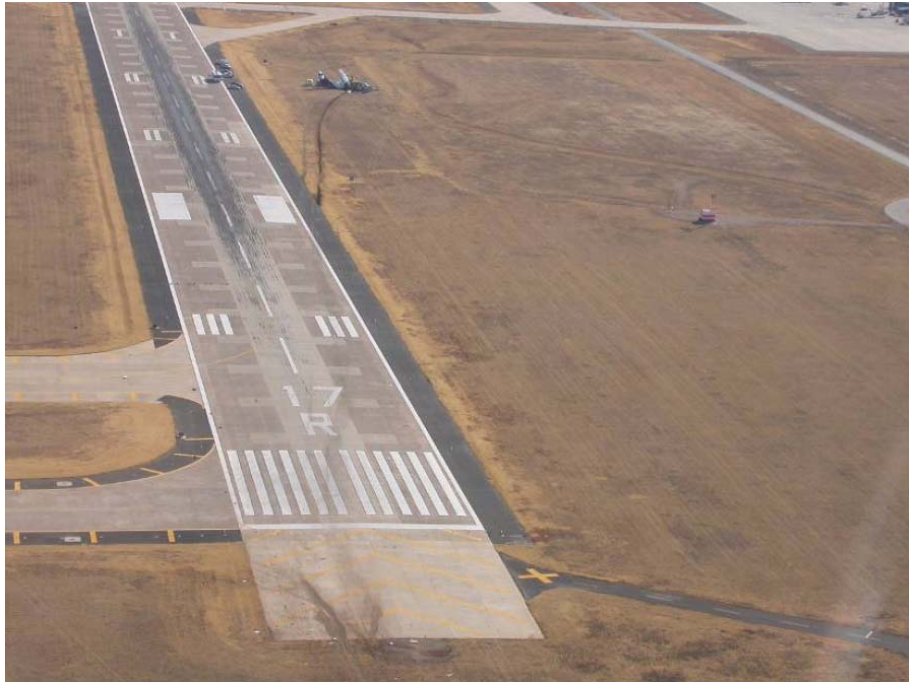
**Figure 1.** Aerial view of approach end of runway 17R and location of wreckage.

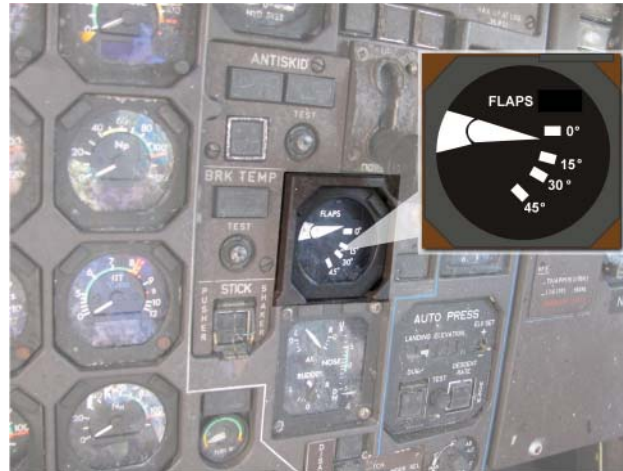
**Figure 2.** Flap position indicator. Inset shows the likely needle pointer position during the flap asymmetry.

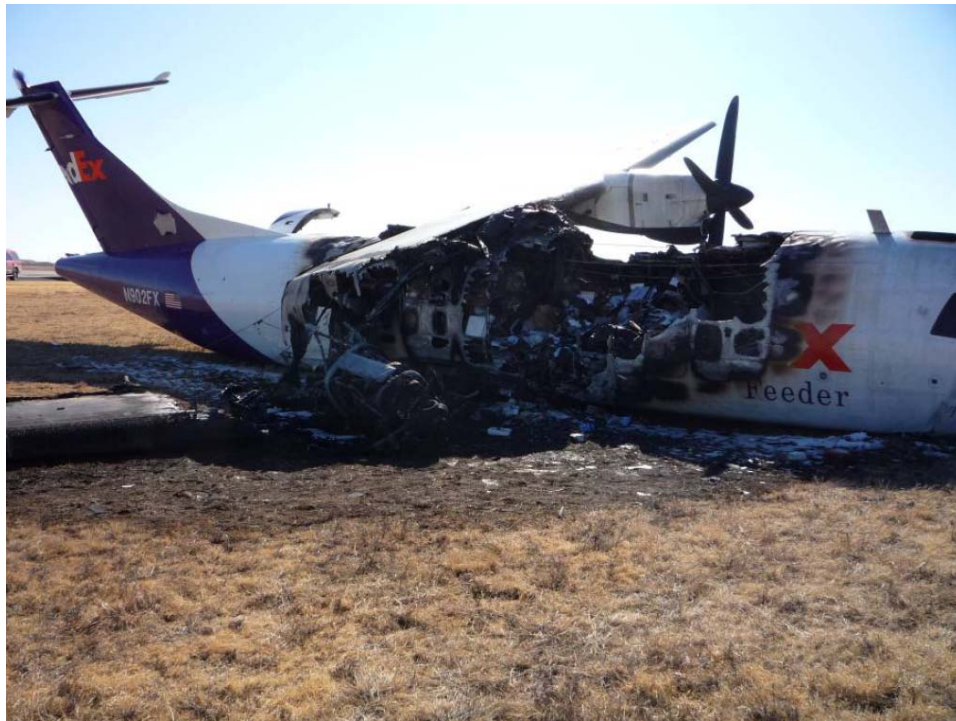
The cockpit flap control lever was found in the 15° position. Examination of the flap system components at the accident site found that the left wing and flap components were intact and covered with soot. The right inboard and outboard flaps and the right inboard flap actuator were extensively damaged by impact and fire. Figure 6 is the right side of the fuselage, showing extensive fire damage to the right wing and flap components. The right outboard flap actuator was found in the retracted position on the ground under the right wing. Damage to the right flaps limited the extent to which preimpact system integrity could be determined. Examination of the available components revealed no evidence of mechanical restriction of movement of the right flaps.

**Figure 6.** Right side of fuselage showing extensive fire damage to right wing and flap components.

X-ray examinations of all four flap actuators showed that their internal components were in place. The left inboard and left outboard flap actuators functioned when tested on the test bench at the manufacturer's facility. Subsequent disassembly and examination of the left inboard and outboard flap actuators revealed no anomalies. Several of the seals for the right inboard and right outboard flap actuators were damaged from fire exposure, and the damage prevented the
