SERIOUS INCIDENT

Aircraft Type and Registration:	ATR42-300, EI-FXA	
No & Type of Engines:	2 Pratt & Whitney Canada PW 120 turboprop engines	
Year of Manufacture:	1992 Serial no: 282	
Date & Time (UTC):	22 February 2012 at 0700 hrs	
Location:	On approach to Glasgow Airport	
Type of Flight:	Commercial Air Transport (Passenger)	
Persons on Board:	Crew - 2	Passengers - None
Injuries:	Crew - None	Passengers - None
Nature of Damage:	None	
Commander's Licence:	Airline Transport Pilot's Licence	
Commander's Age:	58 years	
Commander's Flying Experience:	6,389 hours (of which 3,900 were on type) Last 90 days - N/K hours Last 28 days - 25 hours	
Information Source:	AAIB Field Investigation

Synopsis

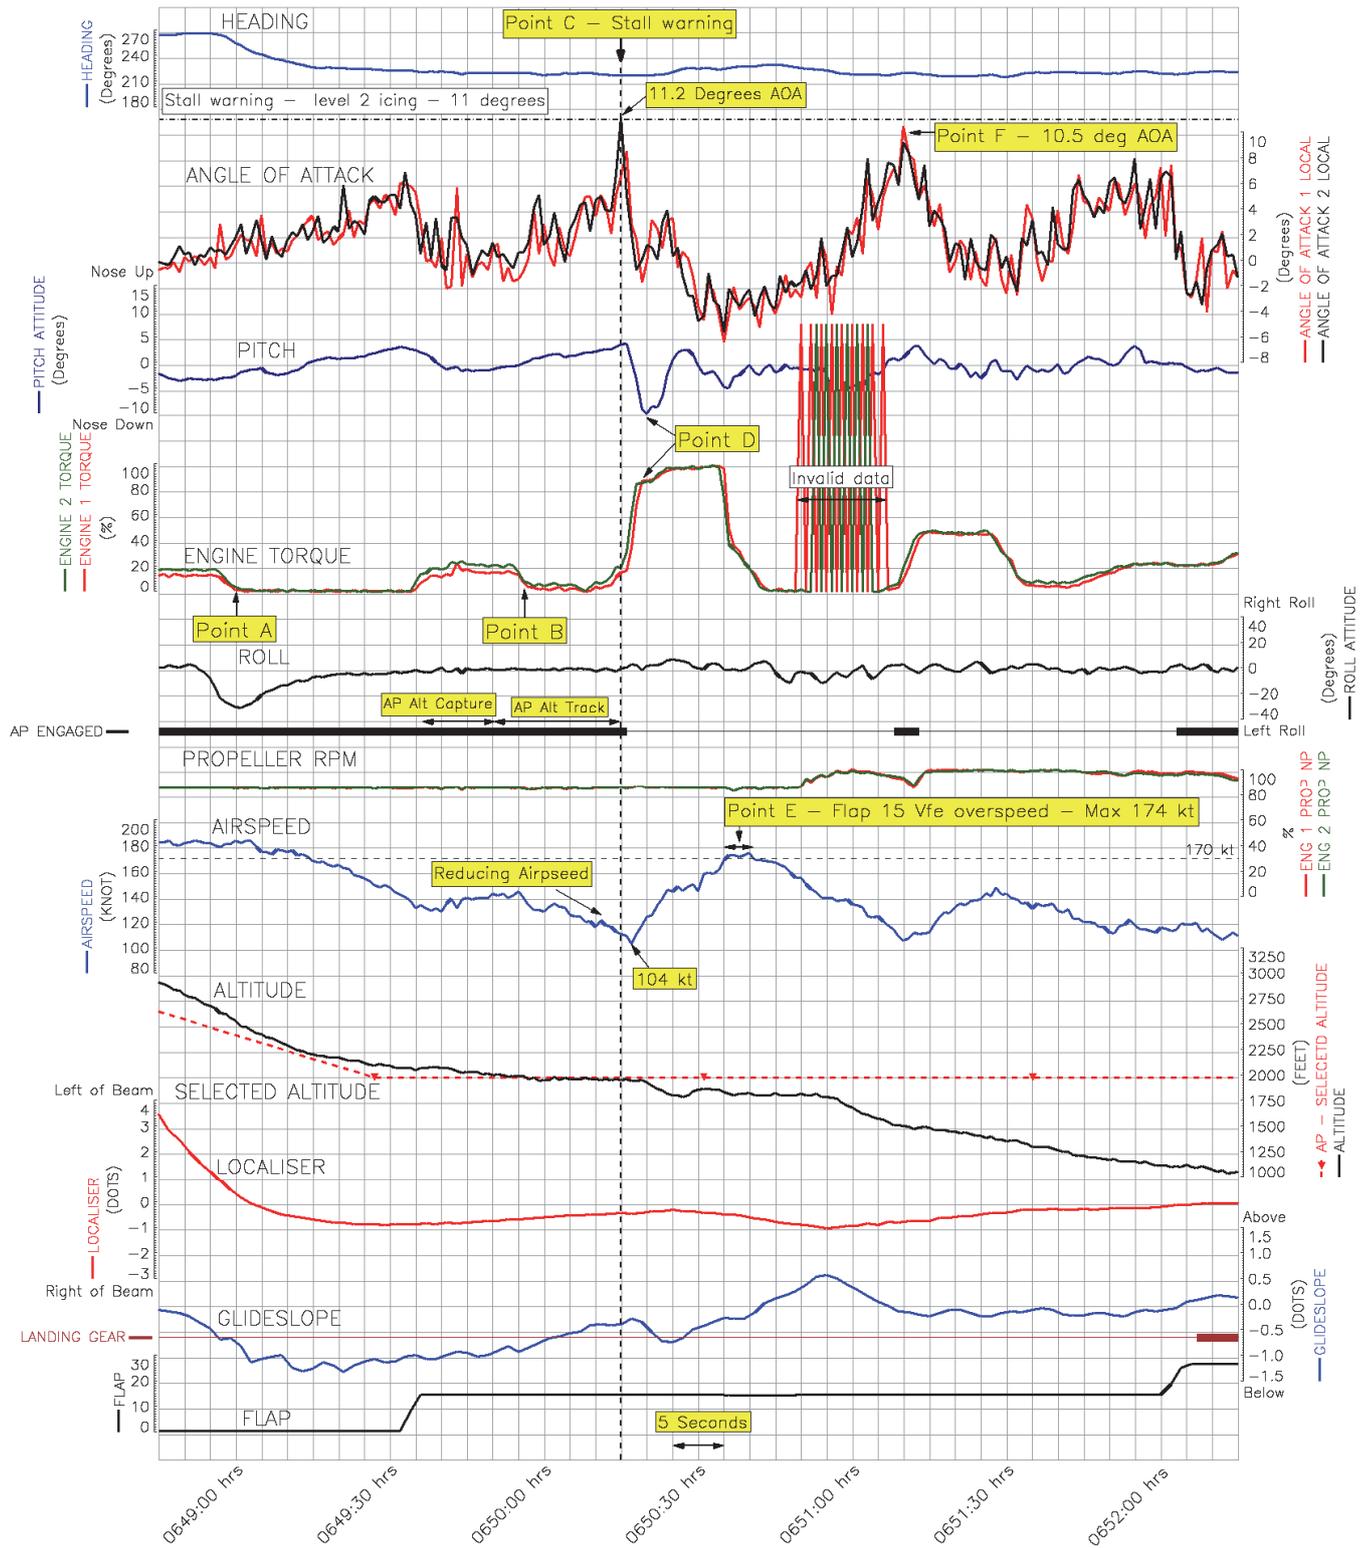
Figure 1
Approach to Glasgow Airport Runway 23

As the flight director captured the localiser the commander instructed the co-pilot to arm the approach mode. Engine torques were reduced to approximately 0% and the rate of descent was reduced. The aircraft was now 8.2 nm from the runway at 2,500 ft and 185 KIAS (see Figure 1, Point A).

At 140 KIAS and 2,100 ft amsl, flap 15 was deployed and the engine torque was increased to about 20%. Approximately 15 seconds later, the autopilot levelled the aircraft at the selected altitude of 2,000 ft amsl. Engine torques were reduced to about 3% (see Figure 1, Point B), airspeed reduced, and the autopilot progressively pitched the aircraft nose-up as it maintained 2,000 ft amsl. Neither of the flight crew mentioned the gradually reducing airspeed.

The co-pilot commented that they were 6.5 nm from the runway, but that the autopilot had not yet captured the glideslope. With the aircraft below the glideslope, the approach controller inquired whether it was established on the ILS. As the first officer keyed the radio to respond, the stall alert sounded and the stick shaker activated. Simultaneously, the autopilot disconnected (see Figure 1, Point C). The aircraft was approximately 1,700 ft agl at 111 KIAS and the angle of attack was +11.2°. The co-pilot called "FLY THE AIRCRAFT [EXPLETIVE]". The commander almost immediately pitched the aircraft nose down to -10° and advanced the power levers almost to full power (see Figure 1, Point D), saying as he did so "I'VE GOT IT I'VE GOT IT DON'T WORRY".

Airspeed reduced to 104 KIAS before increasing. The pitch attitude remained approximately -10° and the co-pilot called “NOSE UP NOSE UP” to which the commander replied “NO”. At 125 KIAS the commander started to pitch the aircraft nose-up, having descended to approximately 1,600 ft agl.

As the aircraft descended, its airspeed reduced to a minimum of 111 KIAS and the angle of attack reached 10.5° (0.5° below the stall alert/stick shaker threshold) (see Figure 1, Point F). Passing approximately 1,500 ft amsl, the flight crew attempted to re-engage the autopilot but it disconnected immediately. Simultaneously, engine torque was increased to 45%, airspeed increased and the angle of attack reduced. The controller asked if the aircraft was still on frequency and the co-pilot replied “AFFIRM, STANDBY WE’VE JUST GOT...
