Aviation Occurrence Report

TransAsia Airways Flight GE222

ATR72-212A, B-22810

**Impacted Terrain and Collided with a
Residential Area**

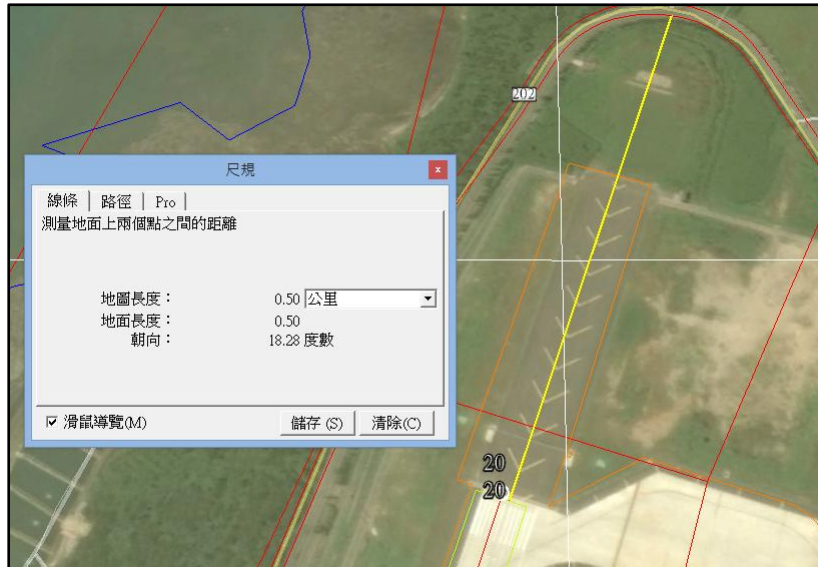
Figure 1.10-3 Available distance measured from Runway 20 (image from Google Earth)

5. According to the Civil Aeronautics Administration (CAA) regulations, a 420 meter simple approach lighting system should have been installed to help pilots visually identify runway 20. The CAA advised that the Runway End Identification Lights, a flashing white light system, was installed at the runway's threshold as an alternative visual aid to replace the simple approach lighting system.

Measurement of the extended center line for runway 20 indicated that about 500 meters was available for an approach lighting system within the airport area, as shown in Figure 1.10-3.

11. Review runway approach lighting systems in accordance with their existing radio navigation and landing aids to ensure that adequate guidance is available for pilots to identify the visual references to the runway environment, particularly in poor visibility condition or at night. (ASC-ASR-16-01-030)

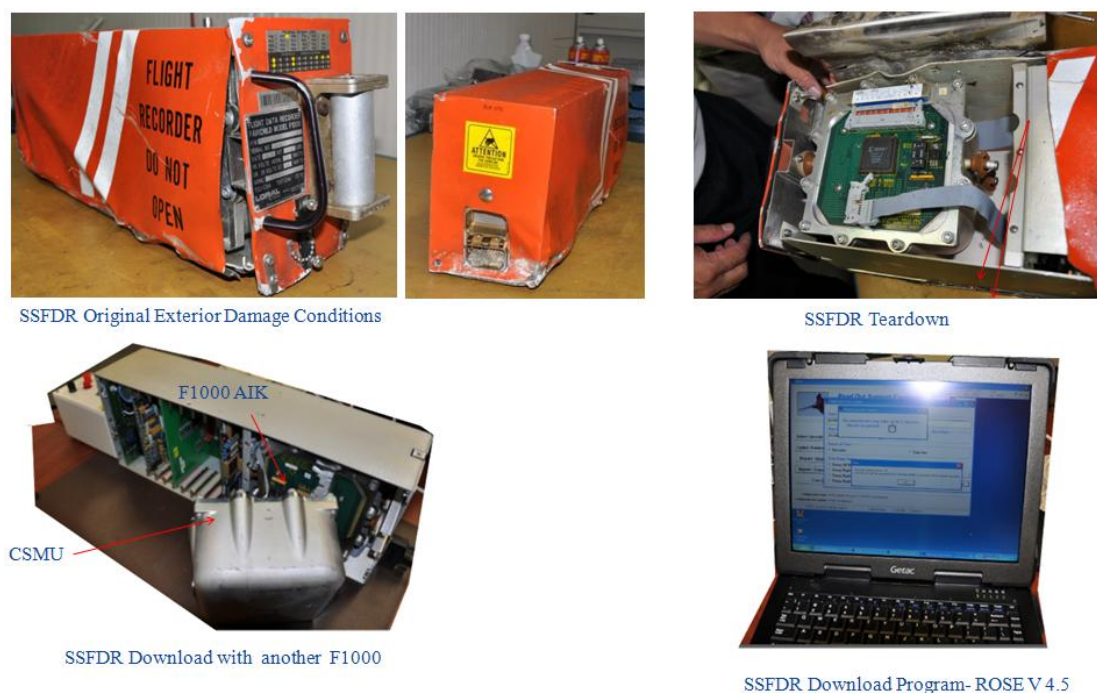
Figure 1.11-2 FDR exterior view, teardown and download process

support units were broken. The CSMU was not damaged and all applicable data was recovered. Figures 1.11-2 shows the FDR exterior view, teardown and download process.

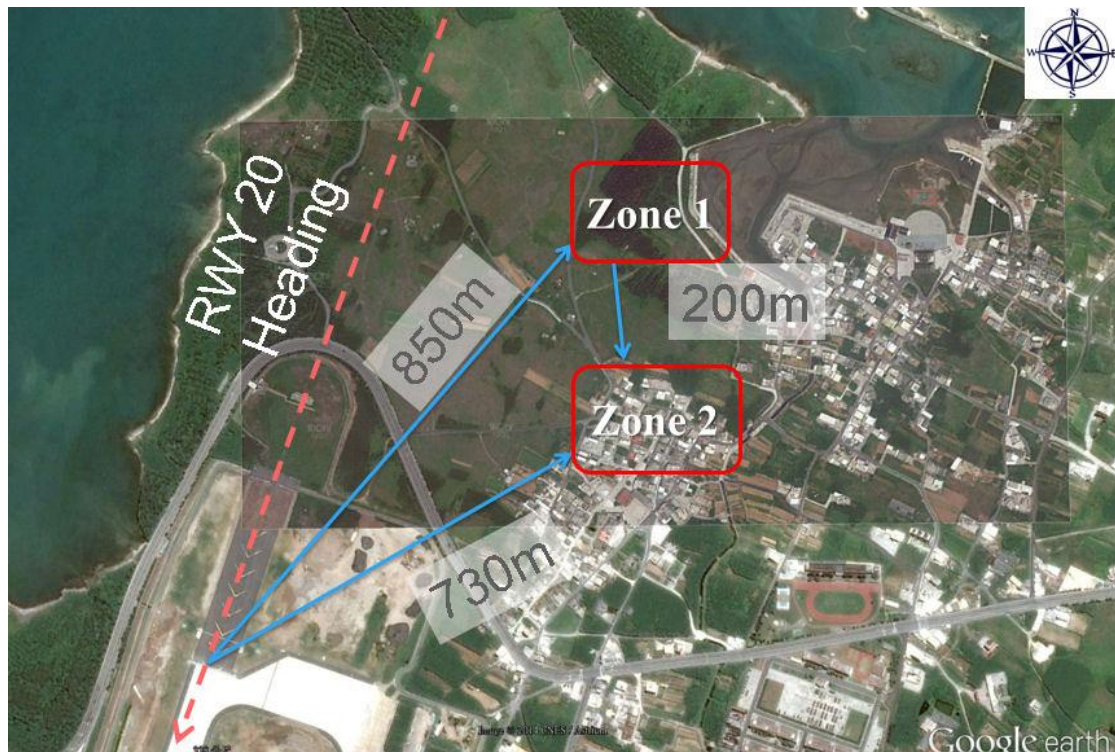
Figure 1.12-1 GE222 site survey zones superimposed on Google map

Figure 1.12-1 illustrates that the aircraft wreckage was distributed in two areas: the foliage or brushwood area (Zone 1); and the residential area (Zone 2). The aircraft impacted terrain approximately 850 meters north-east of the threshold of runway 20 at Magong Airport and then collided with a residential area on the outskirts of Xixi village approximately 200 meters to the south-east of the initial impact zone.

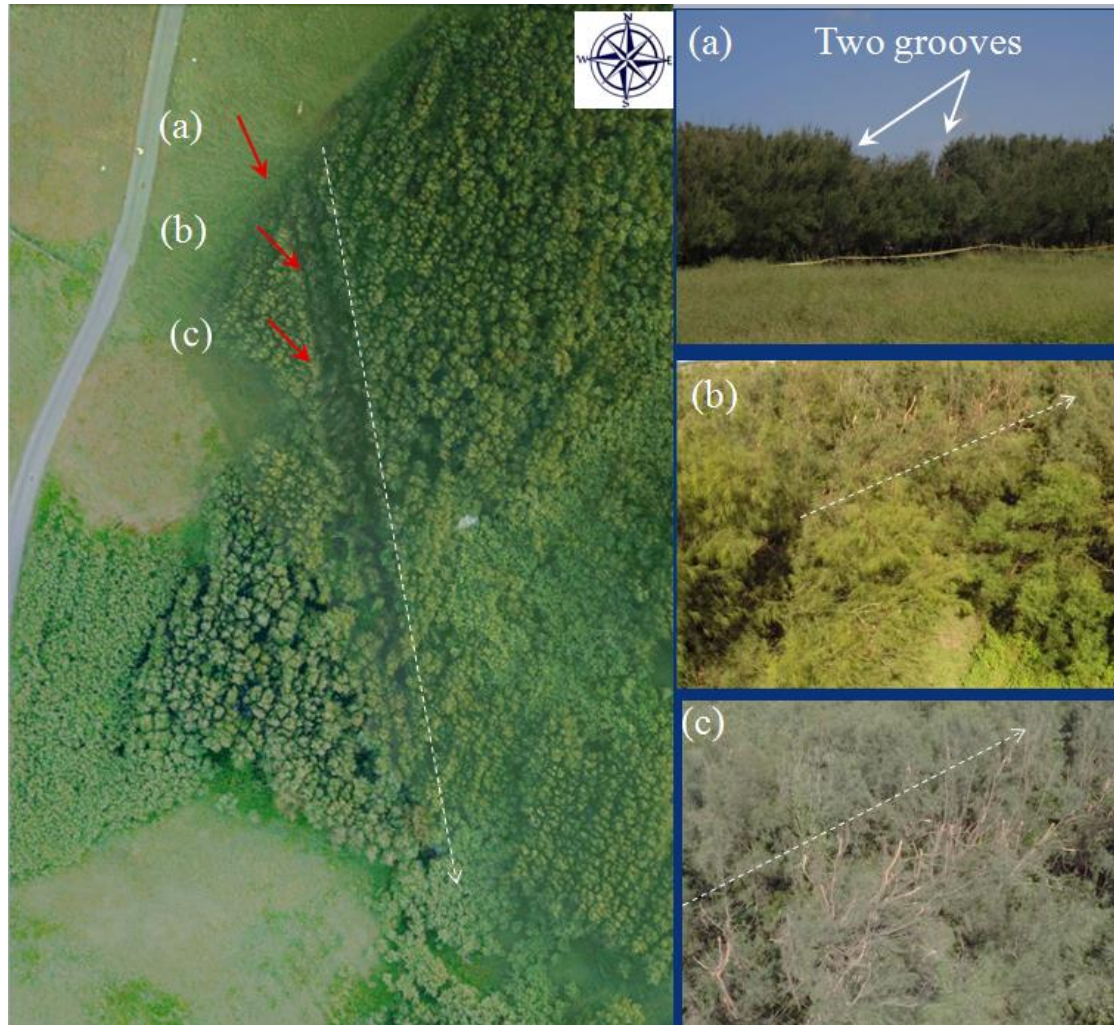
Figure 1.12-4 Initial impact point and damaged foliage in Zone 1

The damaged tree tops indicated where the aircraft first impacted the foliage. The area contained many bent trees and broken branches.

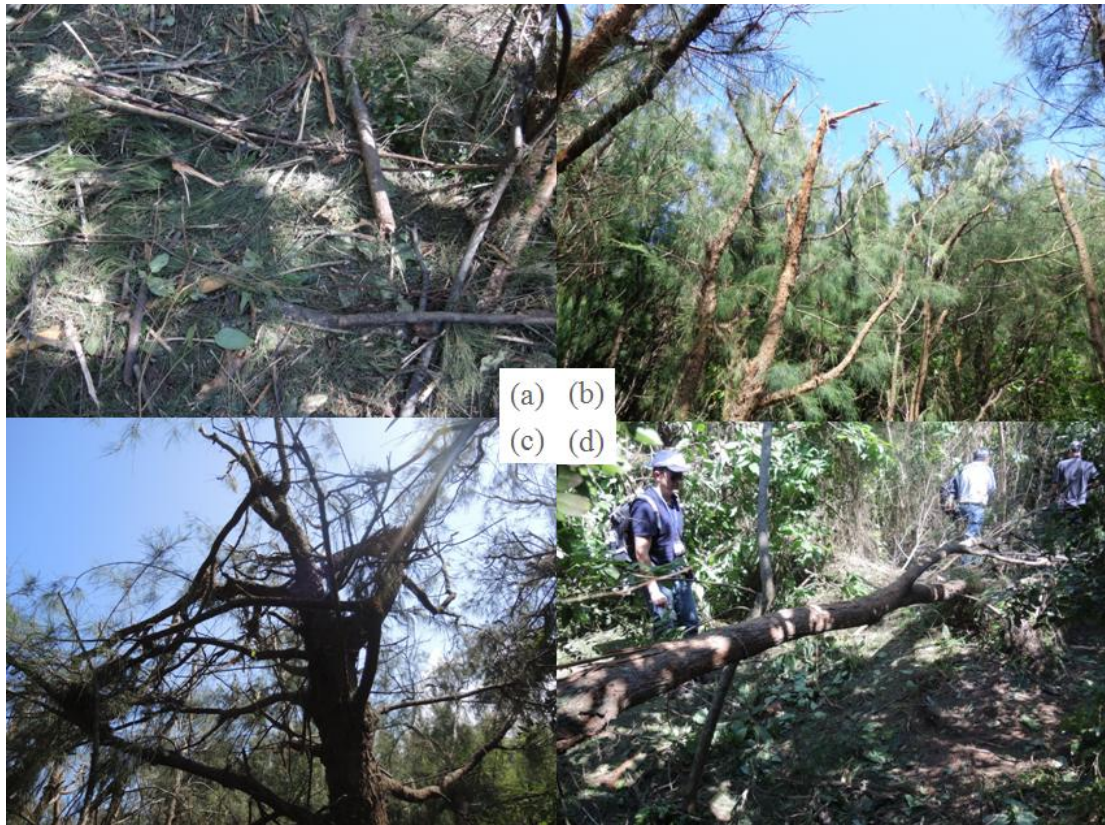
Figure 1.12-5 Damaged foliage and relevant trees

Damaged foliage and relevant tree height (H) information is depicted in Figure 1.12-5 [(a) Damaged trees on the ground, (b) Damaged tree in canopy (H=6.3 meters), (c) Damaged tree in canopy (H=5.5 meters), (d) Felled trees)]. The largest damaged tree had a diameter of about 25 cm.

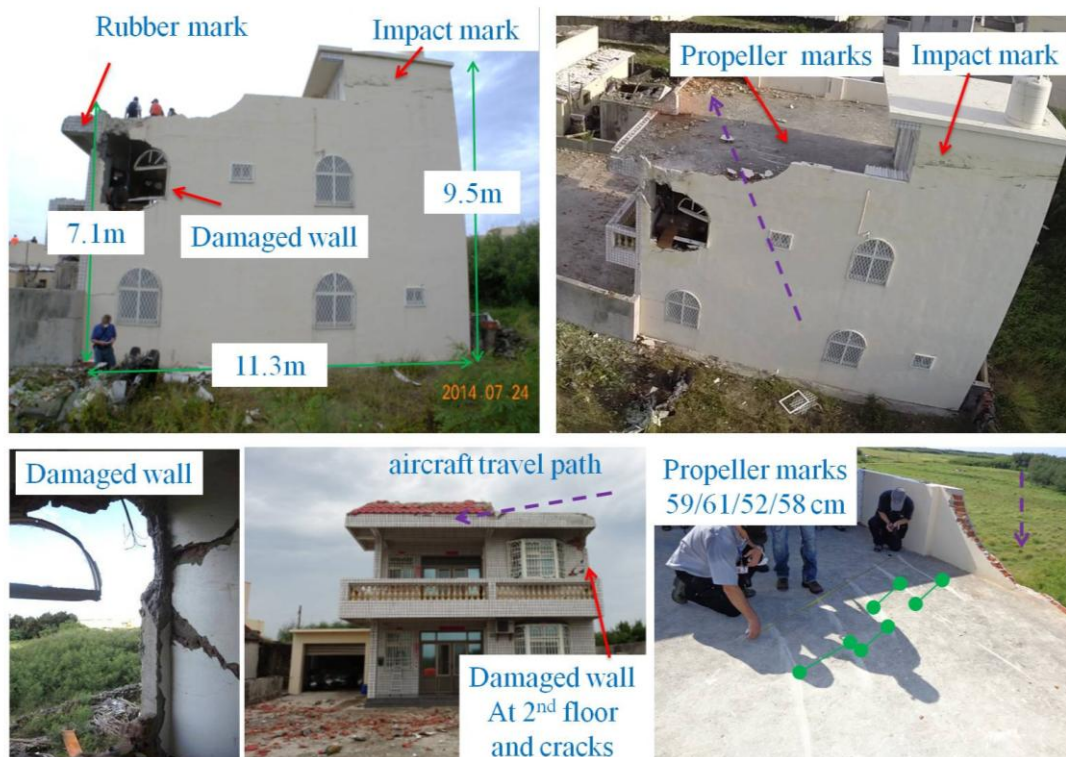
Figure 1.12-9 Initial aircraft impact, propeller, and rubber marks on building

distributed, witness marks were visible on the top of the roof. Those marks were consistent with contact from the right side propellers. There was also a long prominent mark almost as wide as the wall, at the top of the northern side of the building. It continued on to the western wall. The mark was close to horizontal (approximately 10 to 15 degrees). That damage was consistent with right-wing impact. Figure 1.12-9 depicts the relevant aircraft impact marks, propeller marks, rubber marks and cracks at no. 7-1 building.

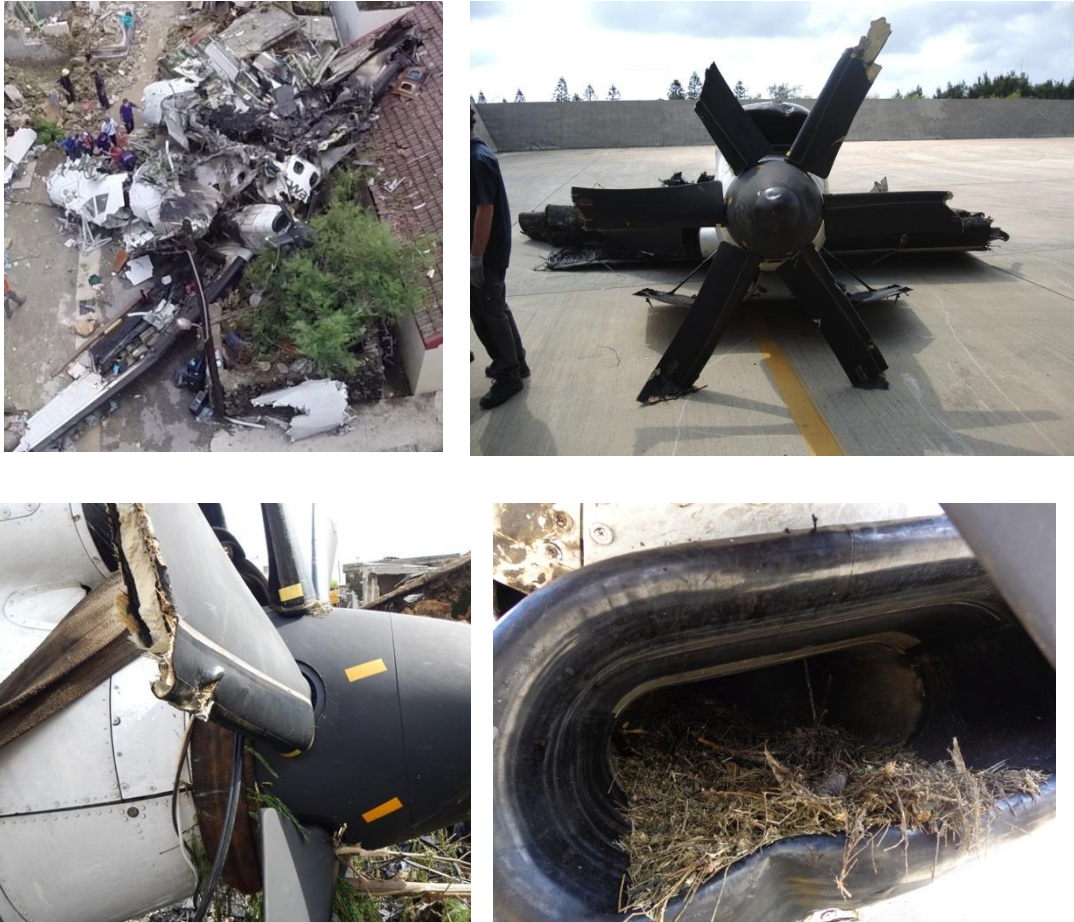
Figure 1.12-10 No.1 Engine

Both engines were recovered from the occurrence site. The no.1 engine was still attached to the left wing. The propeller pitch angle was estimated to be -10° . The no.1 engine air inlet was found full of tree debris. An impact dent was located at the lower part of the intake (see Figure 1.12-10).

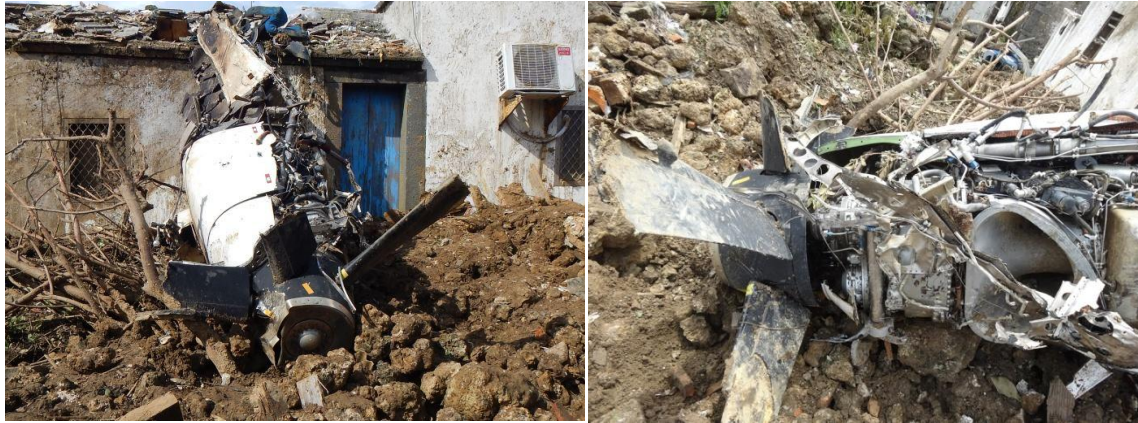
Figure 1.12-11 No.2 Engine

The no.2 engine had separated from the wing but was located in wreckage Zone 2 (see Figure 1.12-11). The propeller pitch angle was estimated to be 10° . No tree debris was found in the air inlet. The remaining propeller blades from the no.2 engine sustained more impact damage than the propellers from the no. 1 engine.

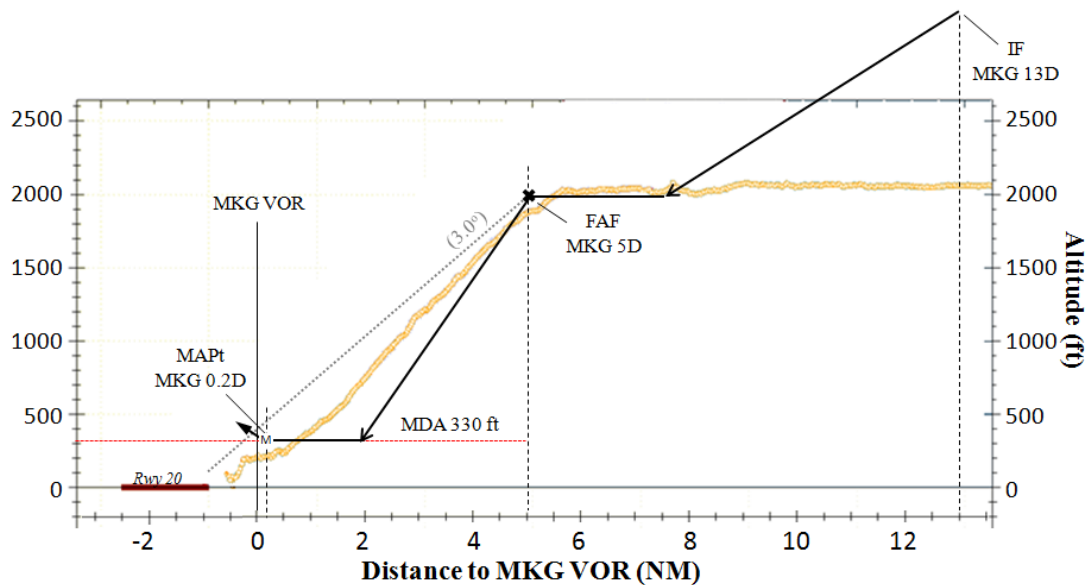
Figure 2.2-1 GE222 approach profile

1. The flight crew did not comply with the published runway 20 VOR non-precision instrument approach procedures at Magong Airport with respect to the minimum descent altitude (MDA). The captain, as the pilot flying, intentionally descended the aircraft below the published MDA of 330 feet in the instrument meteorological conditions (IMC) without obtaining the required visual references.

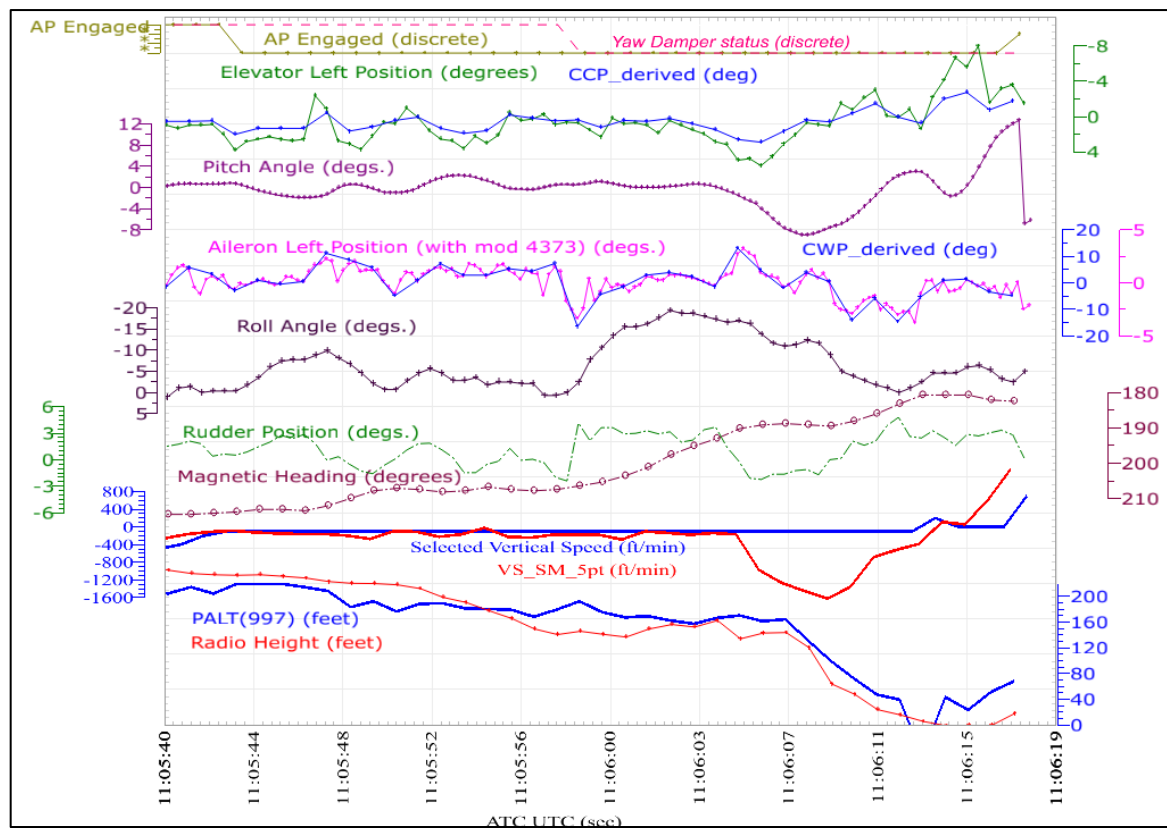
Figure 2.9-1 Relevant FDR and derived parameters

The occurrence aircraft's increased rate of descent from 150 ft/min to 1,600 ft/min between 1906:05 and 1906:10 was the result of an elevator control input by the captain. The nose down pitch angle of the aircraft was a maximum of 9 degrees. While descending, the aircraft turned to the left as a result of left aileron input. That is, the aircraft behavior was consistent with the control surface inputs.
