FINAL REPORT

**RUNWAY TAKE-OFF INCIDENT INVOLVING
AIRBUS A340, REGISTRATION A40-LH
SINGAPORE CHANGI AIRPORT
30 MAY 2007**

AIB/AAI/CAS.039

**Air Accident Investigation Bureau of Singapore
Ministry of Transport
Singapore**

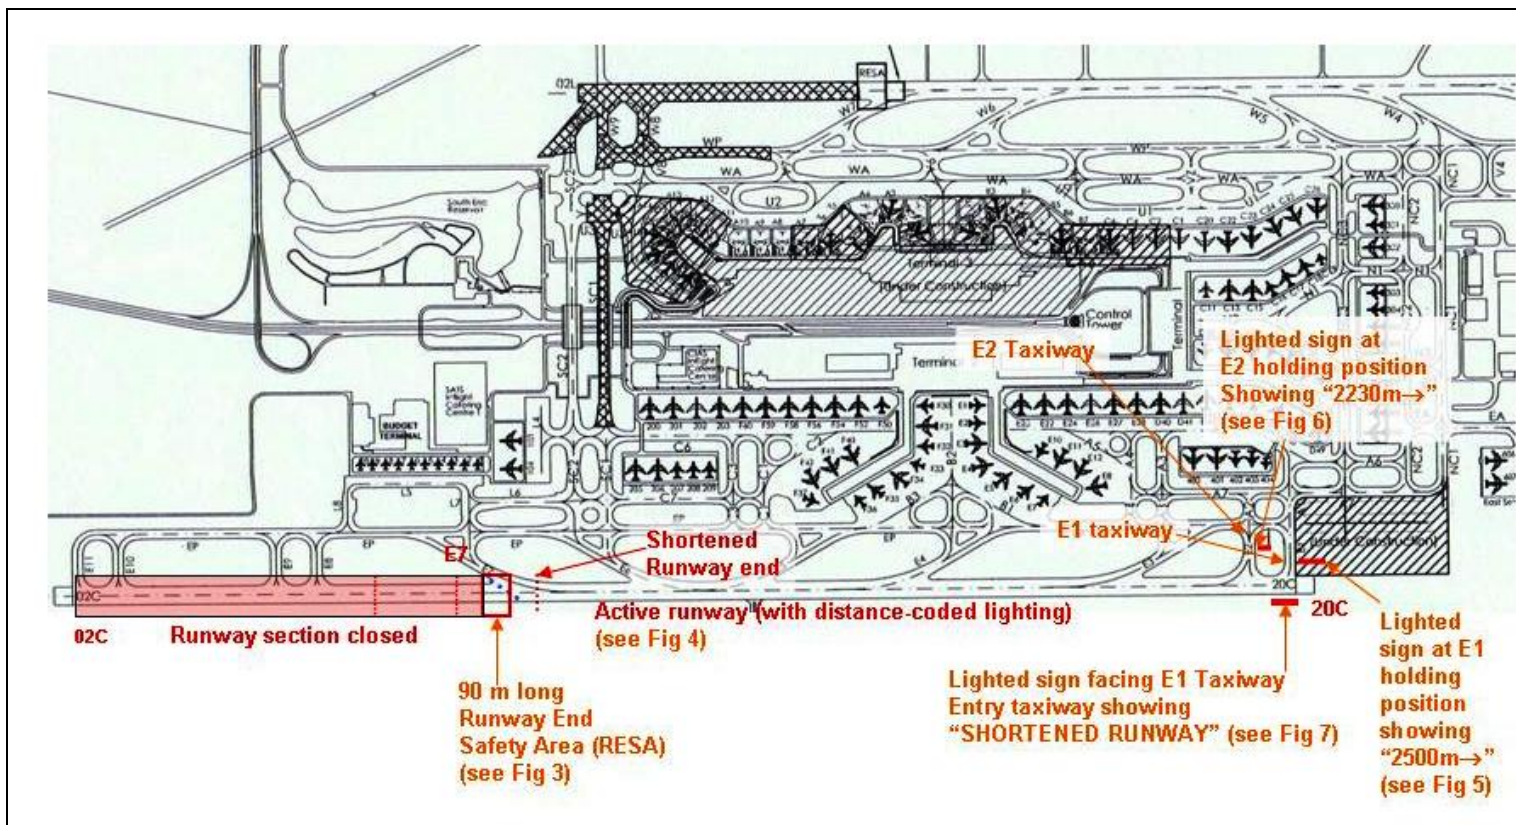
1.10.2 The resurfacing works at the time of the incident entailed a reduction of usable length of Runway 20C. The TORA and LDA were reduced to 2,500 m. The end of the shortened runway was marked by a row of embedded red runway end lights. There was a safety zone of 500 m after the runway end which included a 60 m clearway followed by 90 m of Runway End Safety Area (RESA). (**Figure 2** and **Figure 3**) There were two rows of marker boards with red lights placed in the safety zone, one located at 260 m and the other located at 500m from the runway end.

Figure 2. Layout of the shortened 20C showing the closed section and location of the movement guidance signs

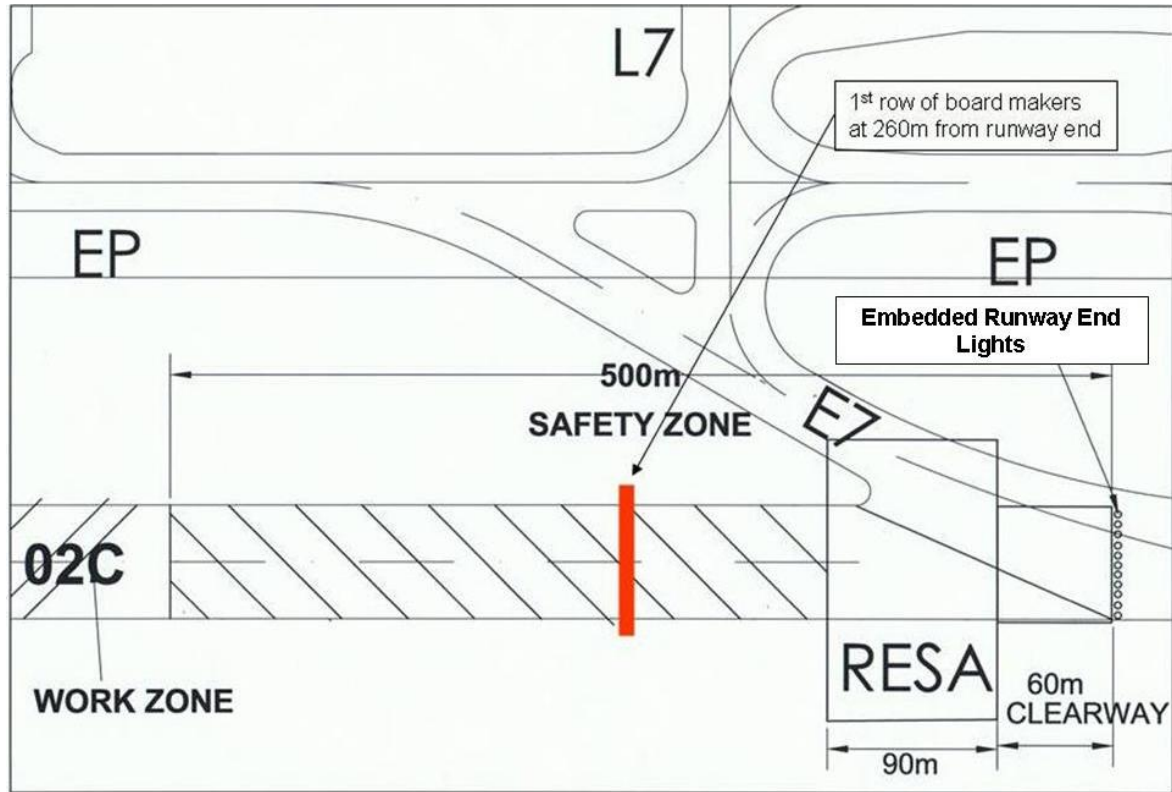
- Establishing a 500 m safety zone from the temporary runway end before the start of the work area
 - Placing marker boards with red lights at 260 m from temporary runway end to demarcate boundaries of closed runway

Figure 3. Safety zone at the end of shortened Runway 20C

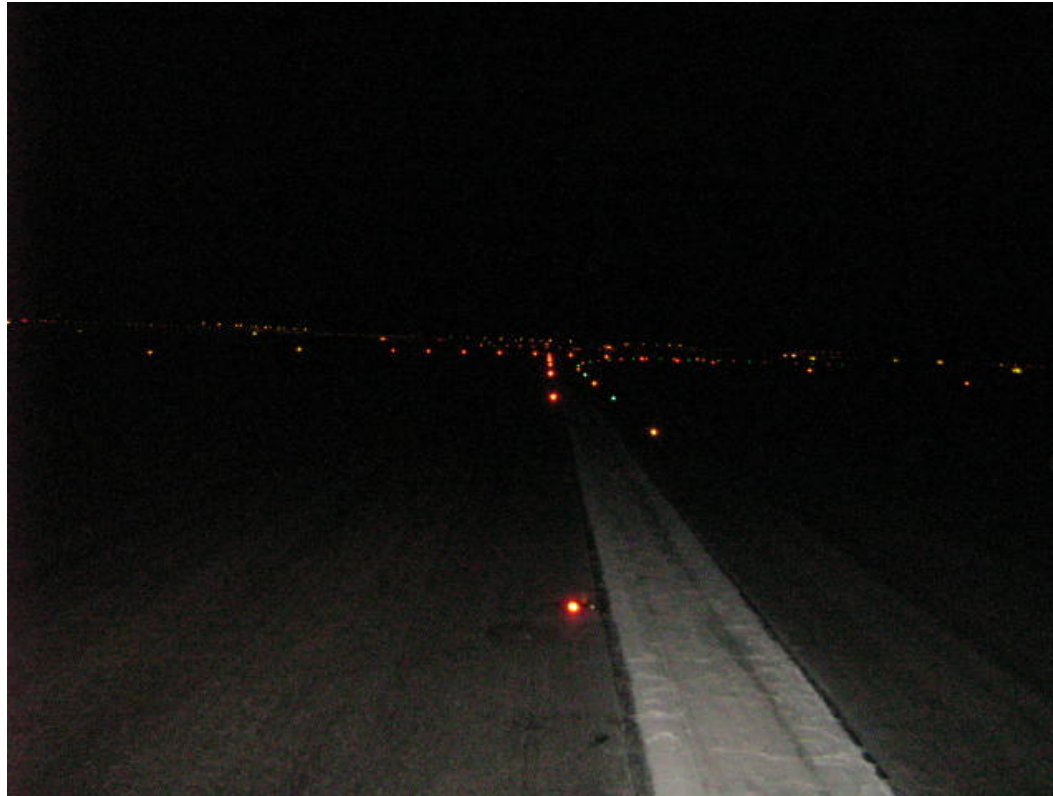
- 1.1.27 During the take-off roll at about 120 knots, the PIC noticed that the centreline lights changed from white to alternate red and white⁵. The PIC subsequently applied Take-off Go Around (TOGA) power and abruptly made a higher than normal rate of rotation to avoid overrunning the runway. Both the PIC and FO reported that they saw the red runway centre lights upon rotation. Data from the flight recorder indicated that TOGA was applied at 125 knots with positive lift-off at 141 knots.

- The lights were white from threshold to the point 900 m from runway end.
- The lights were alternate red and white from 900 to 300 m.
- The lights were red from 300m to runway end.

Figure 4. Distance-coded runway centre line lights and runway end lights near the shortened end of Runway 20C

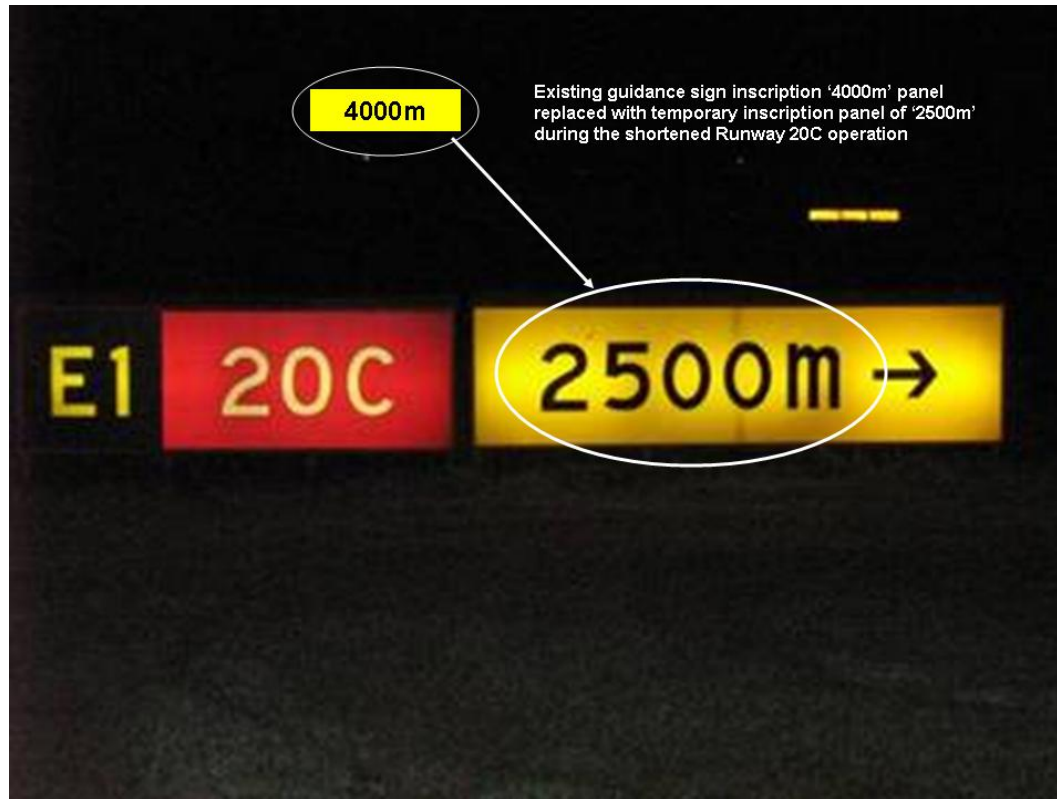
1.10.3 All the existing aircraft movement guidance signs affected by the shortening of Runway 20C were updated by the airport operator accordingly (See **Figure 5** and **Figure 6**). A new guidance sign (**Figure 7**) that indicated 'Shortened Runway' was put up facing taxiway E1, on the left side of Runway 20C, as a last reminder to flight crews before they move onto the runway. All these guidance signs were illuminated.

1.10.4 The guidance signs indicated in **Figure 5** and **Figure 6** conformed to the requirement in Annex 14 to the Convention on International Civil Aviation (Chicago Convention). The 'Shortened Runway' sign put up by the airport operator was not required by ICAO, but was placed there as an additional precaution.

- 2.4.1 The crew did not notice the sign shown in **Figure 5** when they were at the Runway 20C holding point on Taxiway E1. The inscription panel on the guidance sign was replaced with a temporary inscription panel of the same size, font and colour indicating the shortened distance. The investigation team understands that the sign meets the requirements in Annex 14 to the Chicago Convention for normal operations. However, for abnormal operations such as taking off from a shortened runway, the sign did not contain any attention getter to draw the crew's attention to the reduced TORA shown on the guidance sign.

- 3.1.4 The FO did not check the ATIS again even though he told the ATCO he would do so when seeking clearance from Clearance Delivery.
- 3.1.5 The guidance signs pertaining to the shortened Runway 20C positioned along the taxi route to the runway failed to draw the attention of the flight crew to its information.

Figure 5. Guidance sign at E1 taxiway holding position after the original inscription panel showing 4000 m was replaced with one showing 2500 m

- 5.1 The airport operator review the way important information is indicated on movement area guidance signs concerning any temporary runway length changes so that the signs can be effective in drawing flight crews' attention. [AAIB Recommendation R-2008-006]
- 5.2 The airline review its procedure and training of the pilots to improve flight crews' awareness of movement area guidance signs around airports. [AAIB Recommendation R-2008-007]
- 5.3 The airline require its flight crews to report any significant incident which they are aware of to the local air traffic control unit. [AAIB Recommendation R-2008-008]

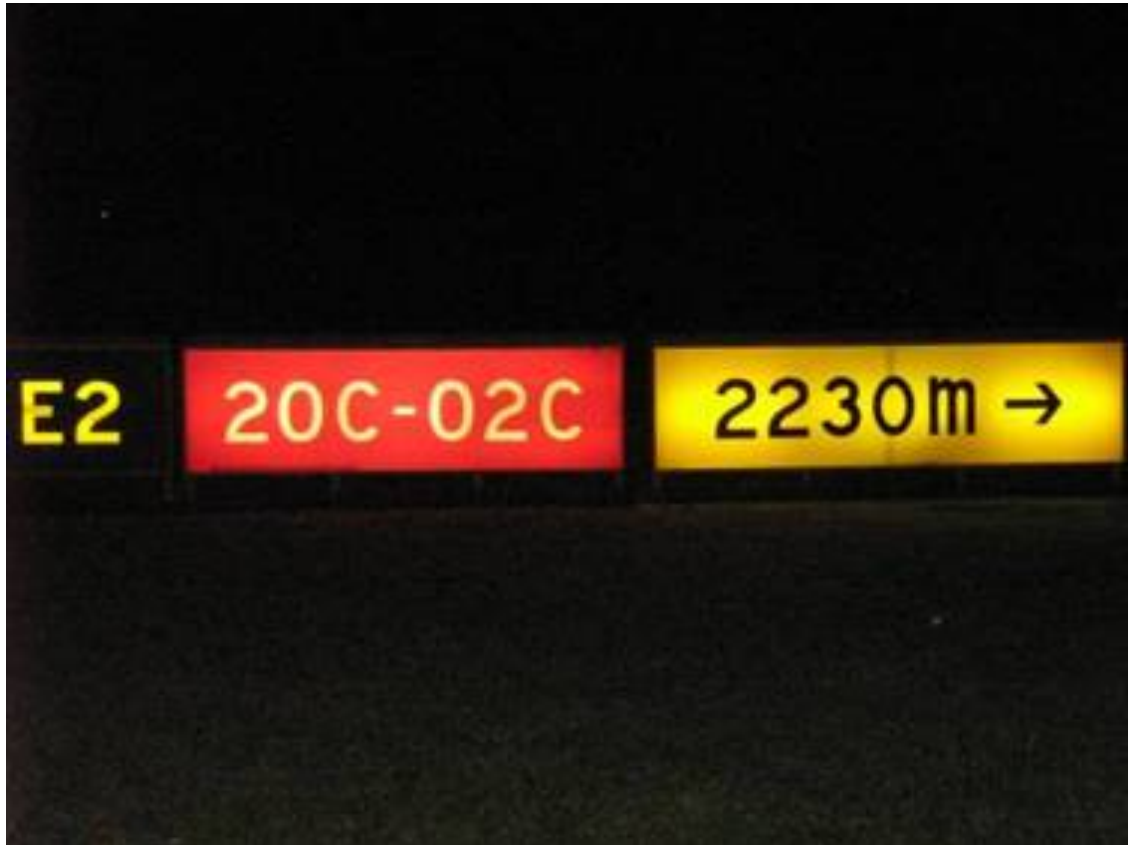
Figure 6. Guidance sign at E2 taxiway holding position after the original inscription panel showing 3850 m was replaced with one showing 2230 m

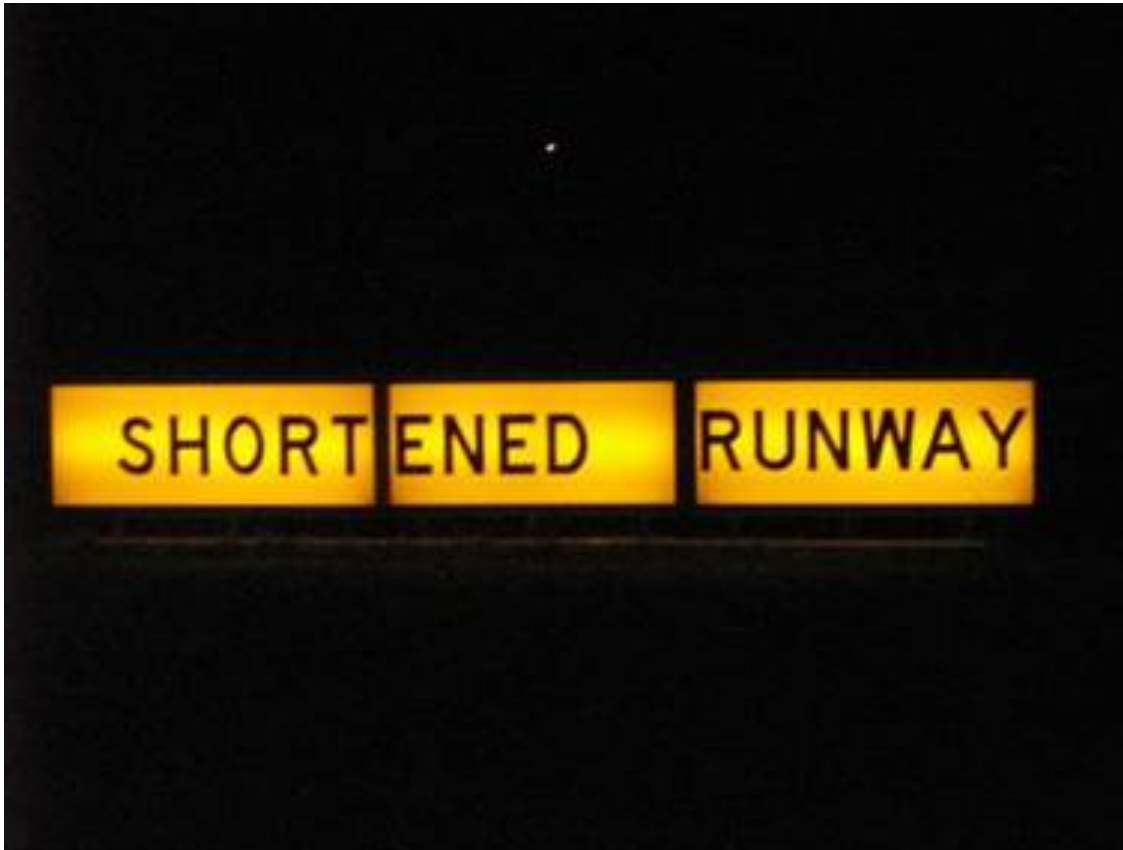
Figure 7. Guidance sign facing E1, on the left side of Runway 20C

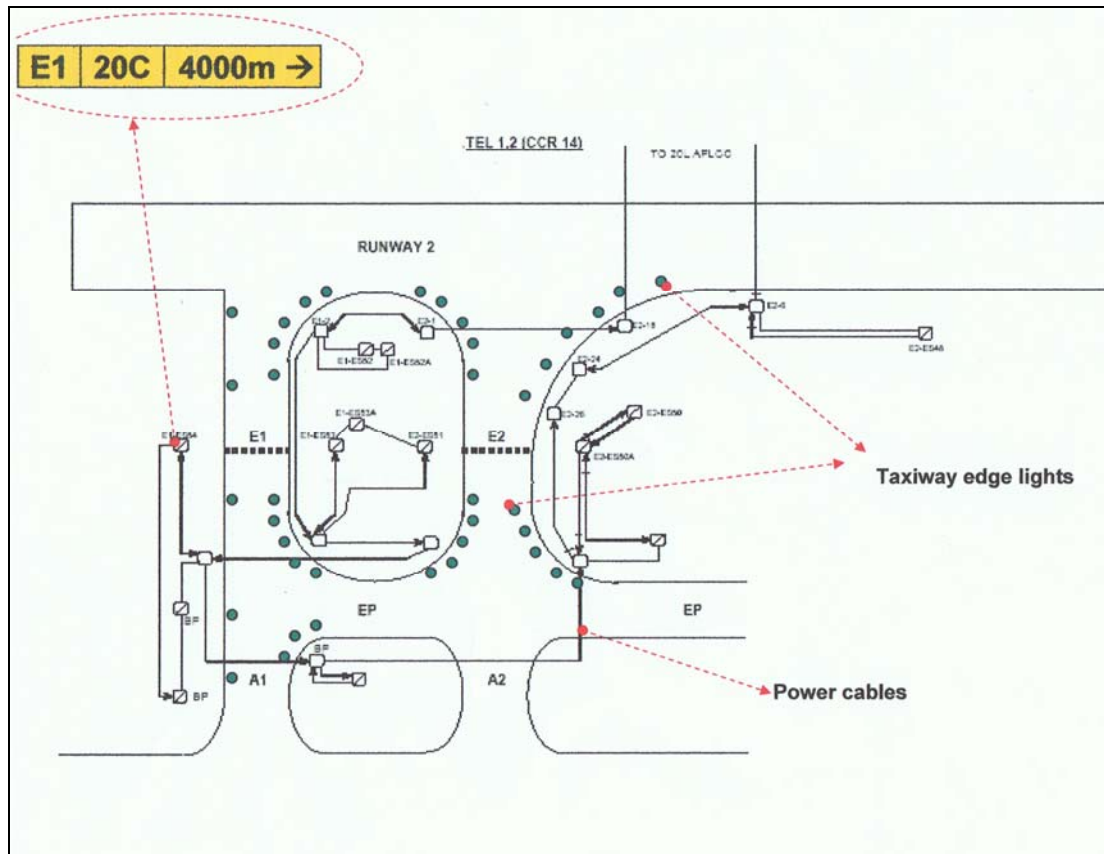
1.10.5 The guidance signs as indicated in **Figure 5** and **Figure 6** were controlled by a single switch in the control tower. This switch controlled also the taxiway edge lights in the vicinity of the guidance signs (see **Figure 9**). The 'Shortened Runway' sign as indicated in **Figure 7** was controlled by a single switch in the tower that controlled also a segment of runway edge lights adjacent to the 'Shortened Runway' sign. There were records indicating that the airfield contractor had checked the lights and

Figure 9. Guidance Signs Control Circuitry
