FINAL
KNKT.11.12.30.04

NATIONAL TRANSPORTATION SAFETY COMMITTEE

Aircraft Accident Investigation Report
PT. Sriwijaya Air
PK-CKM
Boeing 737-300
Adisutjipto International Airport, Yogyakarta
Republic of Indonesia

20 December 2011

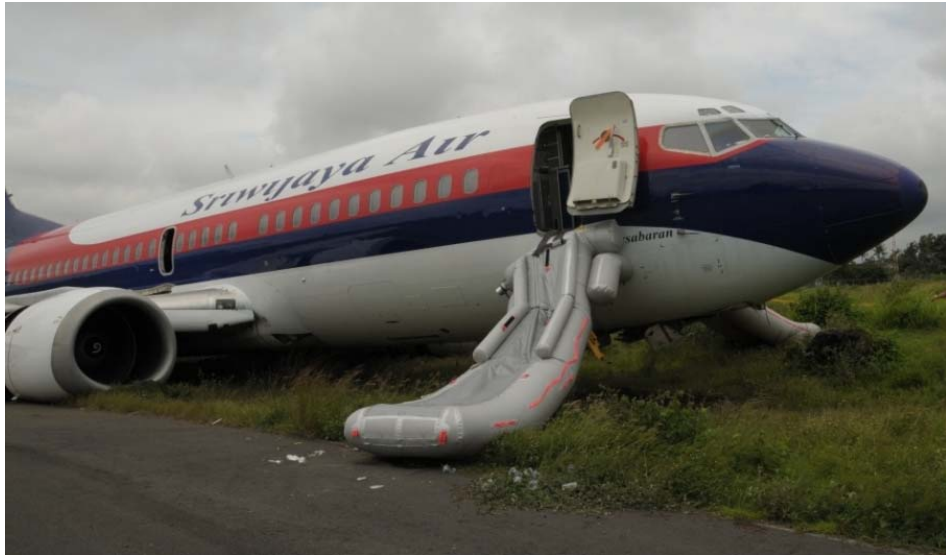
The aircraft stopped at 75 meter from the end of runway 09 and 54 meter on the left side of the centre line.

Figure 1: PK-CKM stopped at 75 meters from end of runway 09

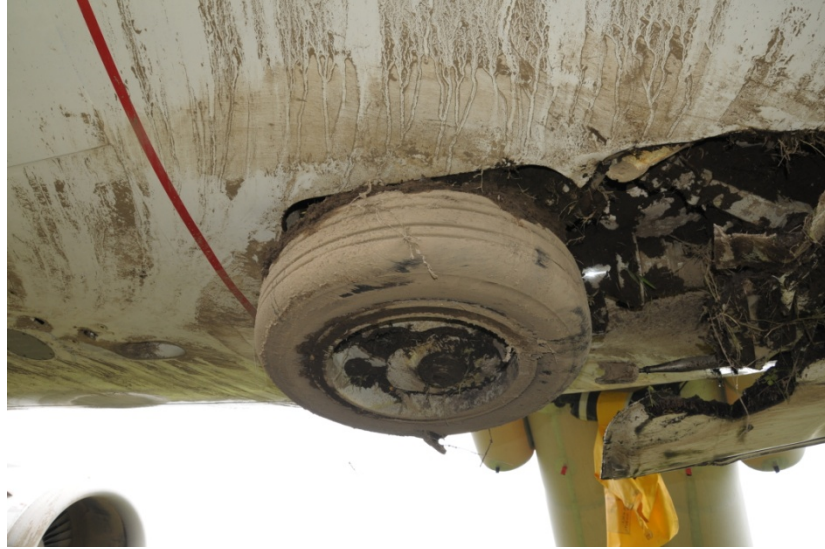
The aircraft hit the ground with nose landing gear and right main landing gear collapsed, damaged the aircraft bottom structure.

Figure 2: Nose wheel

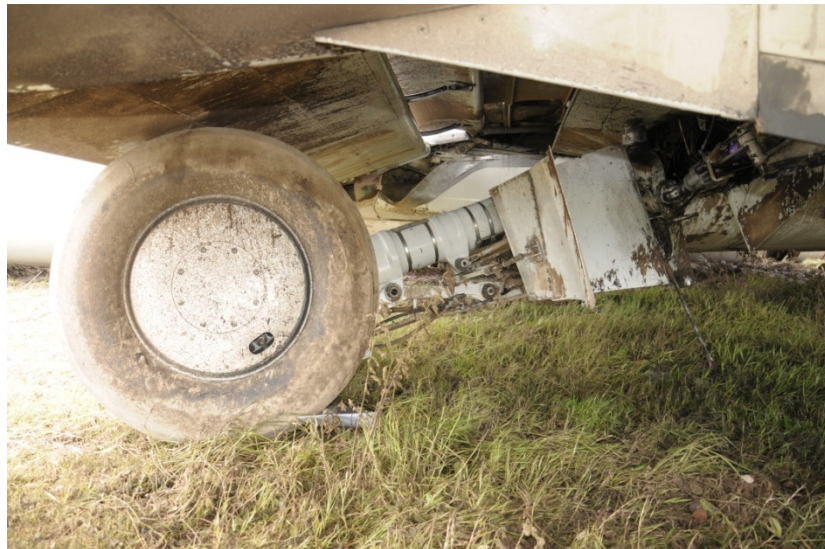
Figure 3: Right main gear.

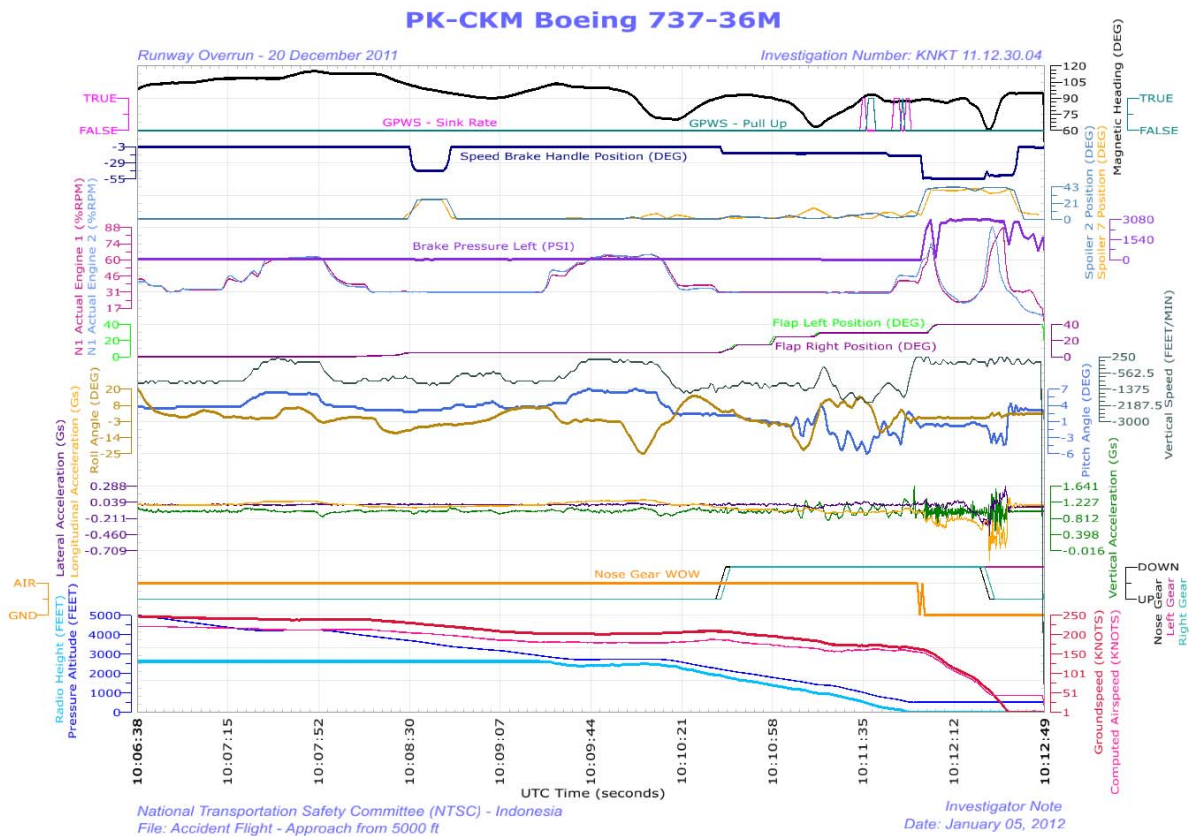
- The aircraft was at heading greater than 090 after started to descend left 2500 ft;
- At below 1000 ft, the aircraft heading was relatively constant;
- The rate of descend recorded vary and up to 1920 ft per minute and below 500 ft AGL, the rate of descend recorded up to 2040 ft per minute.
- The aircraft touched down at 10.12 UTC at speed 156 Kt before it bounced.
- The left and right engines indications were relatively equal during the approach phase. After landing, the N1 value increased then decreased to idle value and increased until the aircraft about to stop.
- The ground spoilers were extended, immediately after landing.
- The flap extended to 40 after the aircraft touch down.
- The brake pressures were relatively at maximum pressure from few moments after touch down until the aircraft stop.

Figure 5: The FDR data plot on approach started from altitude 5000 ft.

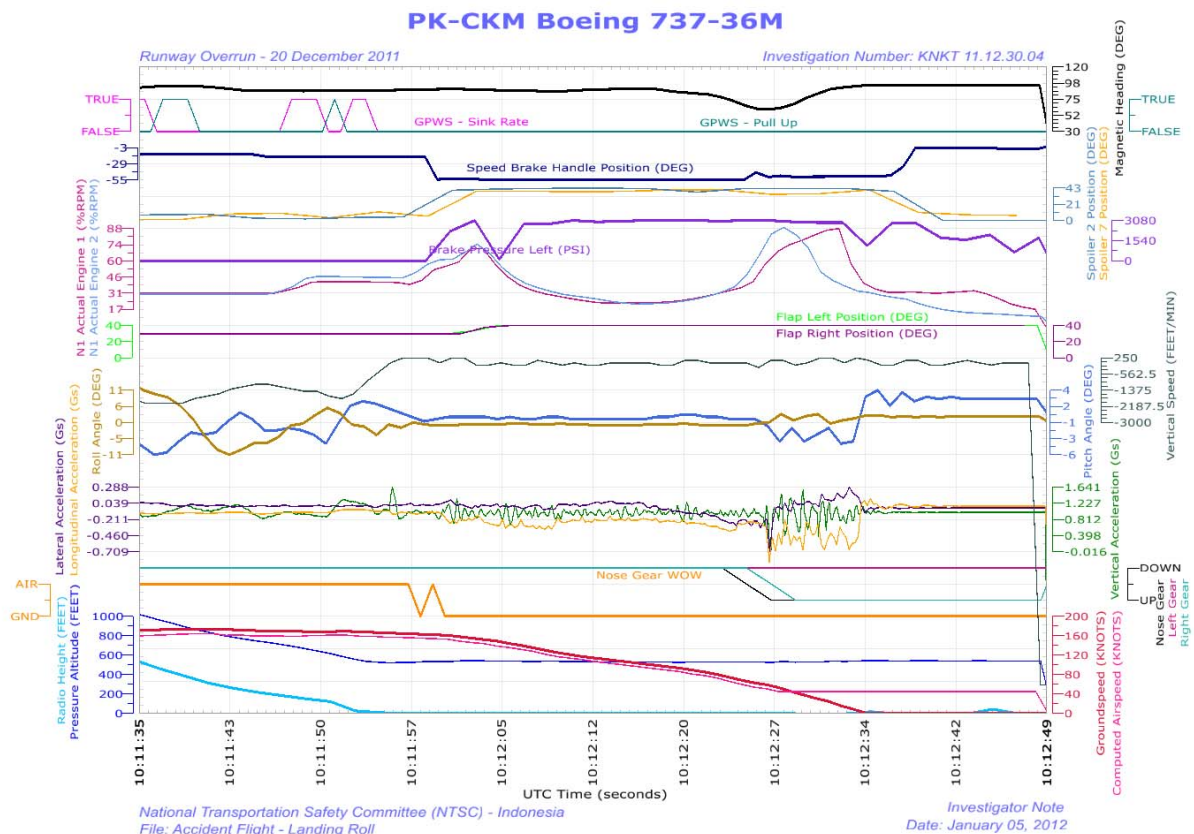
Figure 6: FDR data plot started from altitude 1000 feet.

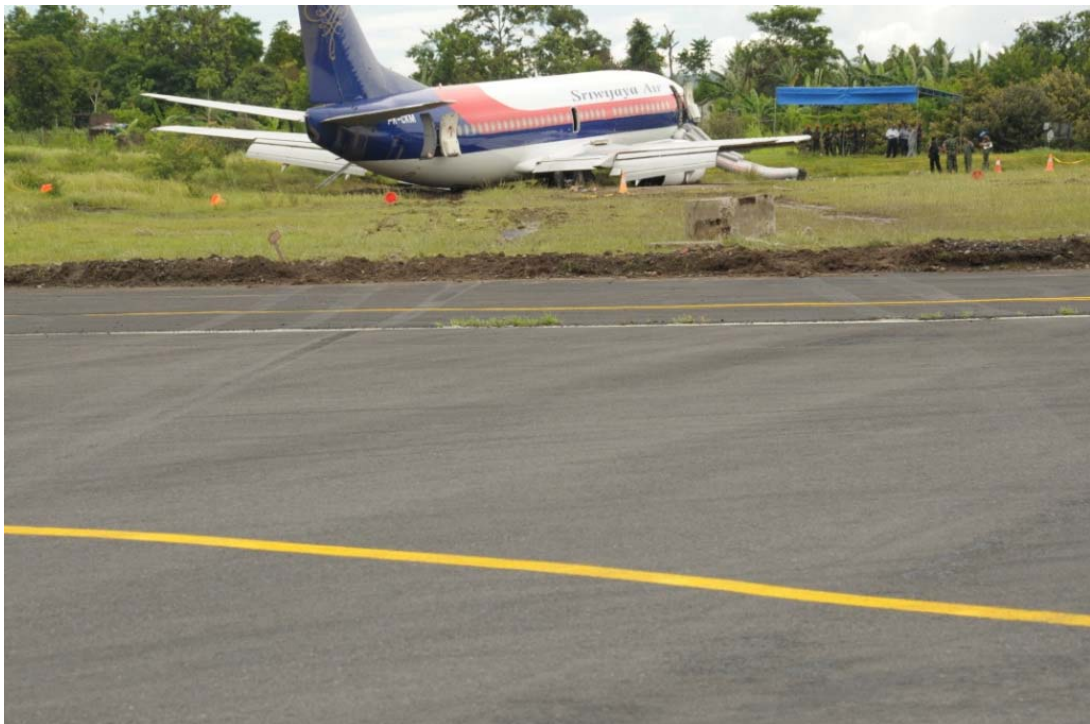
Aircraft tail position was 75 meters from the end of runway and 54 meters left side of runway centreline.

Figure 8: Aircraft final position

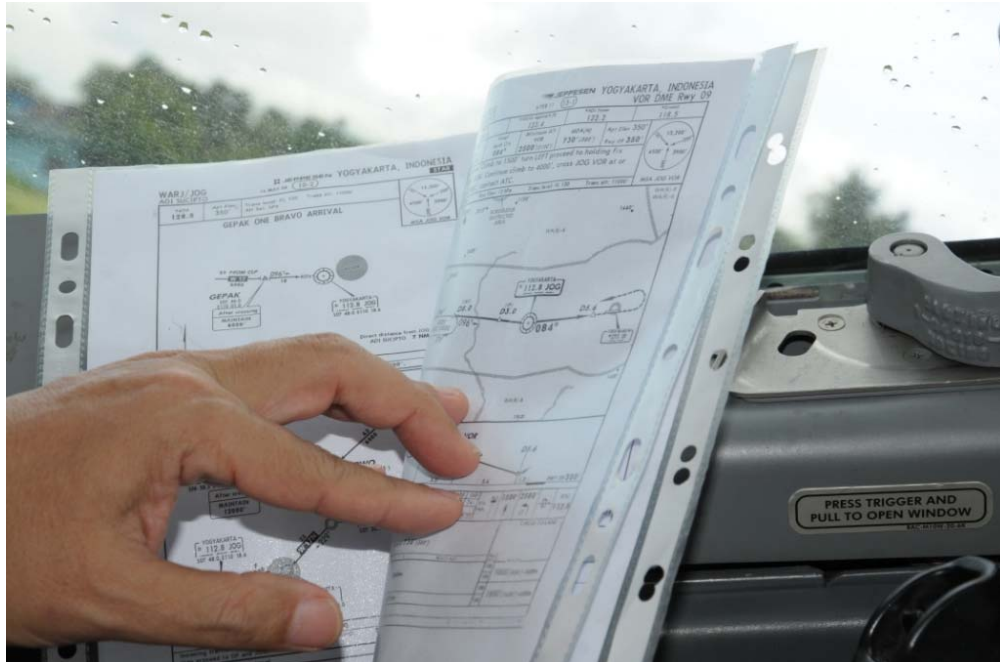
During the investigation it was found on the left writing pad holder found 3 pages of approach chart. The top page was ILS Approach runway 10 Surabaya, second page was ILS approach runway 09 Yogyakarta and the VOR/DME runway 09 on the other side of the page (face down) and the bottom page was Standard Arrival (STAR) runway 09 Yogyakarta.

Figure 9: Approach charts on the PIC pad folder.

The investigation found that the VOR/DME runway 09 was not ready to use on the PIC writing pad holder. The available approach chart was the ILS Approach runway 10 Surabaya. It also found that both pointers of the Radio Magnetic Indicator (RMI) on the left pilot were set to Automatic Direction Finding (ADF).

Missing the crew briefing and no approach chart available might have made the PF not familiar with the VOR/DME runway 09 approach path.
