Aircraft Accident Report

Tail Strike During Landing

Asiana Airlines Flight 340

A321-200, HL7730

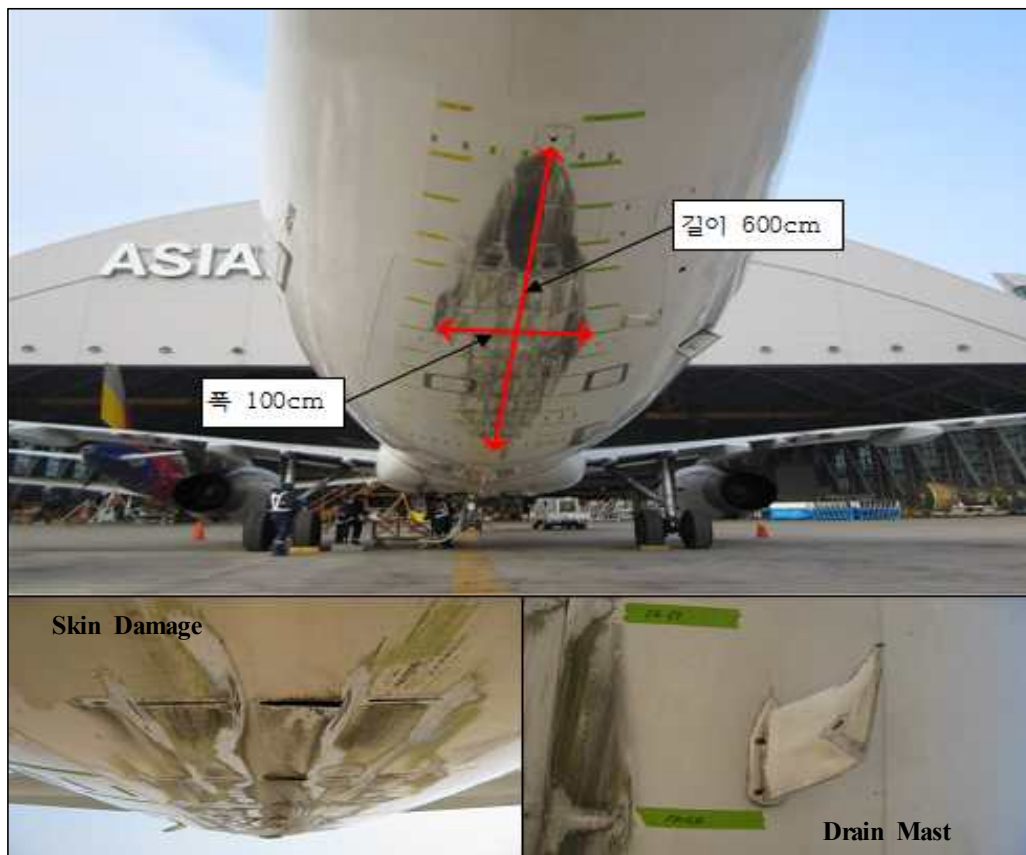
As shown in [Figure 1], as the belly of the rear fuselage contacted the ground during landing, it sustained abrasion damage 100 cm wide and 600 cm long, including wear-through. The drain mast was bent to the side.

[Figure 1] Damage on the Exterior Surface of the Rear Fuselage

As shown in [Figure 4], major repair or replacement of the affected components were performed with technical support of the manufacturer's AOG team for about three months and completed on 12 August 2013. The cost of repairs was about 3.7 billion won (\$ 3.37 million) including personnel expenses.

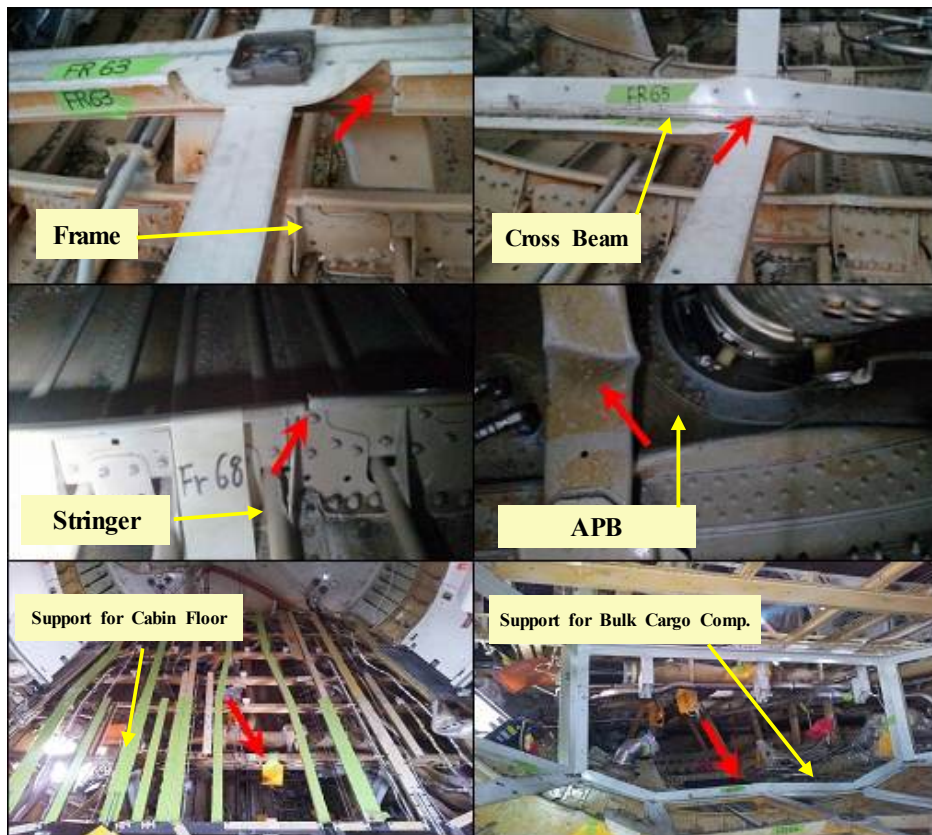
[Figure 2] shows damage to the interior fuselage. Out of frames, major structure of the fuselage, 11 of them from No. 62 to 72 were cracked or deformed. Also, nine stringers⁷⁾ in the same location, from STGR39LH to STGR41RH, were damaged.

CGO floor cross beam at FR62, FR63, and FR64 was damaged, and PAX floor cross beam at FR65 and FR70 was fractured.

The supports for the water tank and the waste water tank were damaged.

[Figure 2] Damage to the Interior of the Airplane

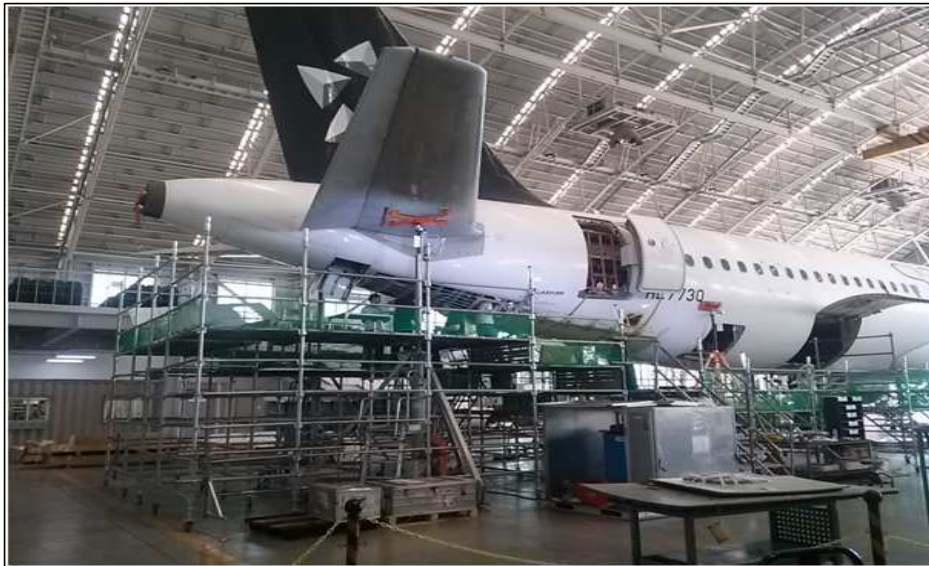
[Figure 4] Aircraft Repair

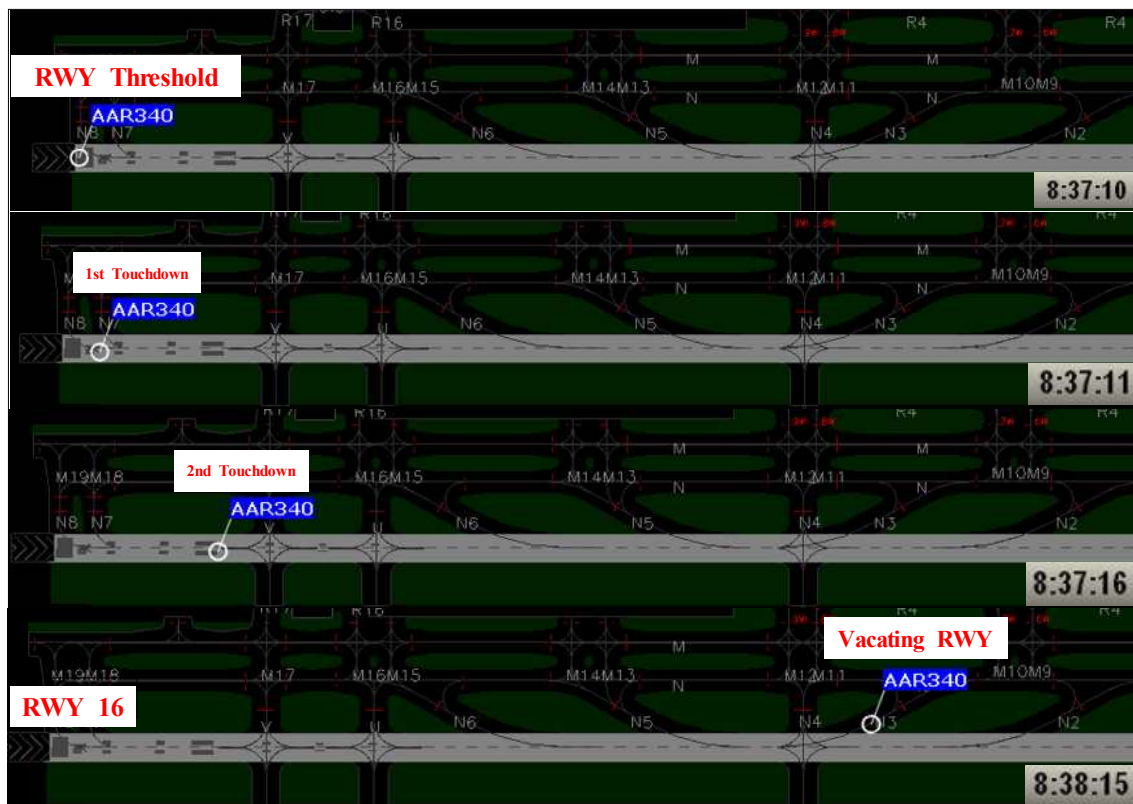
Images recorded by Incheon Airport's Airport Surface Detection Equipment (ASDE) when HL7730 landed are shown in [Figure 6], which show when and where HL7730 passed the runway threshold, performed the initial and second touchdowns, sustained a tail strike, and vacated the runway.

[Figure 6] Major Images Recorded by the ASDE During Landing

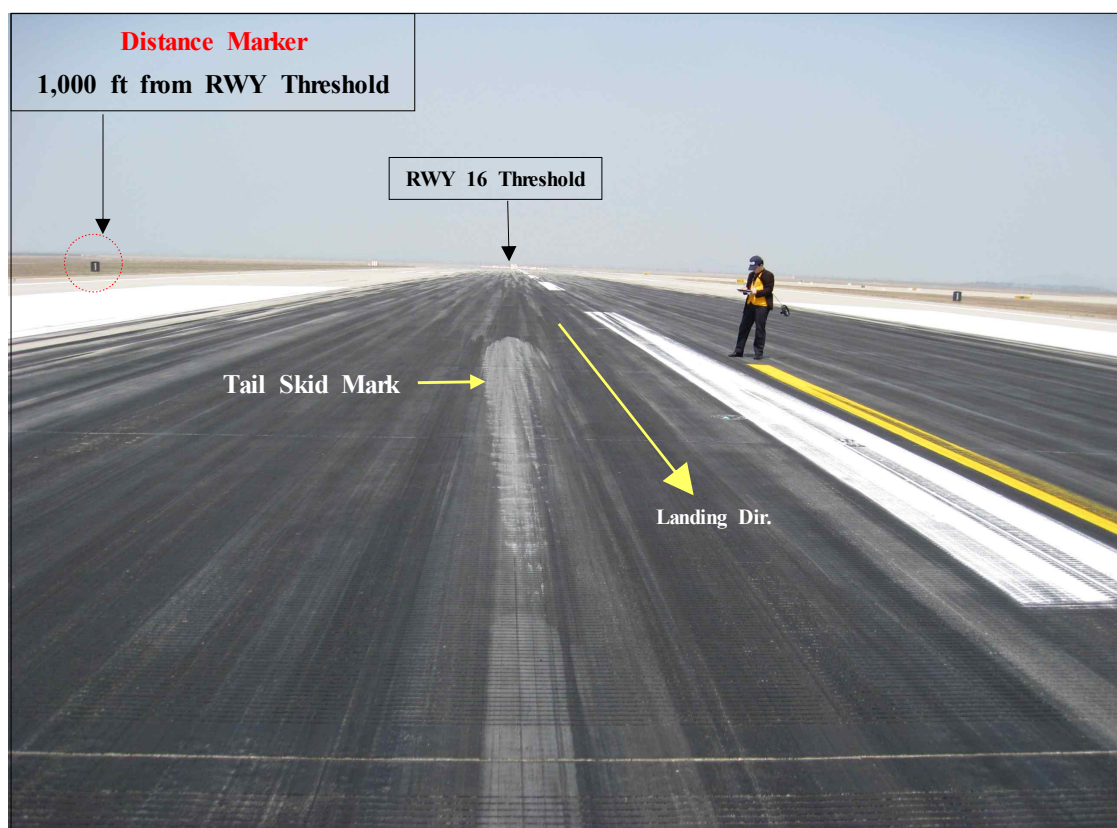
Runway 16's tail skid mark left by HL7730 during landing is shown in [Figure 7]. The mark began about 491 meters from the runway threshold, about 2.2 meters²⁴⁾ to the right of the runway centerline, as shown in [Table 2].

[Figure 7] Tail Skid Mark on Runway

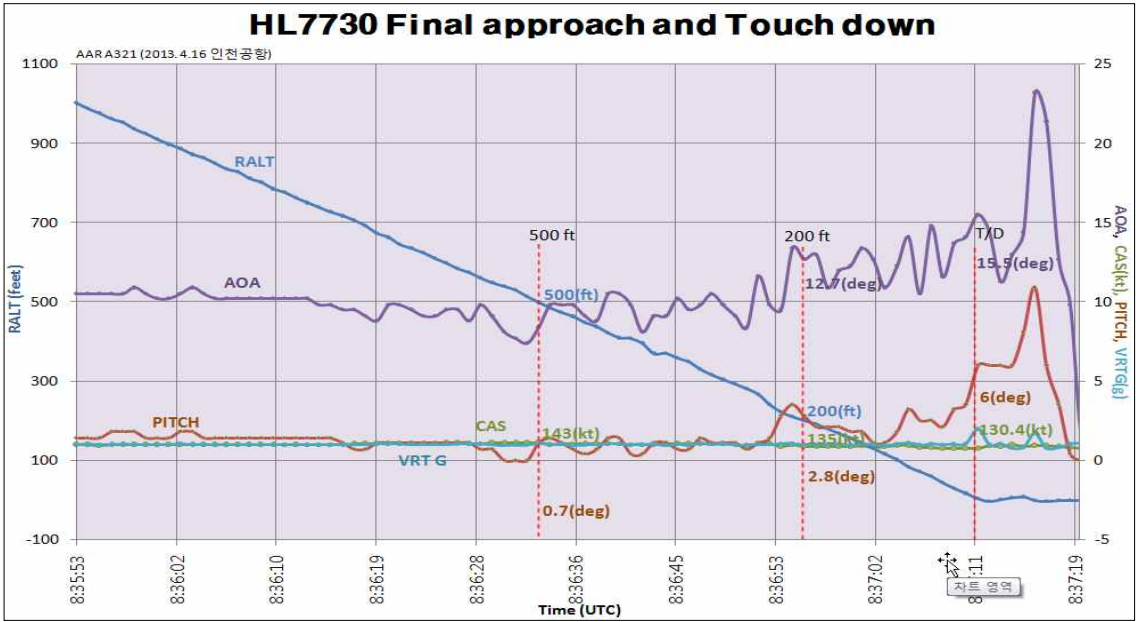
[Figure 8] Major Parameters During Final Approach and Touchdown

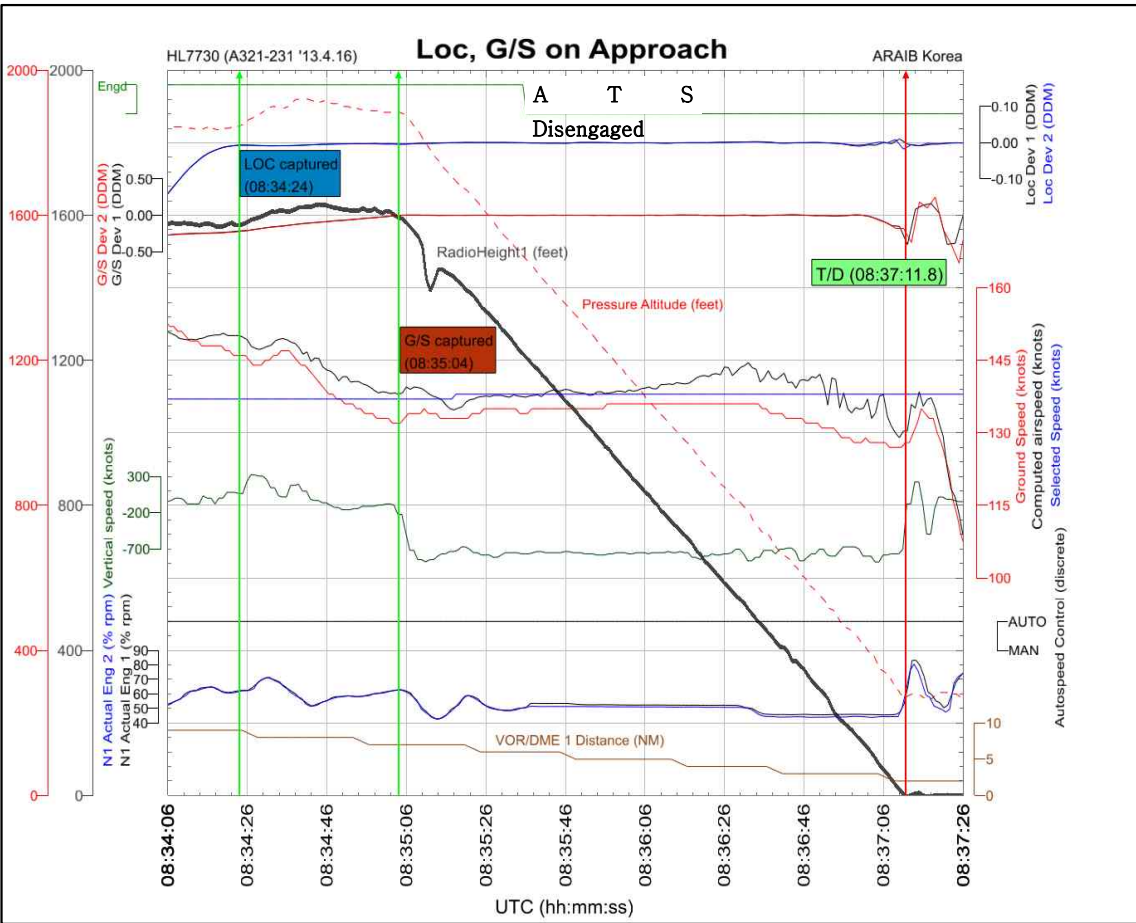
Major flight parameters recorded between HL7730's approach to runway 16 using the ILS approach and touchdown are shown in [Figure 9].

[Figure 9] Major Parameters During ILS Approach and Touchdown

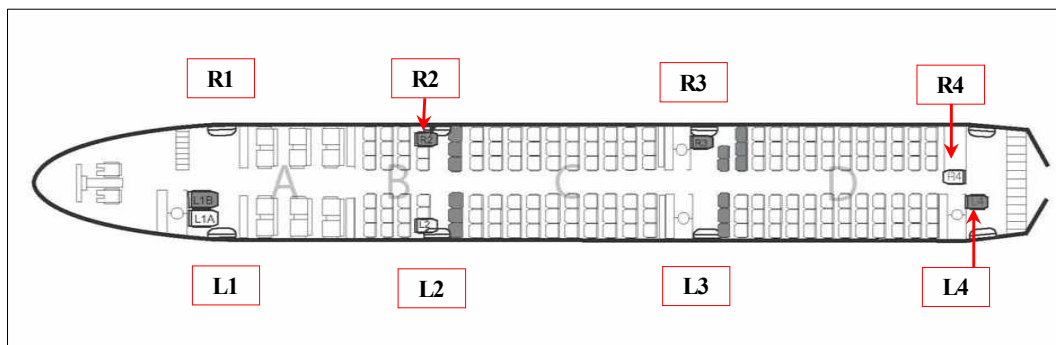
attendants in jumpseats R2, R4, and L4 sustained injuries²⁵⁾ as shown in [Figure 10]."

[Figure 10] Locations of Injured Flight Attendants
