# **Final Report of the Federal Aircraft Accidents Inquiry Board**

concerning the Accident of the aircraft DC-9-32, ALITALIA, Flight No AZ 404, I-ATJA  
on the Stadlerberg, Weiach/ZH, of 14 November 1990

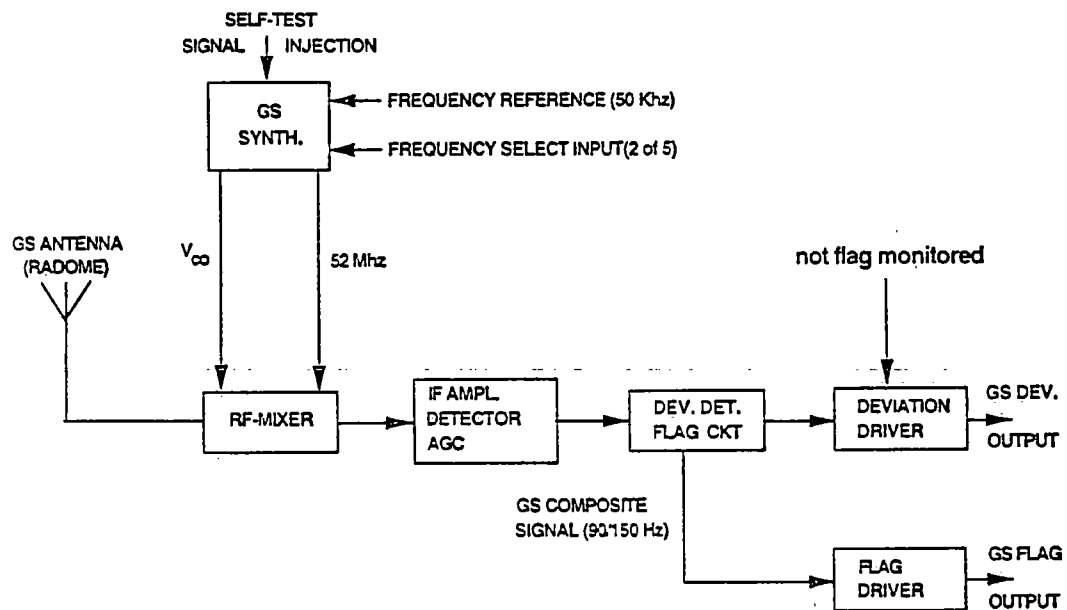
Block Diagram KING KNR 6030 GS Receiver

The receiver KING KNR 6030, S/N 2256 was recovered from the accident site in a badly damaged condition. The unit was considerably deformed and had fire damage. The aircraft plug had been ripped from the cable loom, and separated from the radio rack and was found on the receiver unit. There was no sign of pre-accident damage on this plug.

In the NAV receiver itself, the glide slope deviation signal circuit was followed from the rear mounted unit plug until the interface board. At the transfer between the cable loom and the mother-board a break was detected at the connections E2644 and E2648. The specialists from the Zürich Police Scientific Service (WD) determined that no pre-accident damage was present at this connection. The circuits on both the mother-board and the interface-board were intact.

The IC I 2903 in the glide slope deviation driver was missing. The IC I 2904 in the VOR/LOC deviation driver was found loose in the unit. The Scientific Service specialists determined that both IC must have been pulled from their respective receptacles by acceleration forces.

A detailed examination of the interface-board was not possible due to the high degree of damage. It is noted however, that a fault in an electronic component on this board would tend to have caused a hard-over, rather than a centred indicator needle.

The examination of the NAV receiver KING KNR 6030 gave no firm indications of a pre-crash deficiency. It can not, however, be excluded that this unit could have accounted for a "frozen" centred glide slope indication.

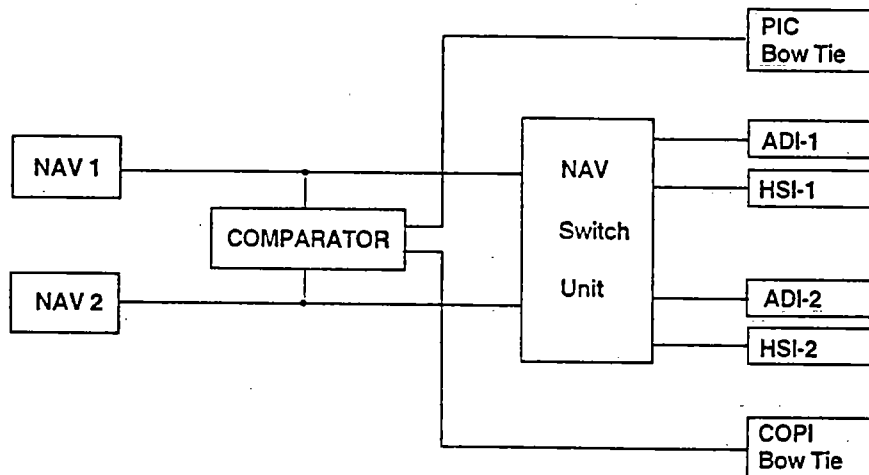
#### Block Diagram of the NAV System

The condition of this unit allowed closer examination. As the rotary switch is positioned by an electric motor, it could not change position during the impact. The examination of the NSU showed that the switch position was undoubtedly RADIO 1.

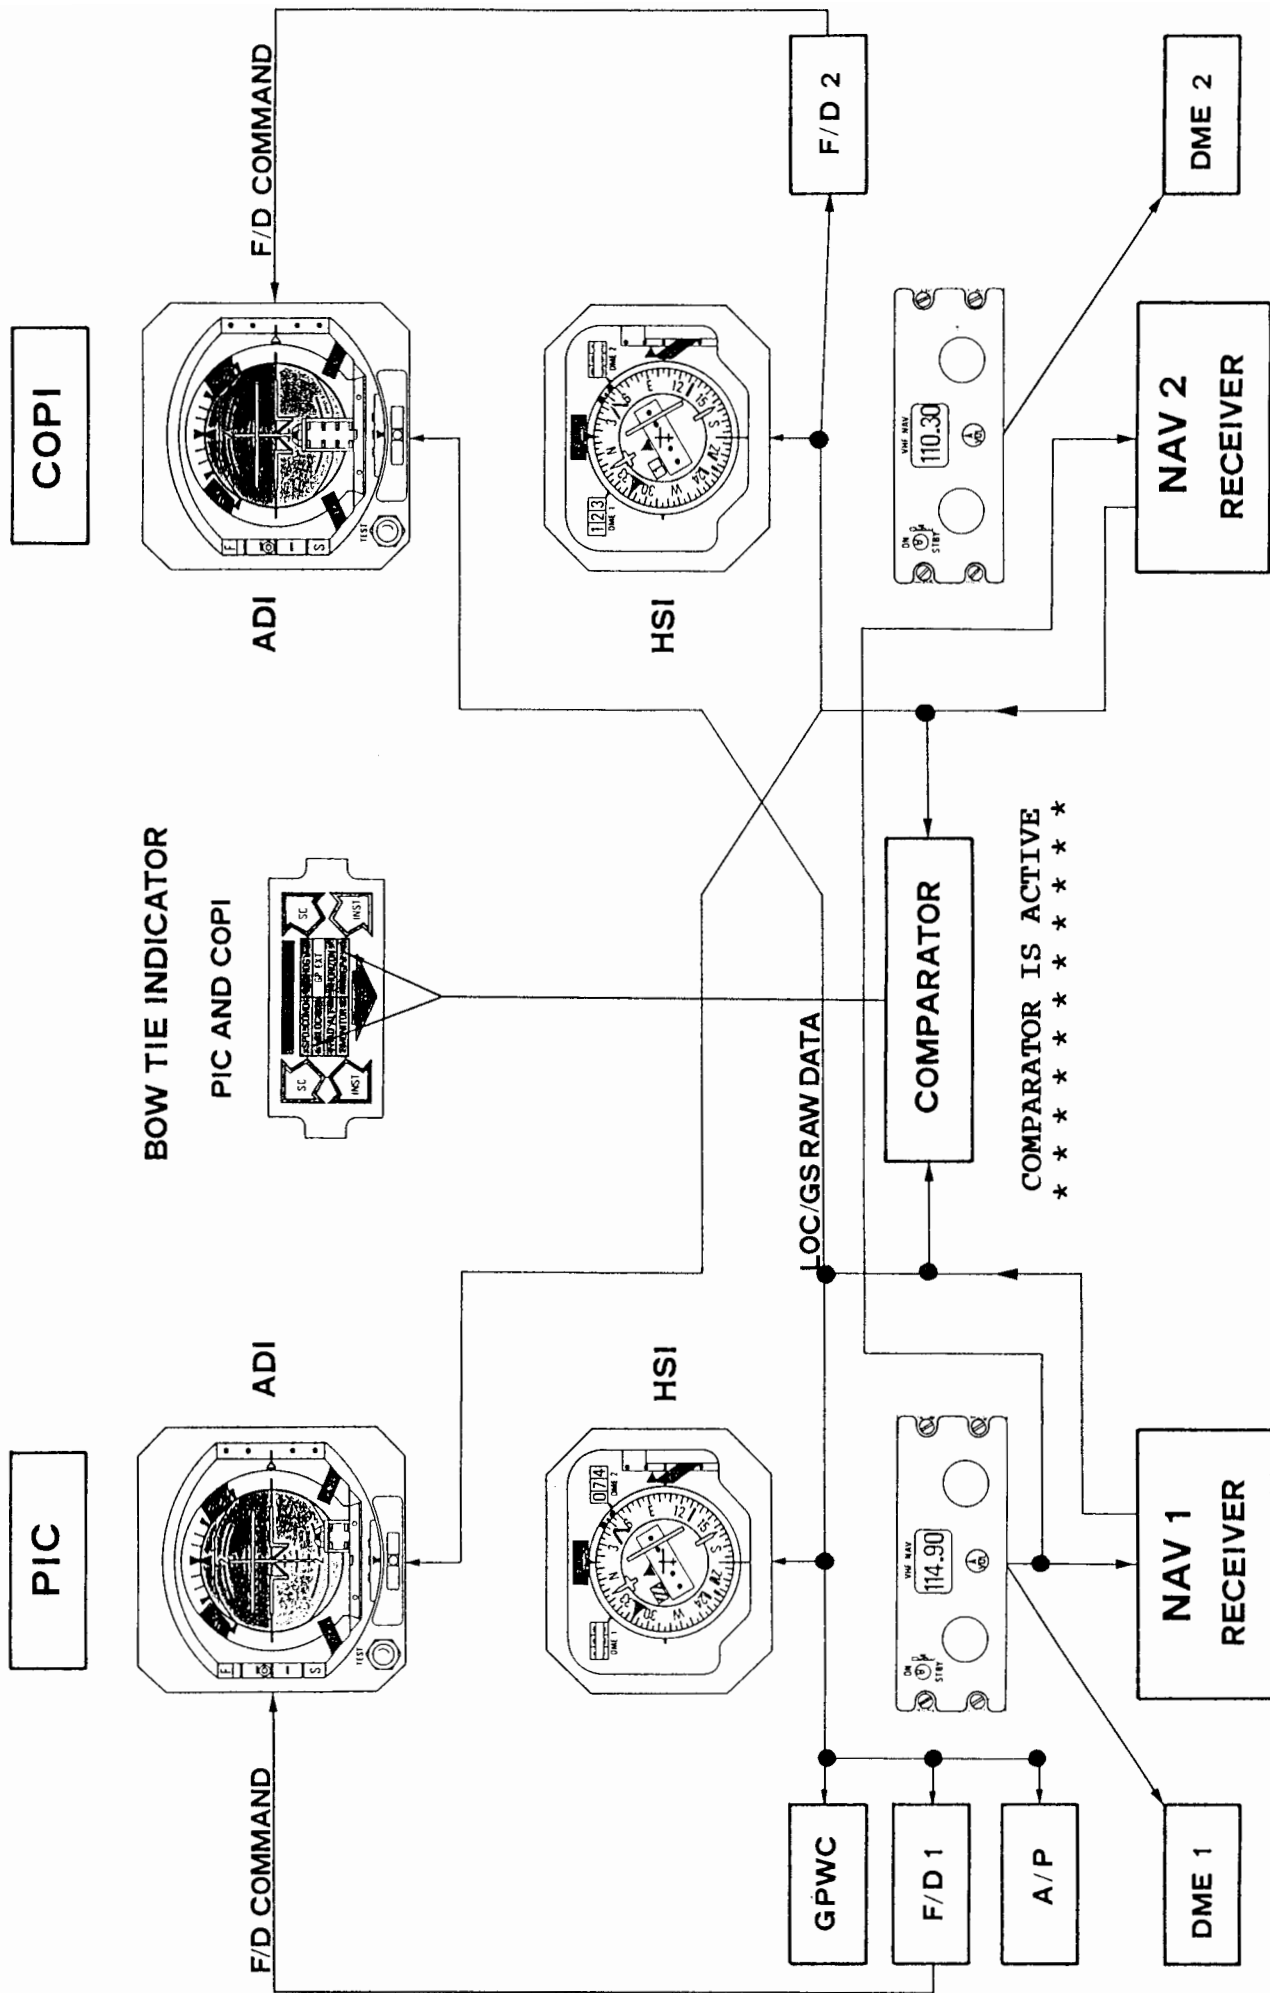
# RADIO SWITCH Selected to APP

**Bildliche Darstellung der Arbeitsweise des „Comparator“ mit dem Radio switch in Stellung APPROACH (*Comparator in Betrieb*)**

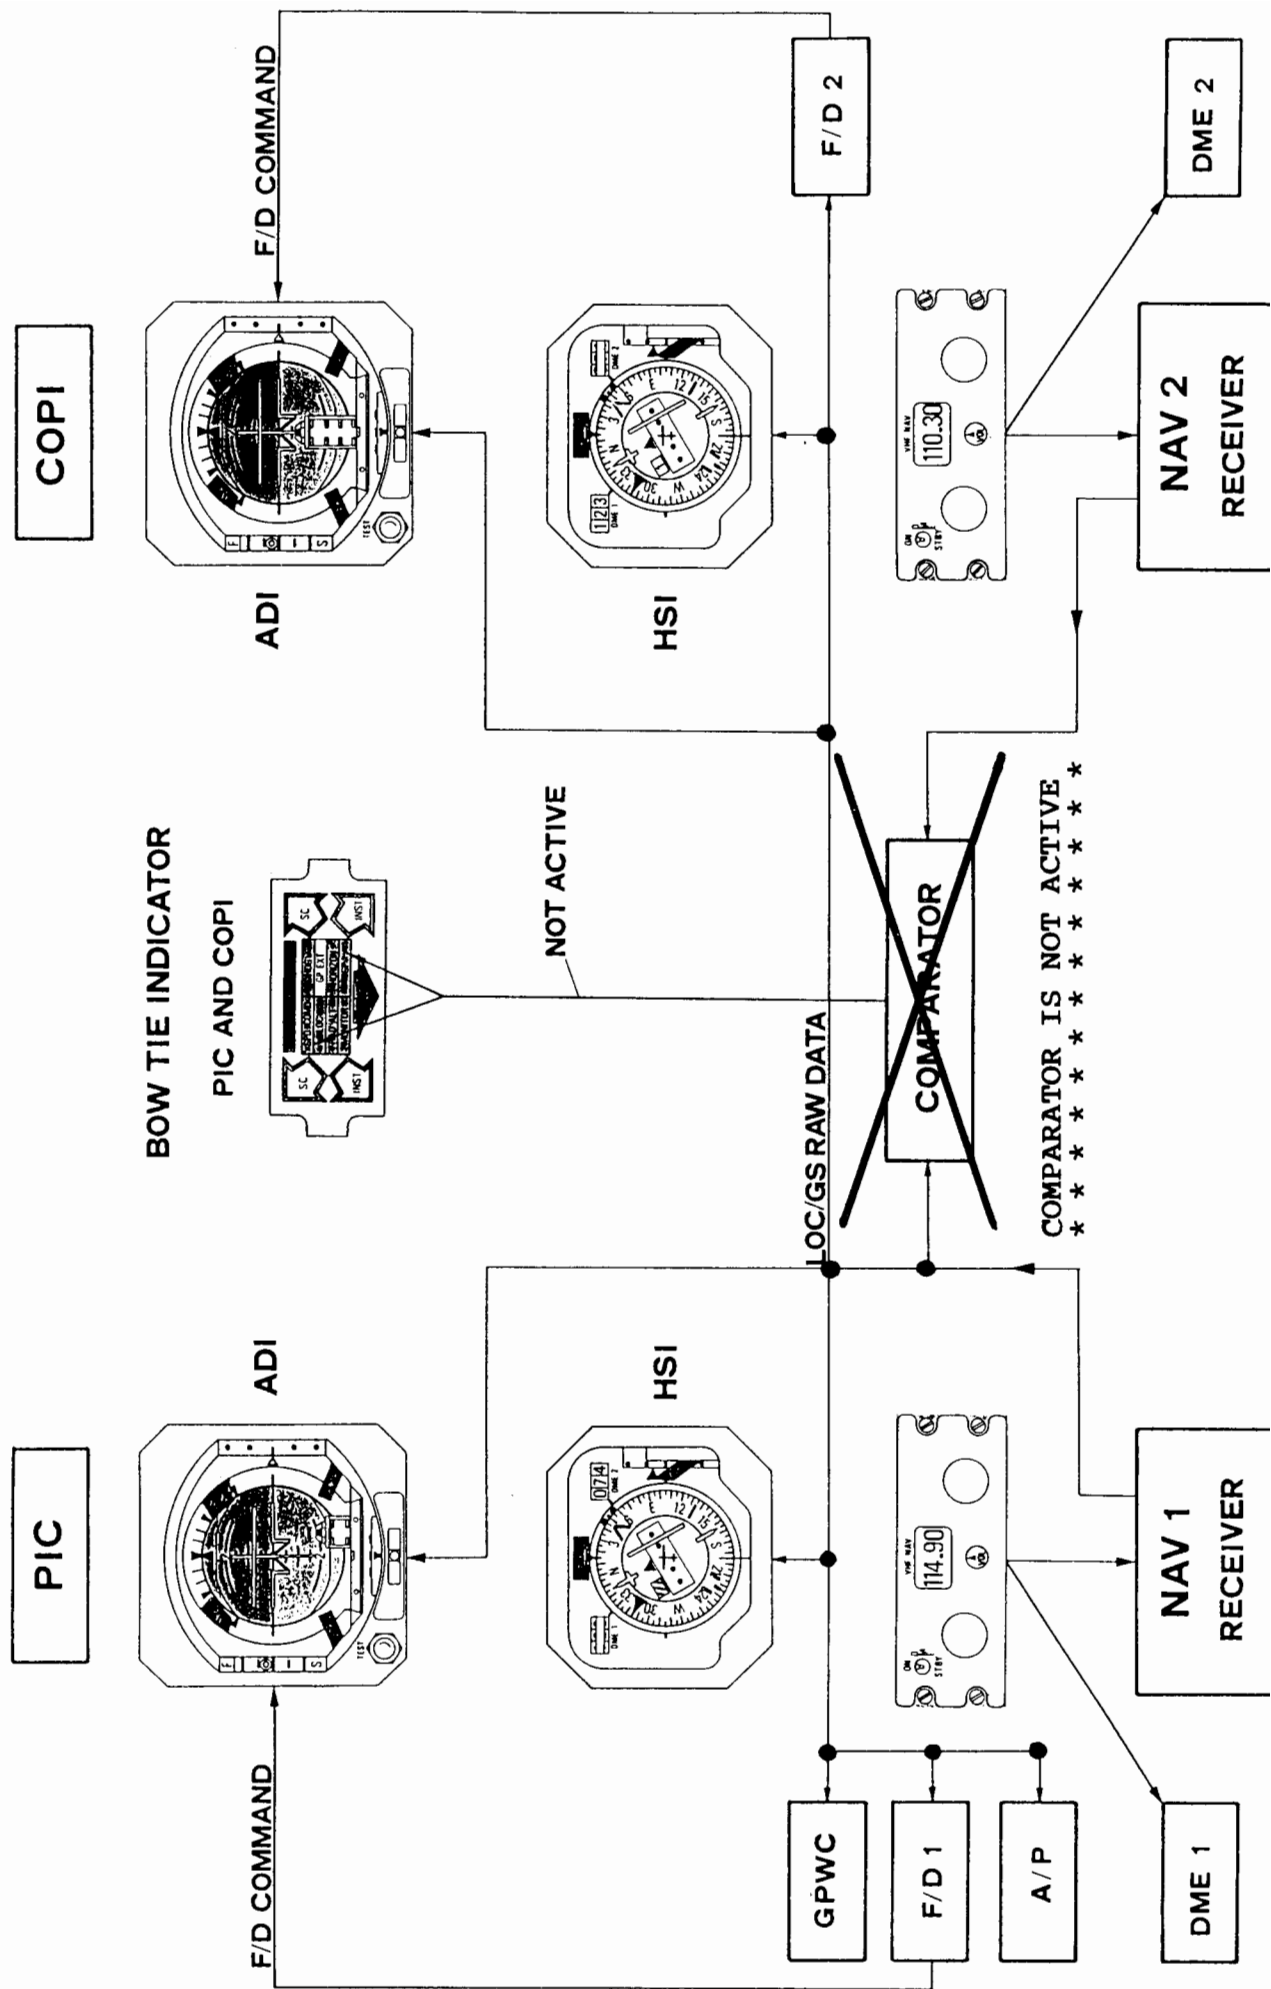
# RADIO SWITCH Selected to 1

The comparator of I-ATJA was recovered from the accident in a considerably damaged state. A closer examination of this unit was impossible. There is a slight possibility that a short circuit in the GP signal input of the comparator could have caused a centred GP 1 indication (without warning flag).

**Bildliche Darstellung der Arbeitsweise des „Comparator“ mit dem Radio switch in Stellung I (*Comparator ausser Betrieb*)**
