AVIATION INVESTIGATION REPORT
A08W0244

CONTROLLED FLIGHT INTO TERRAIN
SUMMIT AIR CHARTERS LIMITED
DORNIER 228-202 C-FYEV
CAMBRIDGE BAY, NUNAVUT
13 DECEMBER 2008

Report Number A08W0244

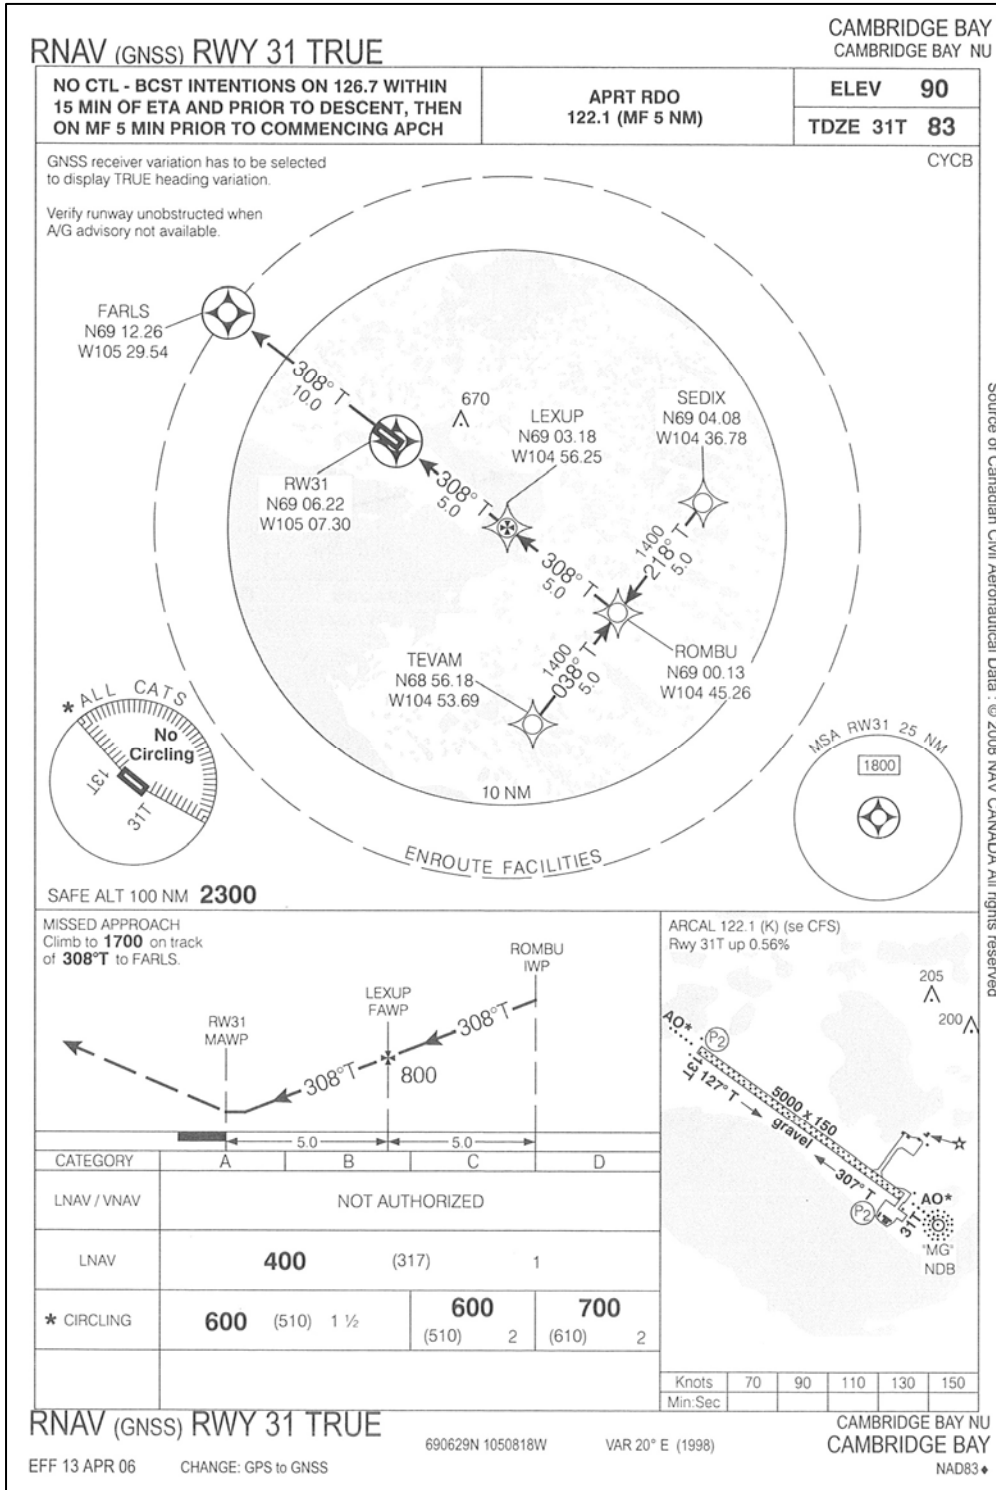
Appendix A – RNAV (GNSS) Runway 31 True

The published minimum crossing altitude at LEXUP is 800 feet asl. The MDA at the threshold waypoint is 400 feet asl. Using a constant rate descent to cover the 5 nm between these two waypoints would require less than a one degree angle of descent. At 3.7 nm from the threshold, the point where C-FYEV descended through 500 feet agl, the normal height above ground would be 620 feet agl. From a point 16 nm to the north of Cambridge Bay, the time to conduct the full instrument approach via SEDIX ¹⁷ at a ground speed of 120 knots would have been about four minutes longer than the time to proceed direct to LEXUP and then to the threshold of Runway 31 True.

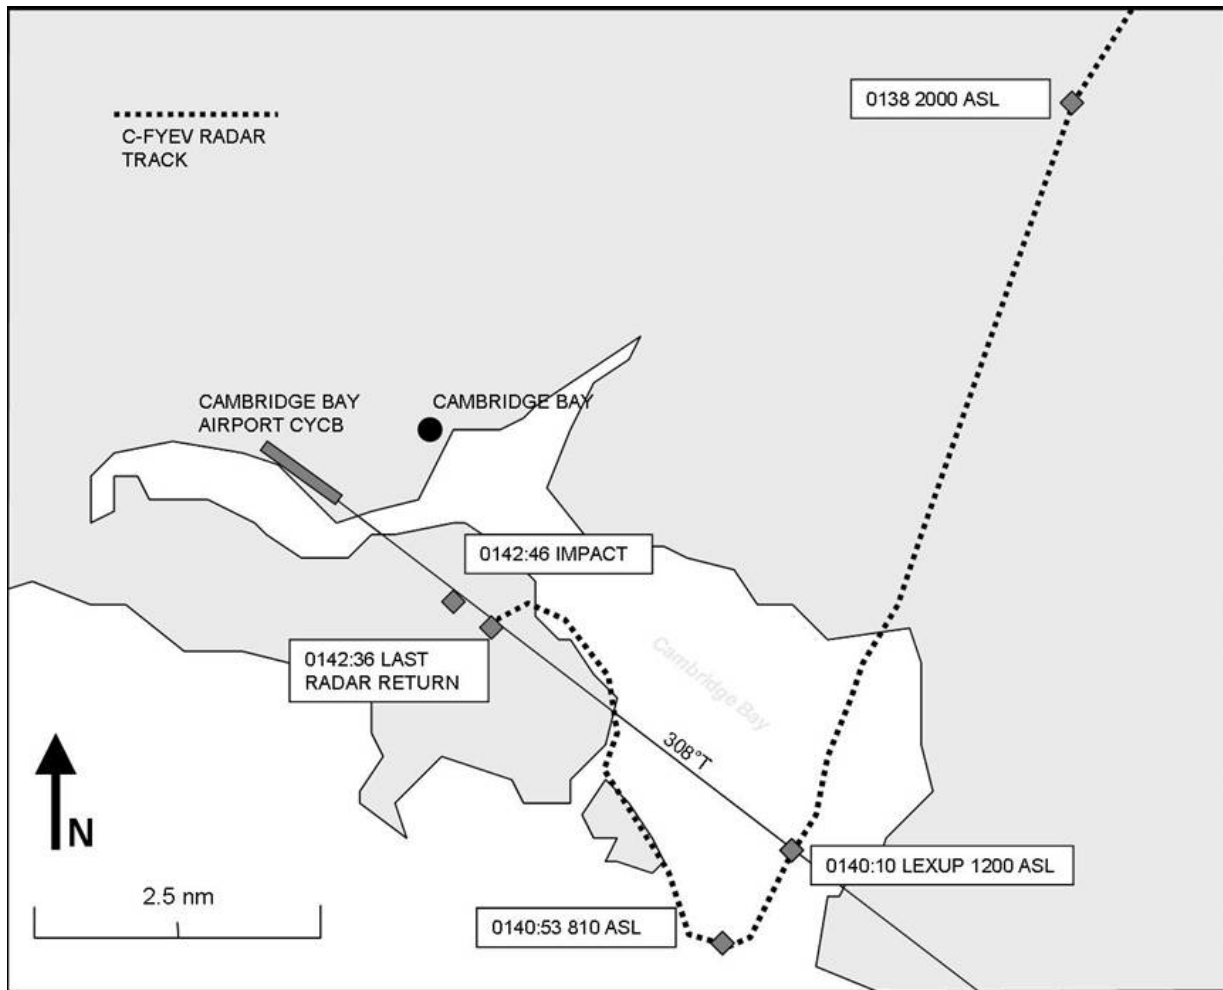
Appendix B – Radar Plot of C-FYEV

Data from the Department of National Defence long range radar (LRR) and short range radar (SRR) based at Cambridge Bay provided position and altitude information to aid in the investigation. Track and groundspeed were derived from this data. The last reliable radar returns at 0142:35 showed the aircraft near the extended runway centreline, about 1.9 nm from the threshold of Runway 31 True, and 0.4 nm from the crash site.

The aircraft crossed the extended runway centreline for the second time, 2.8 nm from the runway threshold; at 2.1 nm, a left turn was made toward the runway centreline (see Appendix B - Radar Plot of C-FYEV). When the runway lead-in strobe lights became dimly visible, the captain turned toward the runway. The precision approach path indicator system (PAPI), positioned on the left side of the runway, 1000 feet from the threshold, was not visible to the crew. Due to reflected glare from falling and blowing snow, the captain requested that the aircraft's landing lights be turned off, and confirmed with Cambridge Bay Airport Radio that the runway lights were at maximum illumination level. A maximum of two runway lights were visible to the captain. Fifteen seconds before ground impact, the propellers were set to

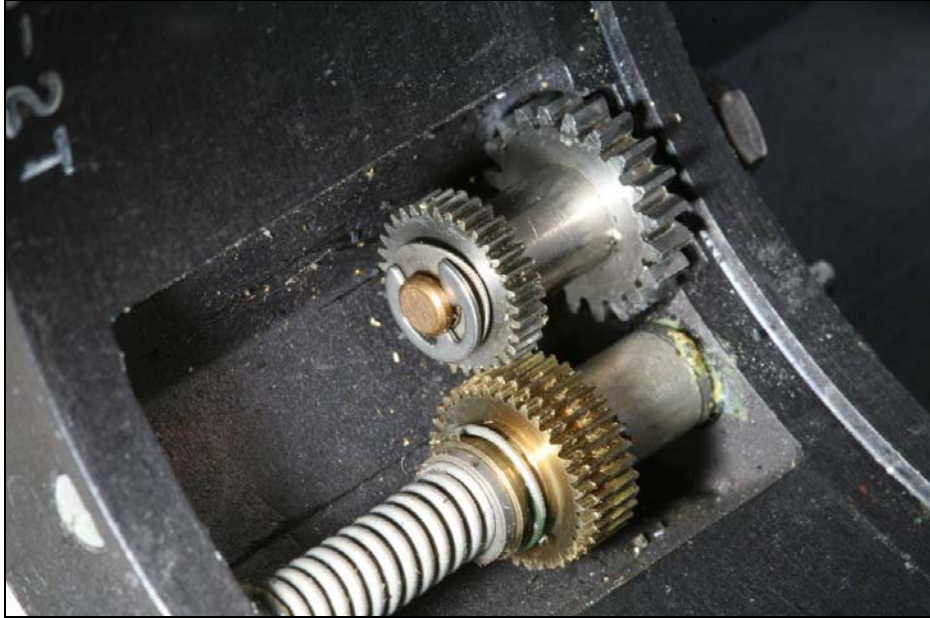
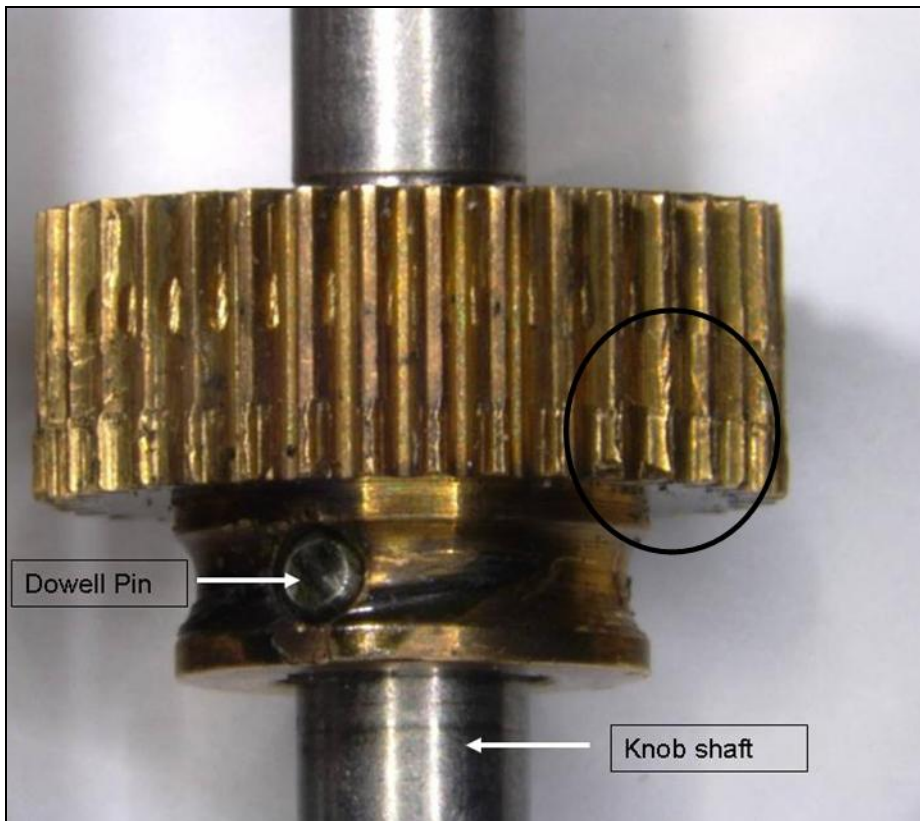
Appendix C – Altimeter Number 1 Gear Damage

TSB testing determined that the No. 1 altimeter (serial number 1386) read 130 feet high. It was noted that the barometric pressure pointer setting mechanism of this altimeter was difficult to turn and felt rough during rotation. When the case was removed, the drive gear (part number 24319) was found to be damaged.

When the barometric pressure/pointer setting mechanism was disassembled, the dowel pin (part number 25096) fit loosely in the knob shaft bore and drive gear (part number 24319). Because the dowel pin retains the gear on the knob shaft, the difference in the bore/dowel pin measurements allowed end play of approximately 0.006 inch. The altimeter *Component Maintenance Instruction Manual* required that, during inspection, the end play of all rotating assemblies should be 0.003 ± 0.001 inch, unless otherwise specified. The knob shaft was bent approximately one degree between the shoulder and the threaded end, and exhibited tool marks in the area of the shoulder. It could not be determined from records when this damage occurred.

Misalignment of the drive gear due to the bent knob shaft, combined with radial and axial play, resulted in improper meshing of the drive gear and the pointer drive train gear, part number 24593. This resulted in abnormal wear and damage to gear part number 24319, which showed advanced wear rub marks and separation of five tooth tips (see Appendix C - Altimeter Number 1 Gear Damage).

Because the aft end of the drive gear drives only the pointer setting gear train, the failure of the teeth did not affect the setting of the barometric pressure scale. However, when the setting knob was rotated, the failed teeth on the drive gear would slip on the driven gear and the pointers would not move synchronously with the barometric pressure setting gear train. This lack of synchronous movement resulted in the loss of the altimeter calibration. The loss of five teeth on this gear created an offset of 139 feet, consistent with the observed error of 130 feet.¹² Similar damage, although not as extensive, was observed in the No. 2 altimeter and did not result in loss of calibration.

Barometric pressure/pointer setting gears

Gear part number 24319 showing representative damaged teeth (circle)
