AVIATION INVESTIGATION REPORT

A09O0117

ERRONEOUS INSTRUMENT INDICATIONS RESULTING IN AIRSPEED AND ALTITUDE DEVIATIONS

BOEING 767-300 SP-LPA

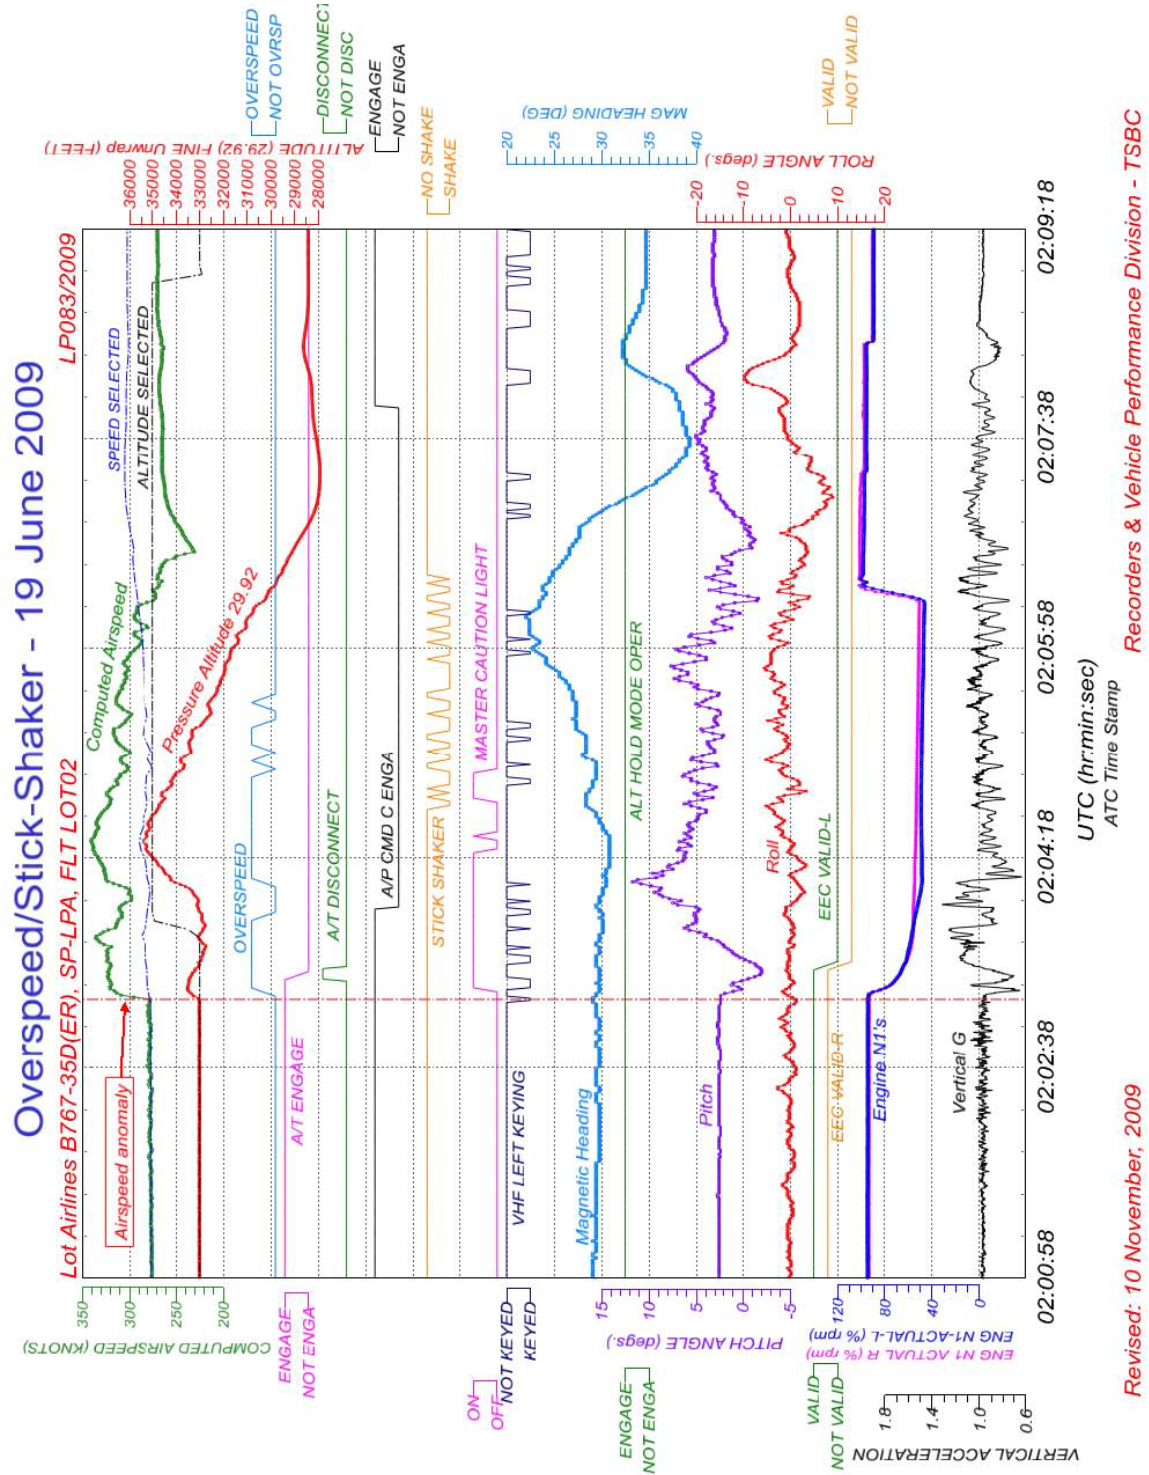
Appendix A – FDR PLOTS

The flight data recorder (FDR) installed on the aircraft was manufactured by Honeywell. The FDR contained approximately 52.5 hours of data which included the occurrence and 5 previous flights. The overspeed event and the subsequent stick shaker activations are plotted in Appendix A – FDR Plots.
