AVIATION INVESTIGATION REPORT

A99P0006

CONTROLLED FLIGHT INTO TERRAIN (CFIT)

DOUGLAS DC-3C C-GWUG

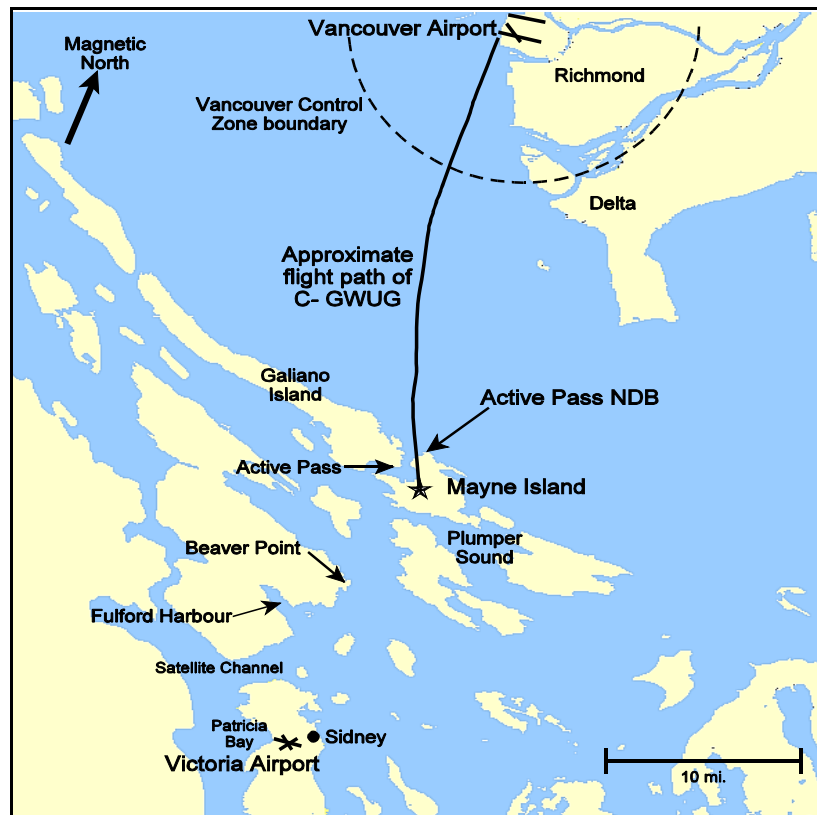
Figure 1 - Aircraft routing and crash site

At 0633:04, the aircraft descended to 800 feet asl for about nine seconds. The last radar data show the aircraft at 900 feet asl and 130 knots. The last radar-depicted position of the aircraft is on a bearing of 189 degrees (true) and 21.8 nm from the Sea Island radar source, coincident with the crash location.
