Final Report No. 2016

involving aircraft ATR 42-320, registration HB-AFC
operated by the FARNAIR company, flight FAT6932

on 29 March 2006

at Geneva airport

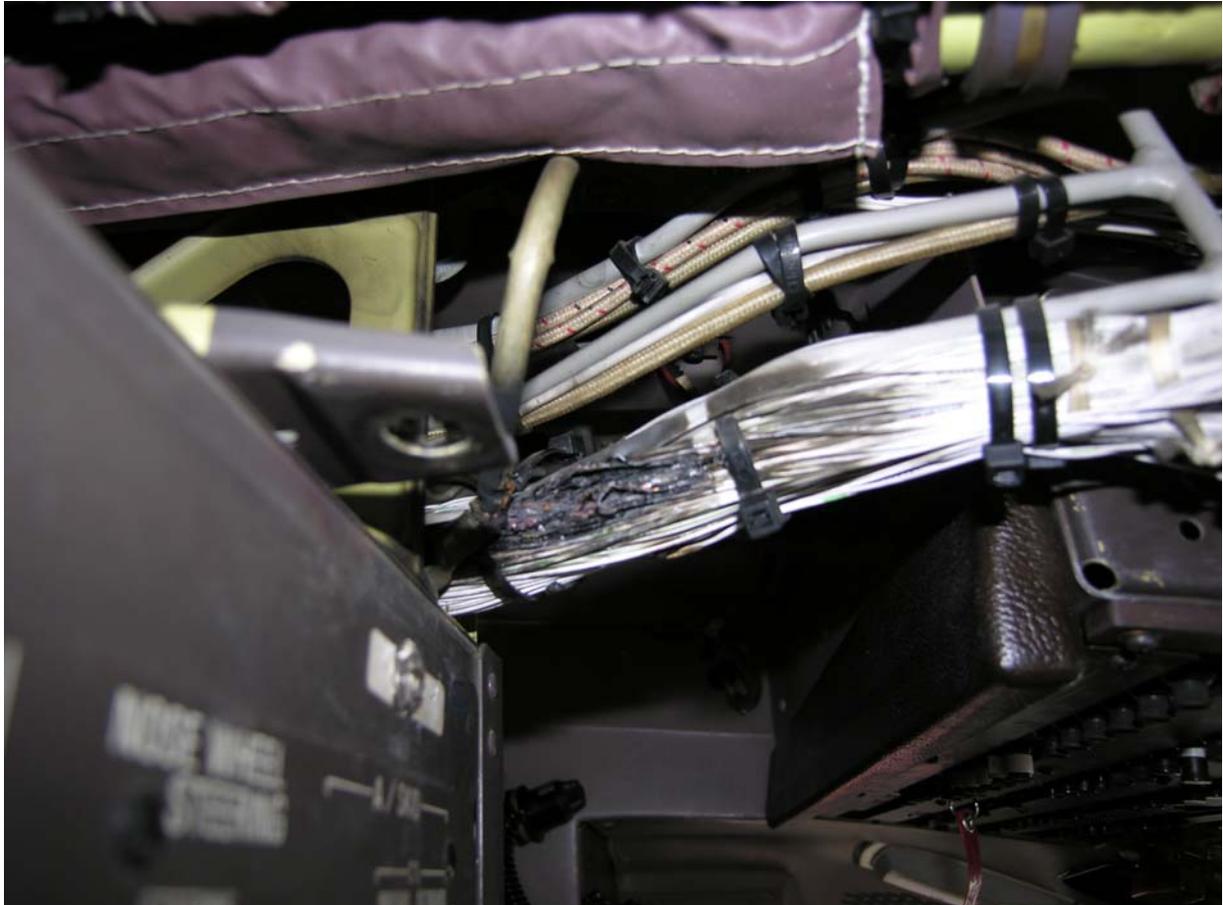
Annexe 1: Wiring strand damaged by the fire

A strand consisting of several hundred electrical wires, fixed by collars to a tubular structure, runs in the 120VU compartment located above the 121VU circuit breaker panel. Forty-eight of these exhibited damage caused by electrical arcing over a length of around 10 cm and over a surface area of approximately 20 cm²; the insulation had broken down and the metal had partially melted. Black traces left by combustion products covered the damaged area of the strand and also extended over some 15 centimetres of the spindle. The onboard systems linked to the damaged wires were not damaged.

The tubular support in contact with the burnt wires was damaged. At this point, the strand touched an earth cable which also exhibited traces of fire.

At one corner of the internal wall's surface of the 120VU compartment, there was a small area bearing trace of fire.

- an earth cable was fitted incorrectly. As a result, its lower terminal was in direct contact with the wiring strand, whereas a space of at least 12.5 mm (0.5 in) is required between these two items;
- the tubular support onto which the strand was tied was deformed; the routing of the bundle of wires which had been modified in this way no longer permitted compliance with the minimum separations required between the structure and other cables;
- the collars fixing the strand to the tubular structure were not tightened correctly;
- the damaged strand contained more electrical wires than the original one because of modifications resulting from application of service bulletins; its diameter had therefore increased.

The assembly faults and the increase in the diameter of the strand of electrical wiring described in section 1.6.3 are the initial factors which slowly generated conditions favourable to the onset of a short-circuit.

The lower terminal of the earth cable was in direct contact with the badly clamped, and therefore insufficiently tightened, electrical wires of a strand which was bulkier than its original design and mounted on a deformed tubular support. Its compactness was thus reduced and there was sufficient play between the wires to allow friction between them and with the earth cable. This phenomenon caused a reduction in the dielectric properties of the insulation of wires touching the earth cable terminal. As a result of wear, this insulation broke down, allowing direct metal-to-metal contact between two conductors, which was the cause of the major short-circuit.

The damage caused by the fire, described in section 1.3.1, is indicative of the development of a fire following a cascade process of electrical arcs giving rise to the phenomenon termed general conflagration: the first short-circuit results in vaporisation of the conducting metal, generating very high temperatures and pressures in its immediate vicinity. The heat resulting from this vaporisation and from the electrical arc itself then break down the insulation of adjacent wires, leaving them exposed and in contact with each other. There is then a progressive cascade of arcs and combustion between the wires in the strand, which only ceases when the overvoltage protection systems activate, i.e. the circuit-breakers trip. To human perception, this succession of short-circuits is virtually instantaneous.
