# AIRCRAFT ACCIDENT REPORT AND EXECUTIVE SUMMARY

Reference:	CA18/2/3/9257	
<b>Aircraft Registration</b>	G-BNLL	<b>Date of Accident</b>	22 December 2013		<b>Time of Accident</b>	20:43Z
<b>Type of Aircraft</b>	Boeing 747- 400		<b>Type of Operation</b>		Air Transportation	
<b>Pilot-in-command Licence Type</b>		ATPL	<b>Age</b>	57	<b>Licence Valid</b>	Yes
<b>Co-pilot Licence Type</b>		ATPL	<b>Age</b>	51	<b>Licence Valid</b>	Yes
<b>Pilot-in-command Flying Experience</b>		Total Flying Hours	±20 050,00		Hours on Type	±12 500,00
<b>Co-pilot Flying Experience</b>		Total Flying Hours	± 5700,00		Hours on Type	± 1400,00
<b>Last point of departure</b>		OR Tambo International Airport (FAOR) at Gauteng in Republic of South Africa.				
<b>Next point of intended landing</b>		Heathrow International Airport (EGLL) at London in United Kingdom.				
<b>Location of the accident site with reference to easily defined geographical points (GPS readings if possible)</b>

**AIRCRAFT ACCIDENT INTERIM REPORT**

**Name of Owner** : British Airways PLC  
**Name of Operator** : British Airways  
**Manufacturer** : Boeing Company  
**Model** : B747- 400  
**Nationality** : United Kingdom  
**Registration Marks** : G

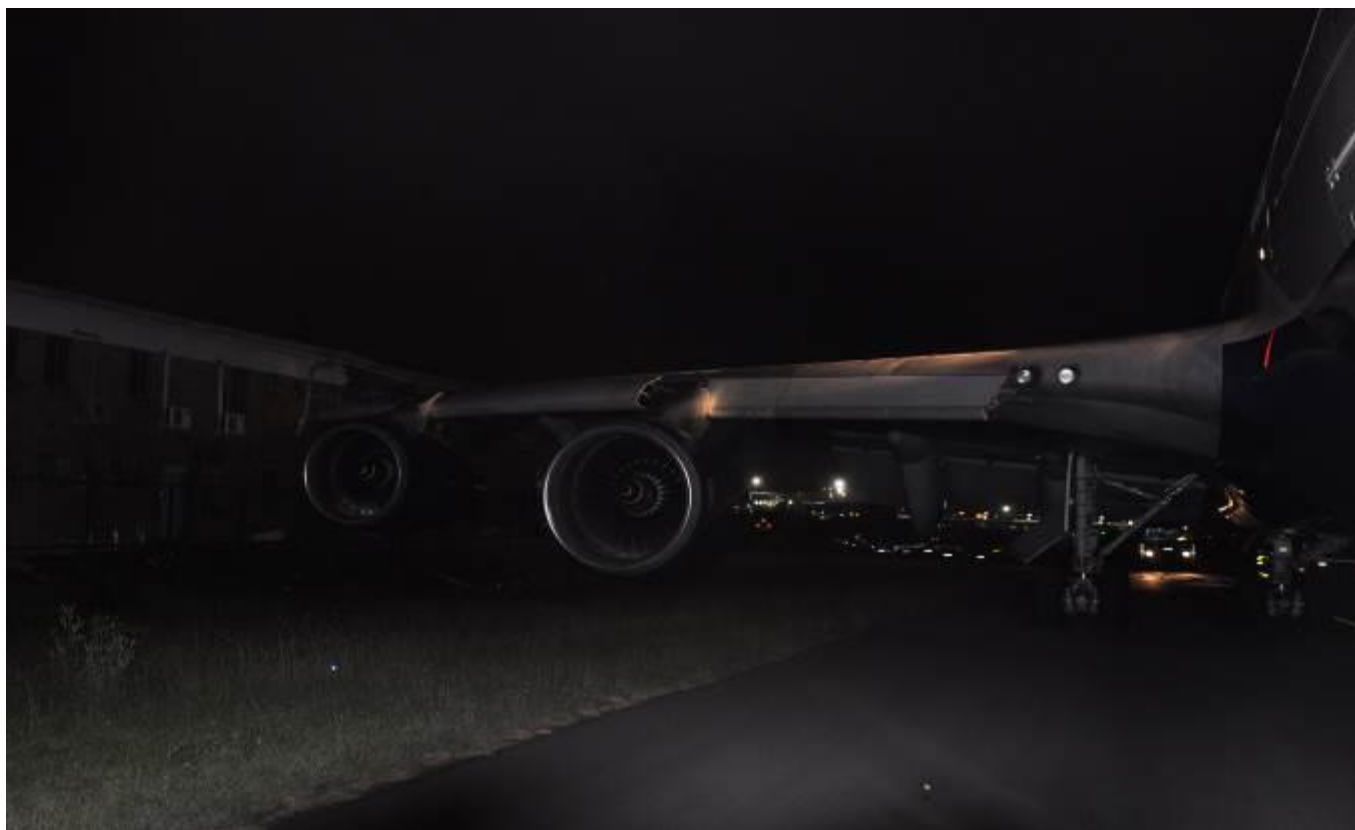
- 1.1.14 According to the CVR, at 20.43:56 UTC (22.43:56 local time) the ATC made a call to the crew saying "Speedbird 34, Tower". After the response from the crew "Speedbird 34, go ahead" the ATC instruction was "Just hold position". It was then that the Captain responded stating "We actually hit something here. Standby please", which was exactly the time the aircraft collided with a building. The starboard (right side) wing impacted the building, causing ruinous damage to both the aircraft and the building. The wing was found wedged in the brick halls of the Bid Air Services building.

Figure 3 The aircraft starboard wing wedged in the Bid Air Services Grooming Operations Building

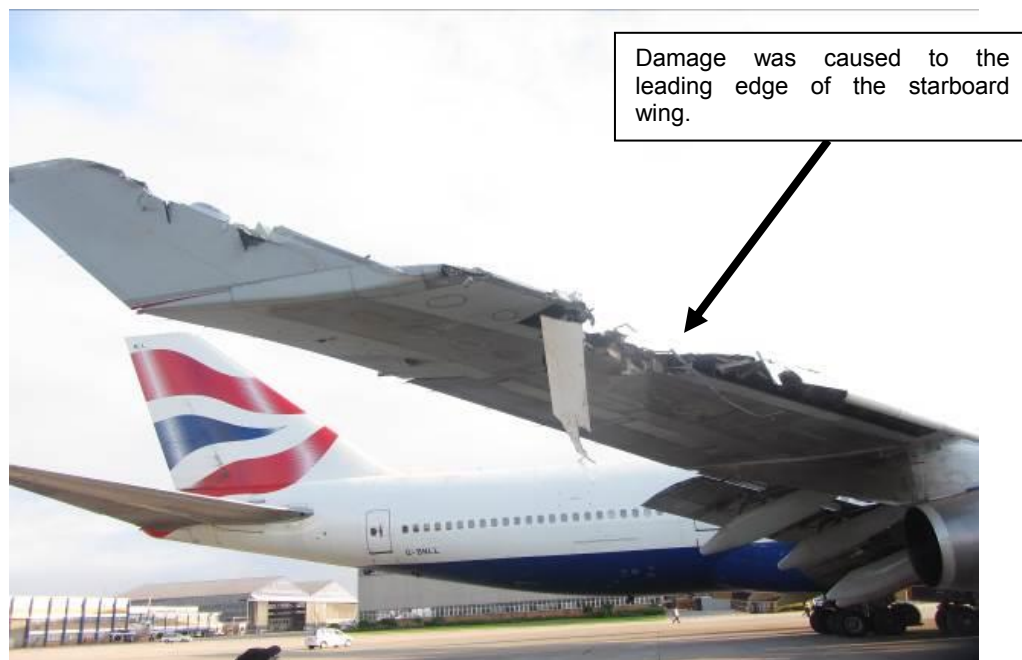
#### 1.3.1 The aircraft sustained substantial damage in the accident.

Figure 4 Damage caused to the starboard wing of the BA034 aircraft

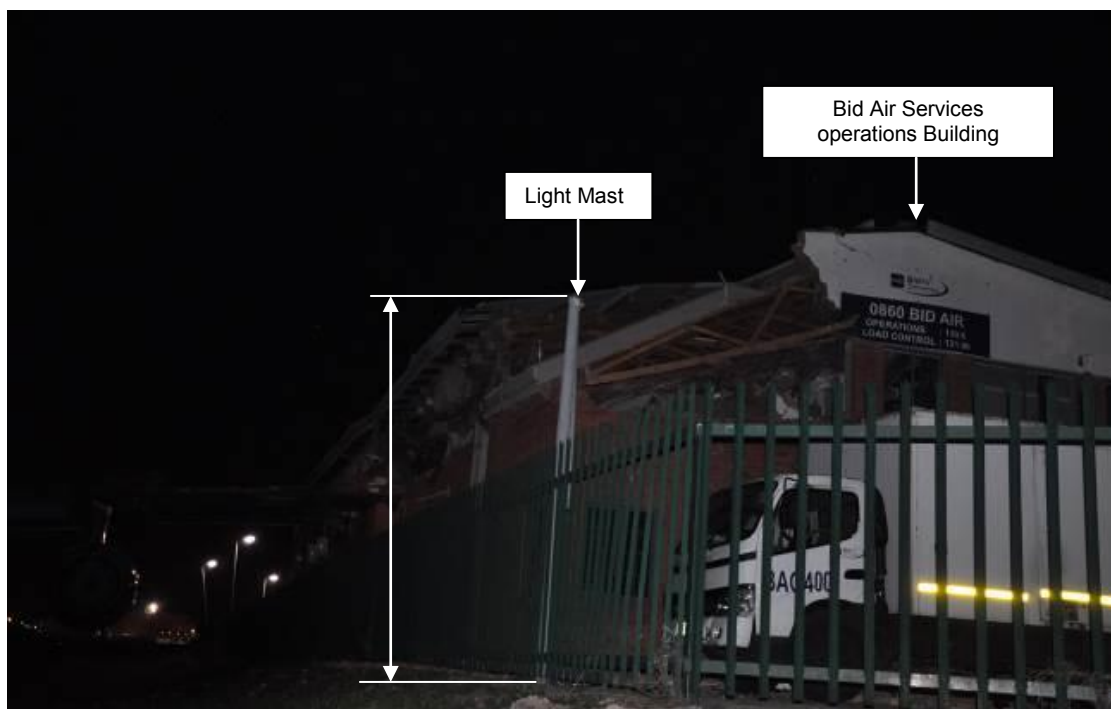
1.4.1.2.1 The first point of impact was determined to be a light mast installed next to the eastern side perimeter fence of the building. The light mast was cut at the same height as where the wing sliced through the hall. The remaining piece of the light mast was found standing at a distance of  $\pm 5$  to 10 meters from the building.

Figure 6 Light Mast damaged in the accident

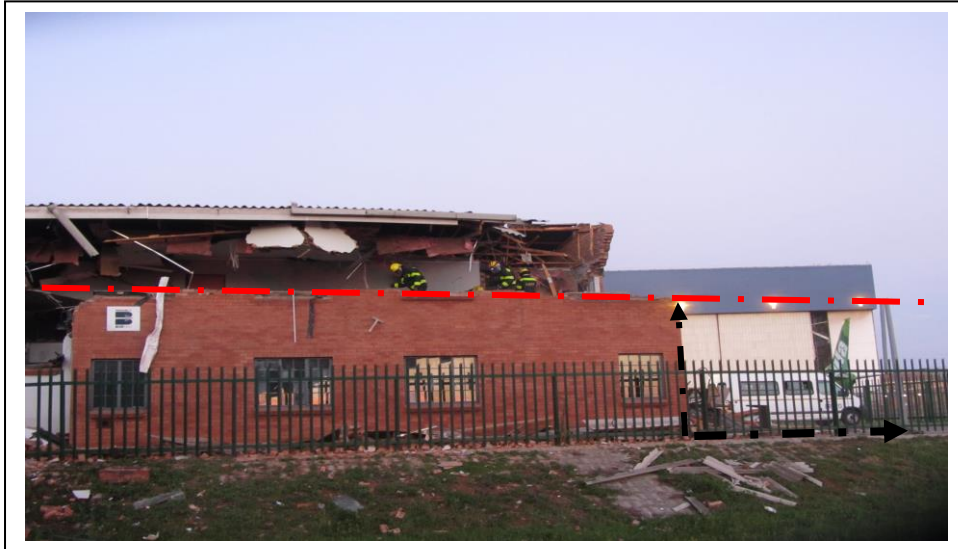
- 1.4.1.2.2 The second point of impact was the halls on the eastern side of the building. The upper eastern hall was completely destroyed from the corner of the building.

Figure 7 Damage sustained by the BidAir Service Build

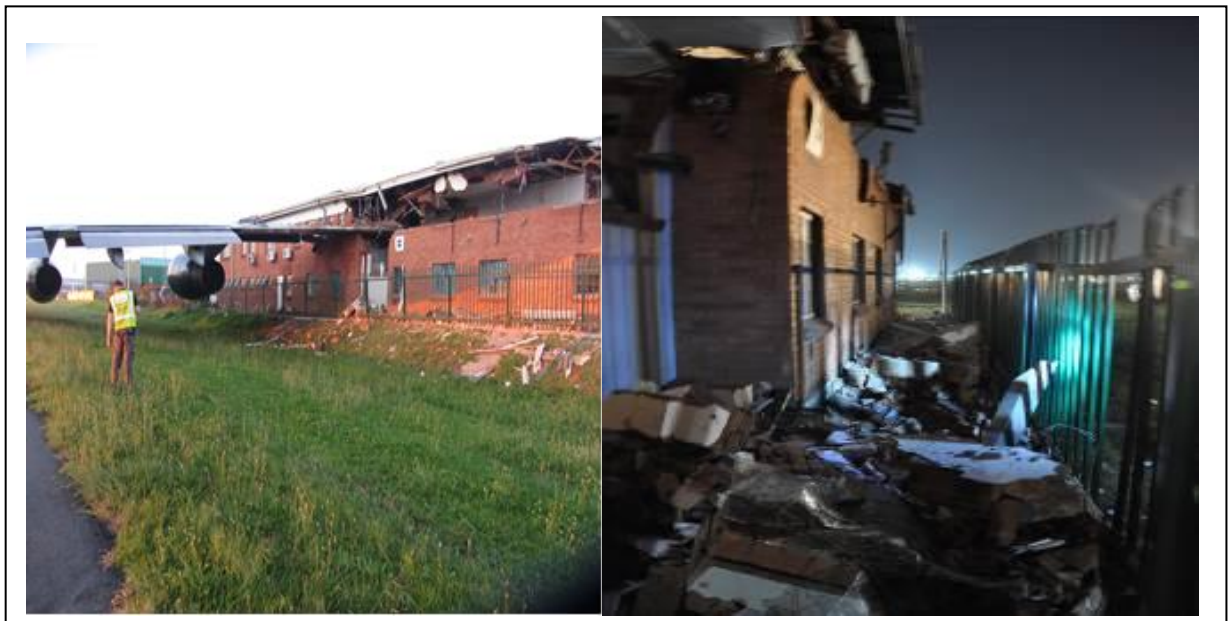
- 1.4.1.2.3 The debris of the building and light mast was found scattered on the premises. The starboard wing was visibly wedged in the building halls.

Figures 8 and 9 BA034 wing wedged in the building halls and debris of building material

- 1.4.1.2.4 It was observed that a substantial amount of fuel from the wing was spilled inside and outside the building. The building was subsequently declared unsafe for use as a result of the accident.
- 1.4.1.2.5 There were several BidAir Services vehicles in the parking area around the premises of the building. There is no evidence of information that any of the vehicles sustained damage. However, due to the fuel spillage and fire risk, all the vehicles were removed to safety immediately.

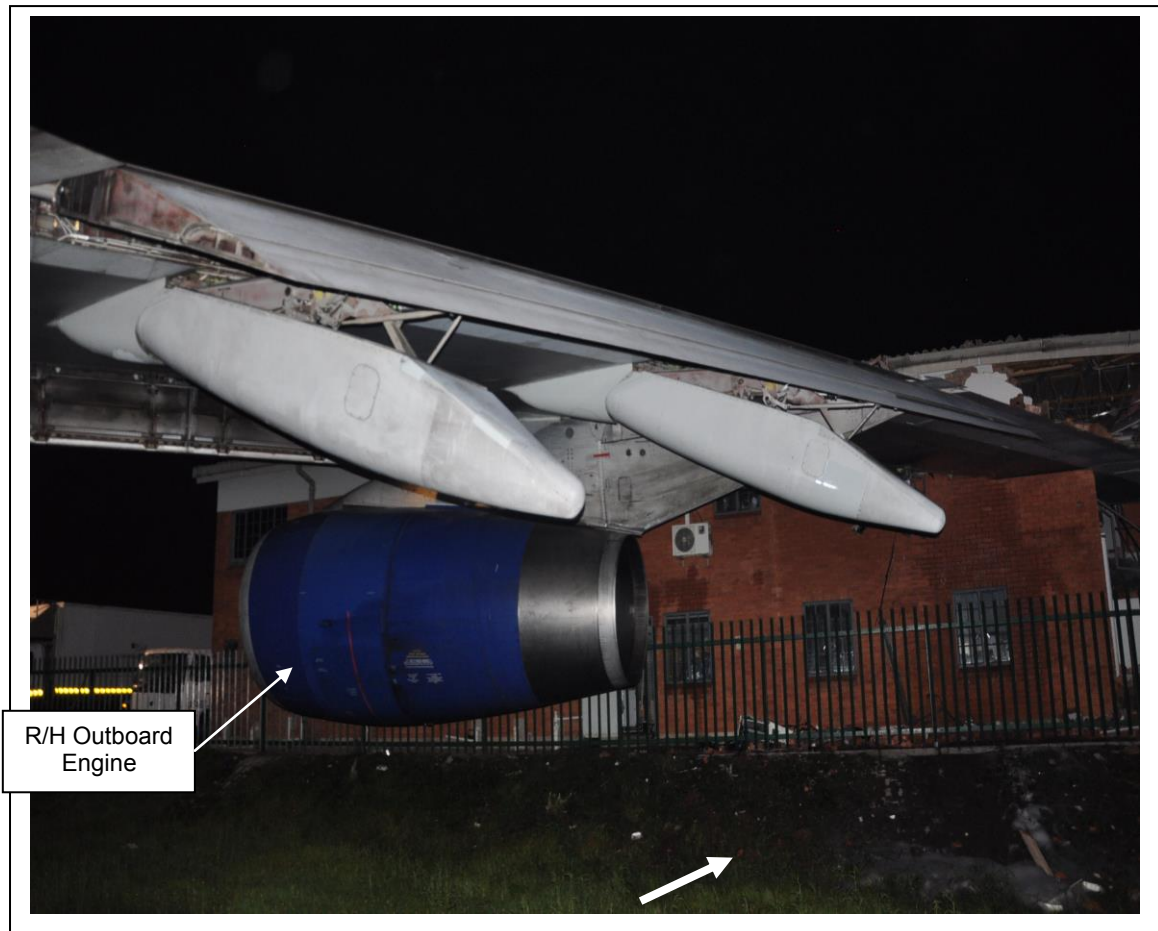
1.4.2.1 Owing to the collision with the BidAir Services building, a large quantity (kilograms) of fuel was spilled, which caused extensive environmental damage.

Figure 10 Fuel spillage and fire fighting agent (foam) stains on building hall and grass below the point where the wing came to a stop.

1.4.2.2 The evidence was that the large quantity of fuel spillage filtered through the grass into the soil off the parameter fence of the building. In order to correctly determine the extent and nature of environment damage, the Operator (British Airways) in consultation with ACSA immediately contacted a locally based service provider, namely HazRisk Solutions. The service provider had to carry out an environmental damage assessment. The result of the assessment was that a jet-fuel spillage soil remediation was required.

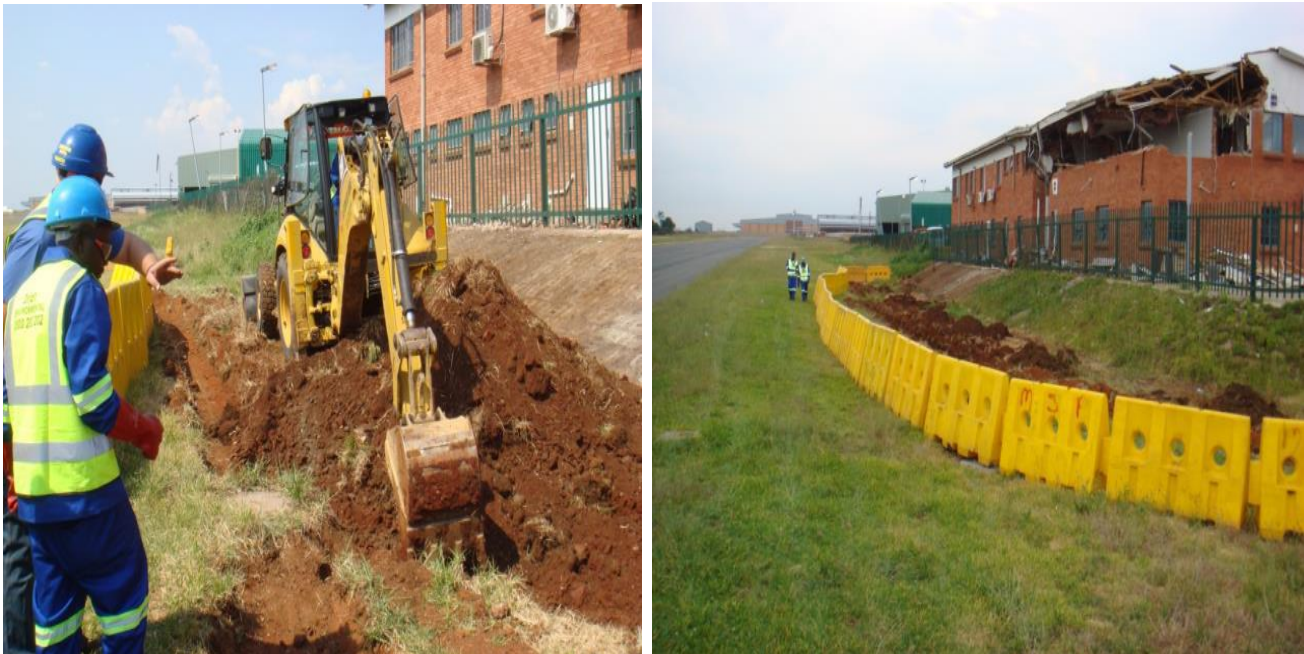
Figure 11 and 12 Remediation of the fuel spillage area

1.4.2.3 On 23 to 25 January 2014, HazRisk Solutions performed the soil remediation process. The last work was completed on 3 March 2014.

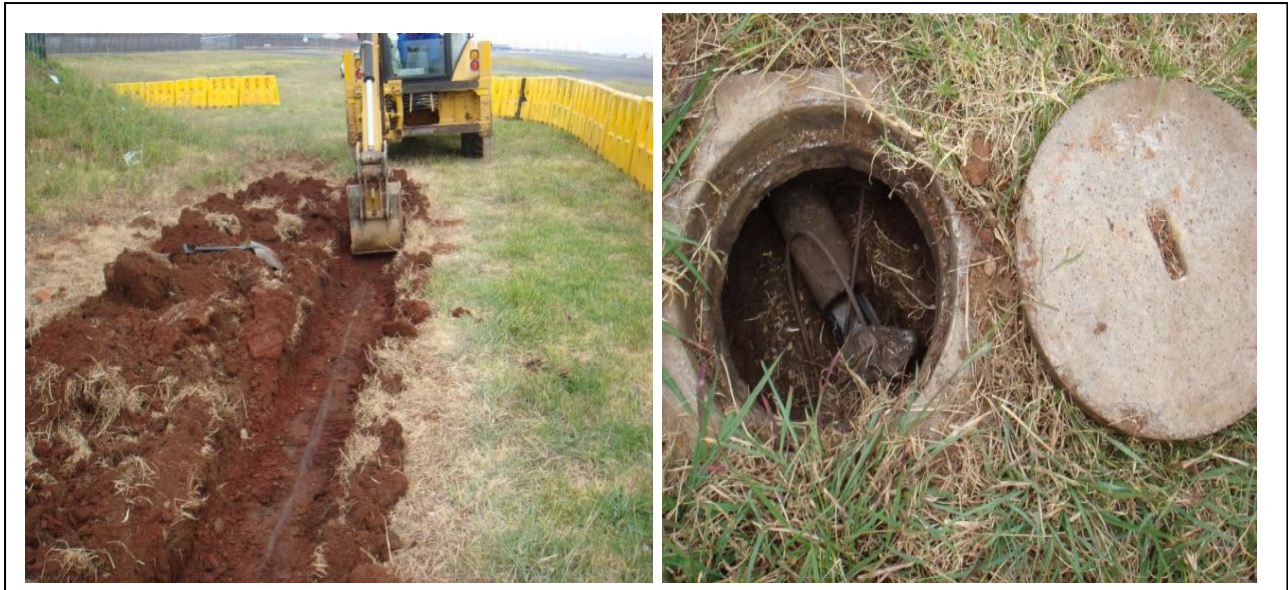
1.4.2.4.3 The Project Manager of HazRisk had discussions with ACSA Officials into the “no plans” issue of the electrical power supply cables underground in the area of work. To assist a decision was made to involve an electrical contractor to help with underground cable detector equipment to carry out detection of electrical cables. It was suspected that 11,000 volt cables (x2) were found within the remediation area (also not on the plans). The inadequate electrical infrastructure plans provided by ACSA posed the following risk:

Figure 13 Electrical and Fibre Optic cables detected underground

1.4.2.4.4 In terms of aviation safety, the information simply shows that it is essential for ACSA to have identified the 11,000 volts electrical cable on the electrical infrastructure plans. The reason for this is if the identified electrical cable was one supplying power to the air navigation facilities (i.e. aerodrome visual aids and radio navigation aids). The apparent risk of damaging the cable would have resulted in equipment failure which could have exposed the crews of the aircraft flying to hazardous condition of inadequate visual and radio navigation aids.

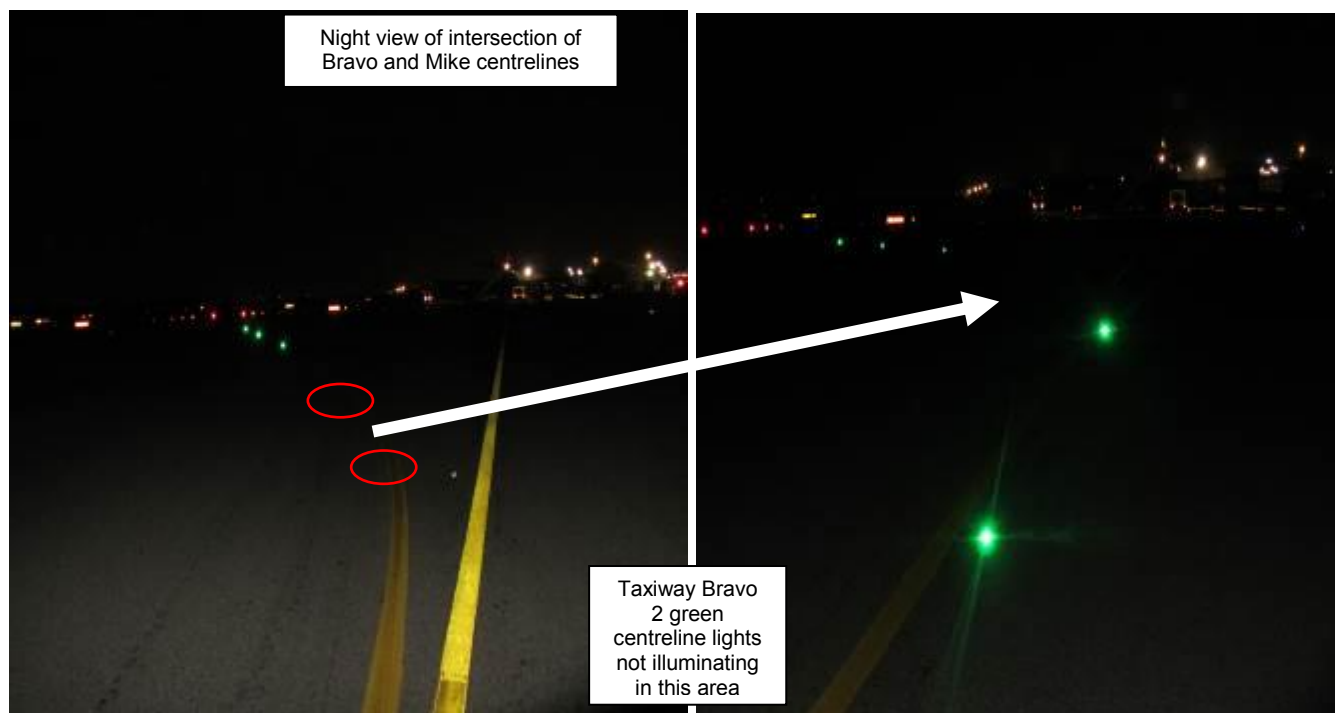
1.5.8.6 However, it was found that 2 taxiway centreline lights were unserviceable and that the illuminated information sign – taxiway location sign on the left hand side of Bravo – was also unserviceable. The A-SGMCS system recording showed that the ARFF vehicle drove past the area of the unserviceable centre line lights and information signage, but they did not report it to the relevant party.

- It is important to note that 2 centreline lights installed on the curve/bend of Bravo toward the Category 2 holding point were found unserviceable (not illuminating). The picture below was taken on the night in question showing the location of the 2 unserviceable centreline lights.

Figure 18 & 19 Two centreline lights not illuminating on curve to Cat 2 holding point

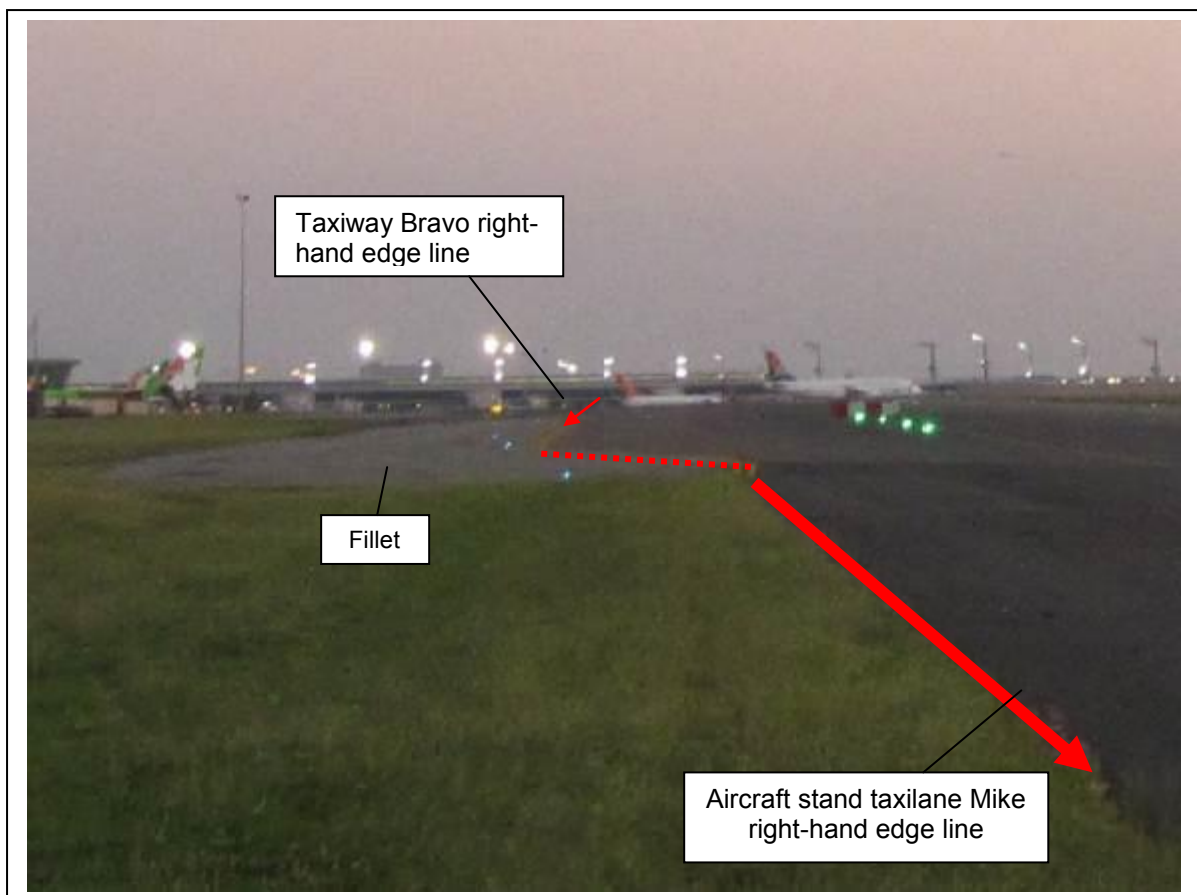
- The picture below was taken during the morning on the day after the accident. It shows the right-hand edge lines of Bravo and Mike at the intersection/junction.

Figure 31 Right-hand edge lines of Bravo and Mike

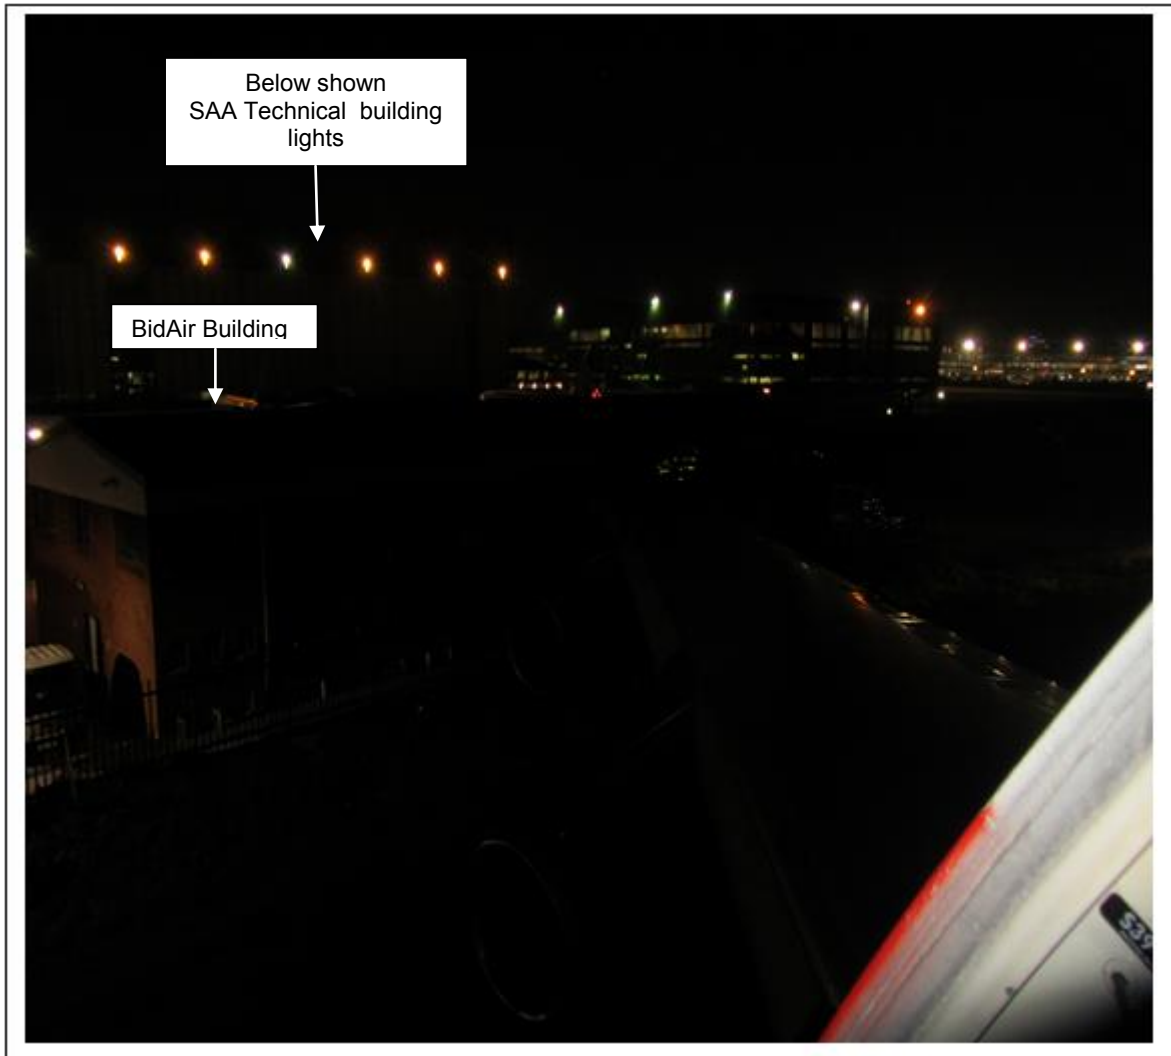
1.11.4.15 The Captain indicated that the Co-pilot could not judge the proximity of BA034 to the building because of the strong apron background glare. The evidence of the A-SMGCS, FDR and CVR shows that BA034 had long since passed the aprons. The investigation determined that the background glare which the Captain referred to might be the lights on the right side from the SAA technical building.

Figure 36 SAA technical building lights at the back of BidAir Services building toward the right side

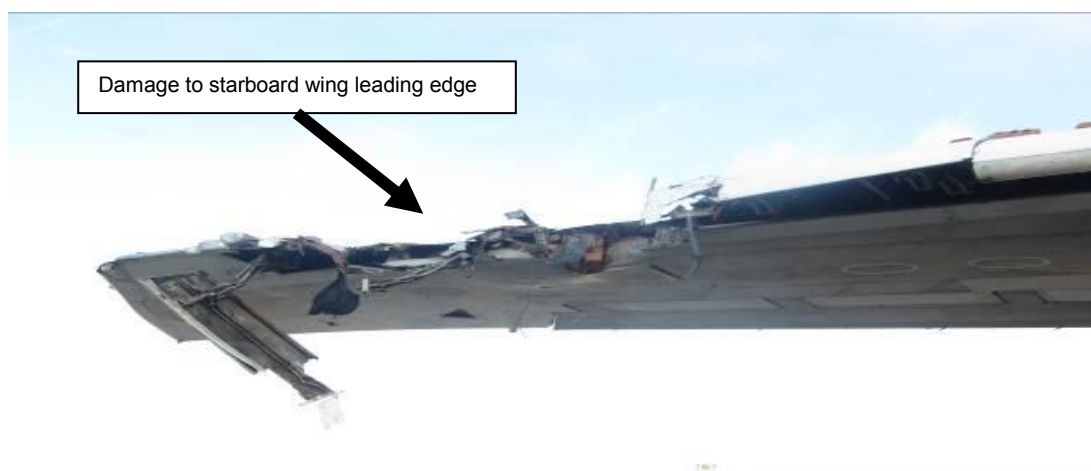
- 1.12.2.1 BA034 starboard (right side) wing impacted the BidAir Services building. The identified wing and its structural elements had sustained substantial damage resulting from the impact.

Figure 40 Damage caused to wing leading edge

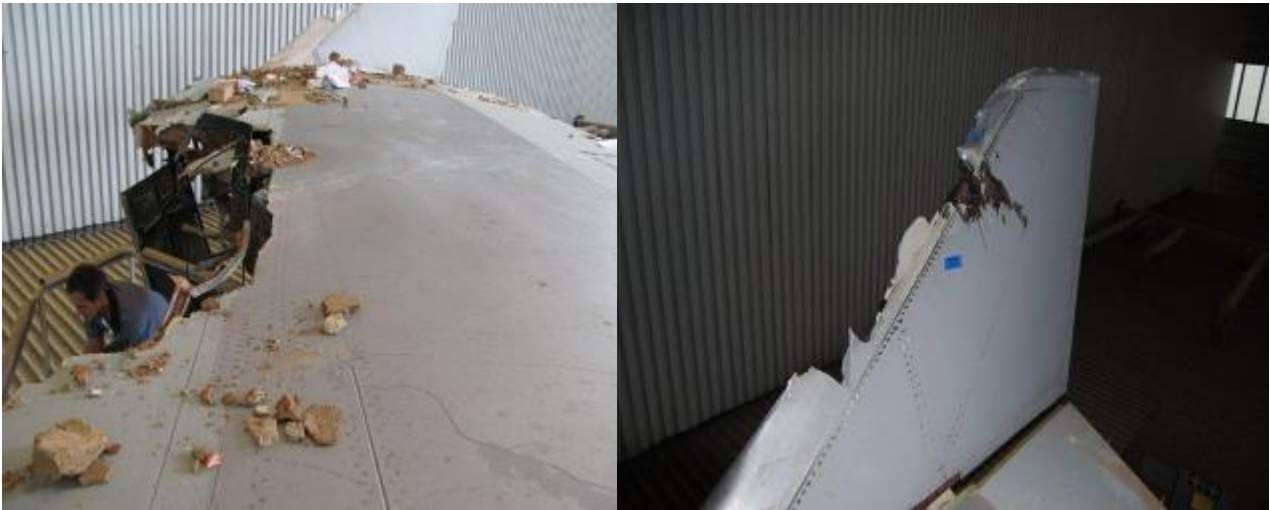
Figure 41 Damage caused to wing upper skin structure and winglet
