**AVIATION INVESTIGATION REPORT
A14W0177**

RIGHT MAIN LANDING GEAR COLLAPSE

**JAZZ AVIATION LP (DBA AIR CANADA EXPRESS)
DHC-8-402, C-GGBF
EDMONTON INTERNATIONAL AIRPORT, ALBERTA
06 NOVEMBER 2014**

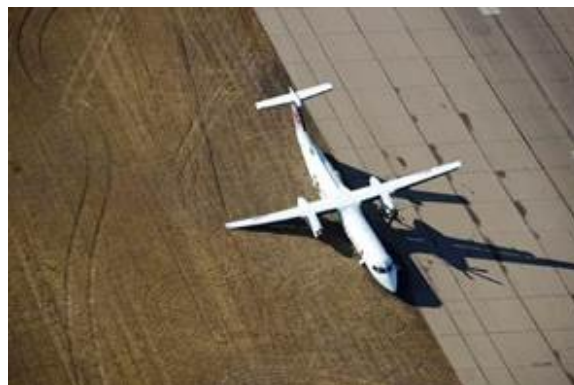
Throughout the approach phase of the landing sequence, the landing gear control panel indicated that the landing gear was down and locked. The aircraft touched down very lightly on Runway 02 at CYEG. As the wheels spun up, a pronounced vibration shook the aircraft 2.4 seconds after initial touchdown; while the nose wheel of the aircraft was still airborne, the right main landing gear (MLG) collapsed. The right-side propeller blades struck the runway, and all were sheared on contact. One large section of a propeller blade penetrated the aircraft cabin next to passenger row 7. At the same time as the propeller contact, the nose landing gear came down hard and its tires ruptured. The aircraft slid slightly to the right and came to a stop off the right edge of the runway, approximately 3200 feet past the touchdown point (Photo 1).

Photo 1. The occurrence aircraft at the accident site

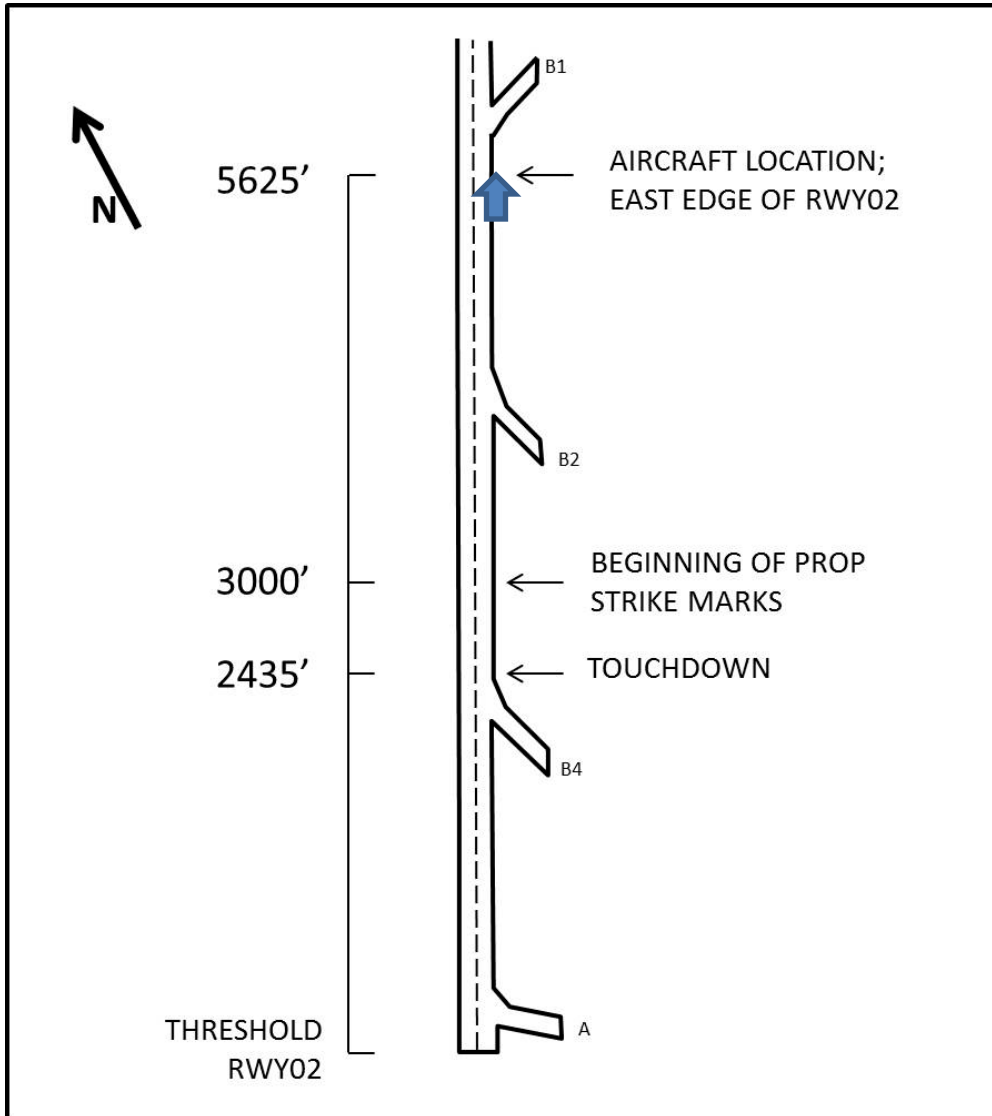
The area of the propeller strike marks was about 40 feet long, with approximately 2 feet between marks (Figure 1). Based on the propeller speed of 1020 revolutions per minute (rpm), which had been briefed by the crew and recorded on the DFDR, these strike marks indicated an approximate ground speed of 120 knots. However, the DFDR recorded an airspeed of 105 KCAS at the time of the collapse, and the DFDR with WOW recorded an airspeed of 118 KCAS just before the collapse.

The nose wheel left marks on the runway indicating that it had come down hard at the same time as the propeller strikes began. The distance from the propeller strike marks to the nose

The aircraft landed slightly right of centre line on Runway 02 at 2435 feet from the threshold. Throughout the landing phase, the landing gear collapse, and the subsequent slide to a stop, the aircraft maintained runway heading. It came to rest 3190 feet after touchdown. The left side main wheels were still on the runway. The left side of the fuselage was on the right-hand edge of the runway asphalt, still parallel to the runway heading. The right wing was touching the ground. The nose landing gear had collapsed rearward during the slide and was approximately 5 feet from the right-hand edge of the asphalt.

Figure 1. Landing path of Jazz 8481 on Runway 02

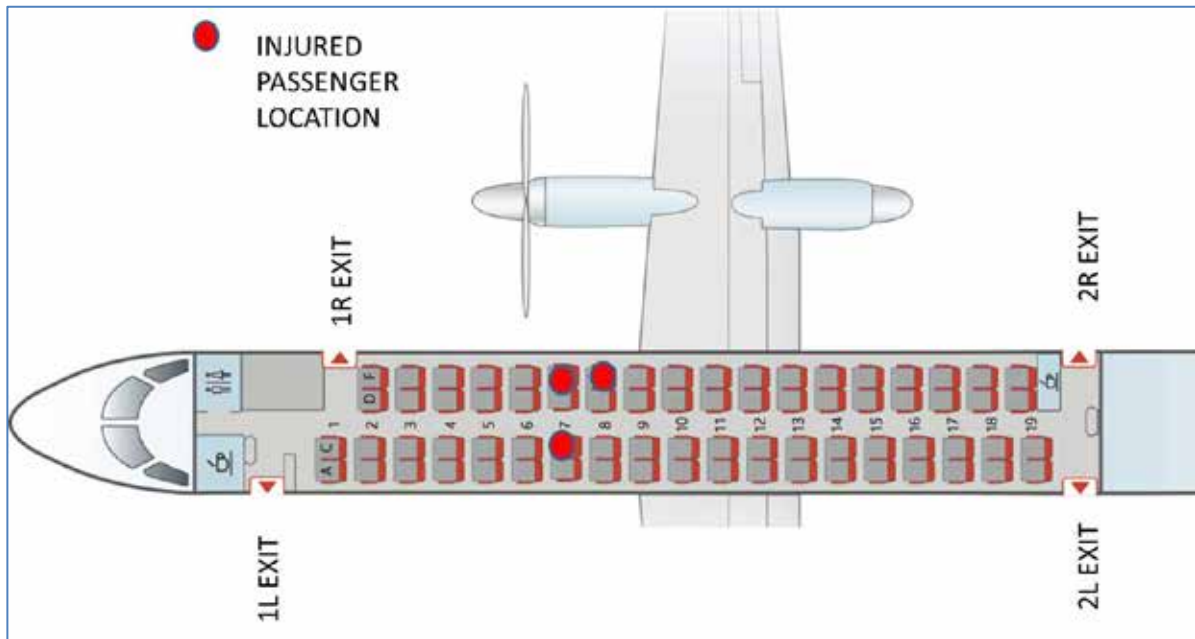
Passengers in seats 7F, 8F, and 7C were injured as a result of the partial propeller blade that punctured the fuselage (Figure 2); these injuries were consistent with plastic pieces in the cabin interior (side wall, window, etc.) blowing into the seating area. There were also blunt-force injuries, abrasions, and small puncture wounds. There were no injuries related to the evacuation.

Figure 2. Jazz 8481 cabin layout showing location of injured passengers

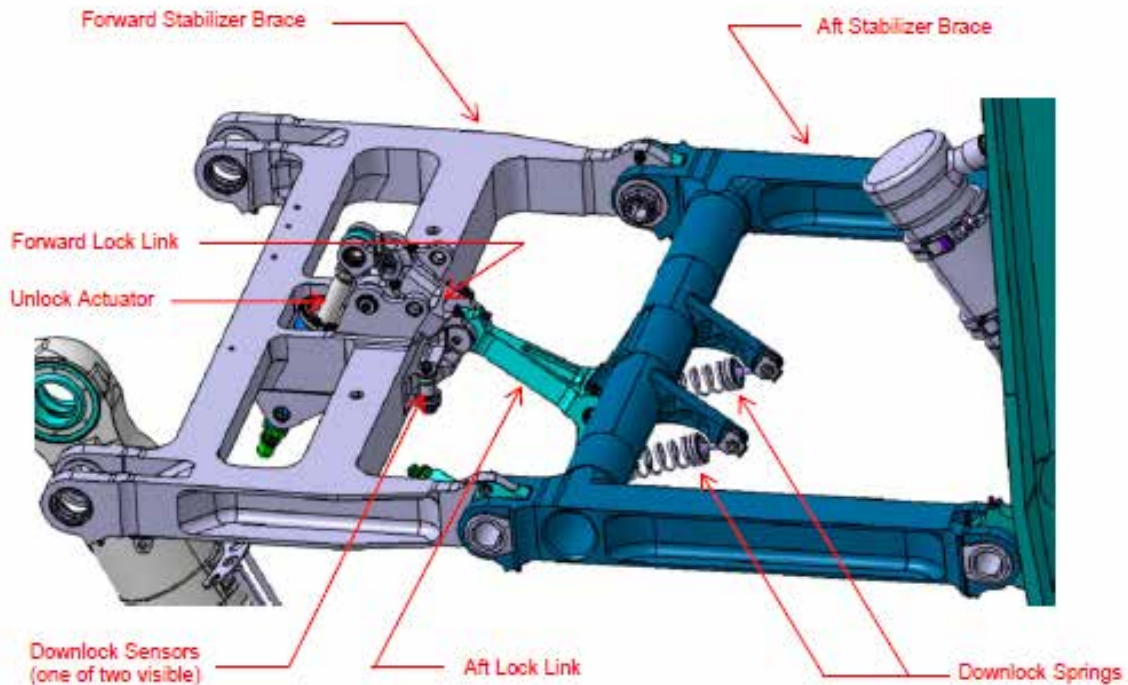
The landing gear stabilizer brace was also inspected and tested according to the ATP at the manufacturer’s facilities. The inspection revealed no anomalies other than a slightly larger-than-normal over-centre measurement; however, this was normal and due to in-service wear. The stabilizer brace was also subjected to rigorous vibration tests; the plan was to subject it to a maximum of 0.29g in the vertical direction (representing the load on the stabilizer brace with the 1248-ounce-inch tire imbalance at 35 Hz). A few resonance sweeps were performed, as well as a number of dwells at various frequencies up to 0.4g; very noticeable vertical vibration at the centre of the brace could be seen at this g level, at the resonant frequency. This was followed by the test spectra according to the planned test. In addition to the test plan, in an attempt to force the brace to unlock, additional cases were run that were not representative of the loads on the brace during the incident. With the unlock actuator in the pressurized condition, the brace was tested at accelerations up to 2g. None of the test cases that were applied resulted in the stabilizer brace coming out of lock; however, the pressurized test jig attachments prevented this in any event.

An unexpected high rotational imbalance was created on the number 3 tire when it failed during takeoff. During landing, the failed number 3 tire was spun by contact with the ground and was maintained at a rotational speed that was the same as or very close to one of the natural frequencies of the main landing gear (MLG). This caused the lock links to trigger (through the proximity sensors gap) the proximity sensor electronic unit (PSEU) to de-energize the solenoid sequence valve (SSV), thereby relieving system pressure from the extend port of the unlock actuator. In this condition, the excessive vibration then caused the lock links to overcome the force from the downlock springs and unlock the stabilizer brace as a result of gear dynamics, which led to collapse of the right MLG.

Zoomed view of the main landing gear stabilizer brace assembly (part no. 46400-27/-29) (Source: UTC Aerospace Systems)
