# Investigation Report

Type of Occurrence:	Serious incident
Date:	21 August 2008
Location:	Frankfurt/Main
Aircraft:	Transport aircraft
Manufacturer / Model:	Airbus Industry / A340-313
Injuries to Persons:	None
Damage to aircraft:	Minor damage to airplane
Other damage:	Vehicle (passenger bus) damaged
Source of information:	Investigation by BFU
State File Number:	BFU 5X015-08

At 0622<sup>1</sup> hrs, an Airbus A340-313 (A340) collided with a passenger bus on the apron in the area of the crossing of taxiway G and the taxi area road proceeding parallel to taxiway N of Frankfurt/Main Airport (EDDF).

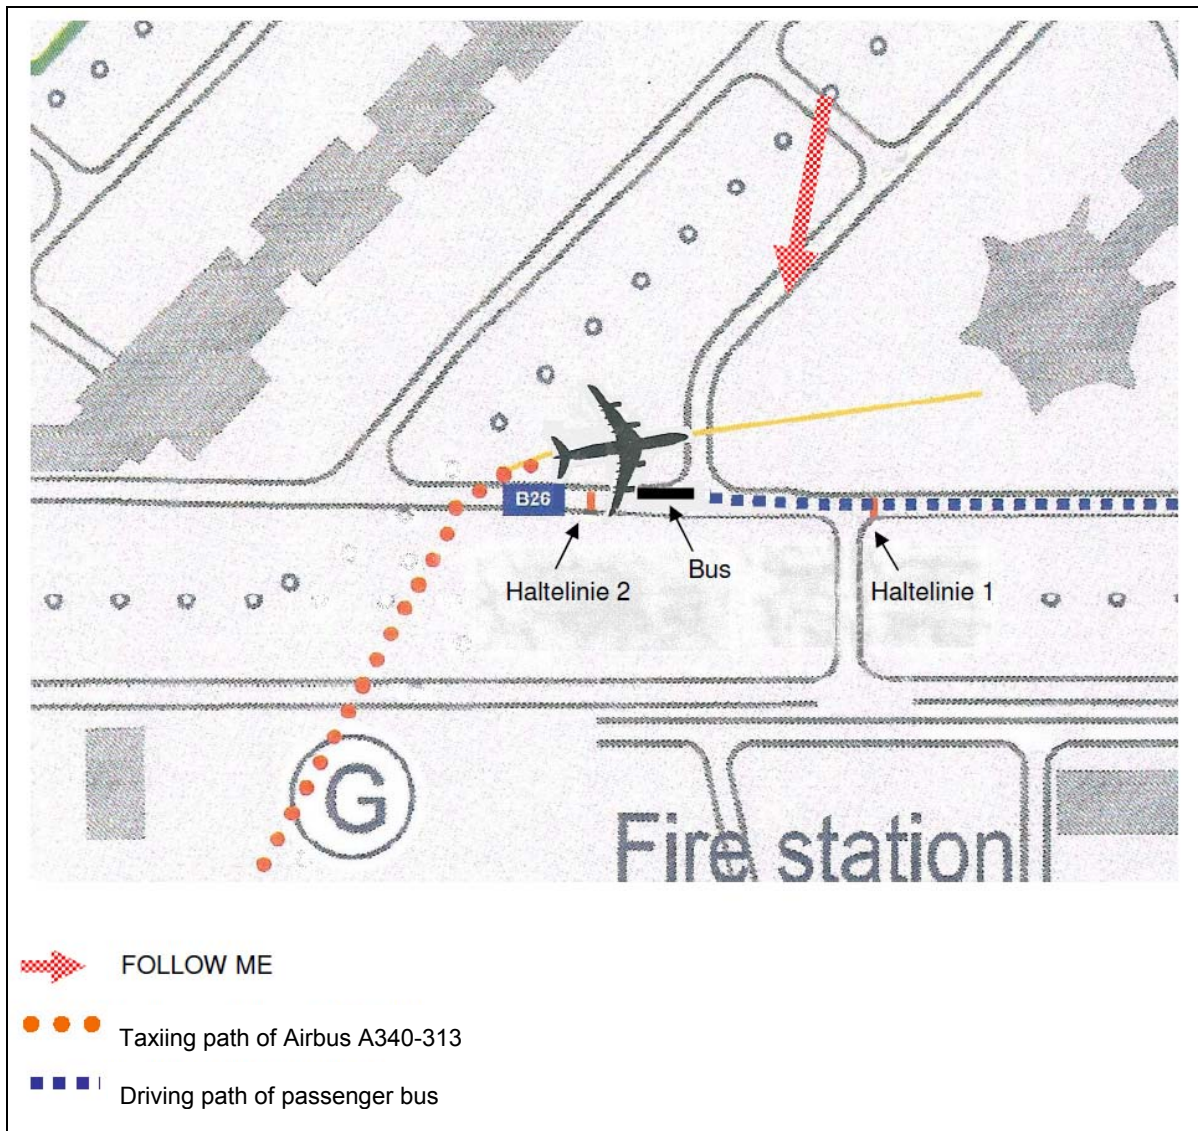
Reconstructed taxiing and driving paths

The investigation revealed that it might be impossible for a vehicle stopped at the first stop line marking on the taxi area road to physically see an aircraft taxiing via taxiway G to parking position B26 due to oncoming traffic. Therefore, the passenger bus driver had no reason, in this case, to stop at the first stop line marking and give the airplane the right of way. After he had noticed the Airbus A340 and brought his vehicle to a stop, the bus already was at a position where the collision was unavoidable.

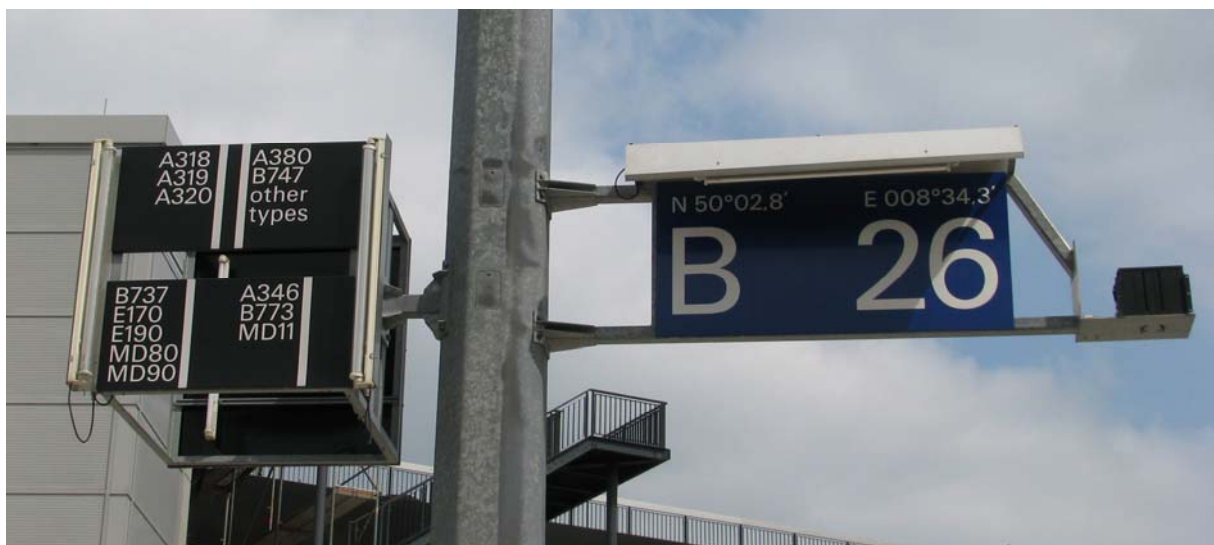
The operating status of the visual guidance system was monitored and documented in the system itself. It showed that the AGNIS/PAPA was not operating at the time of incident.

AGNIS / PAPA at parking position B26

The explanation of the PIC according to which a taxiing clearance towards the parking position was given by apron control as well as by the switched-on AGNIS/PAPA, was incorrect with respect to the system AGNIS/PAPA. It is proven that the system was switched off at that time.

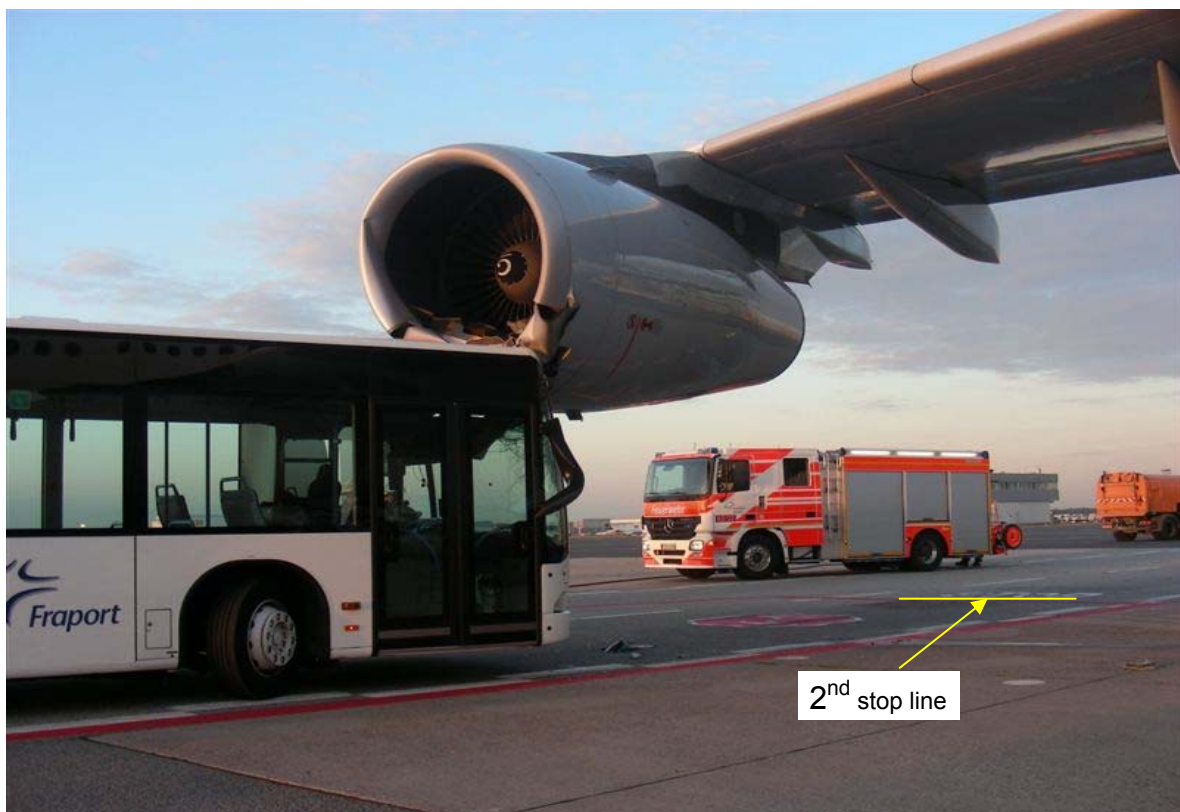
Engine No. 4 of the Airbus A340 rested with the bottom side of the engine cowling on the upper front part of the passenger bus. The airplane was on the yellow guide line for parking position B26, and the passenger bus was on the taxi area road approximately 8 m in front of the second stop line marking for vehicles.

Airplane and passenger bus on the apron

The lower part of the cowling of the airplane's engine No. 4 was compressed; parts of the damaged cowling were found in the engine. The interior of the engine was damaged. It had to be removed for further damage identification and repair.

The passenger bus's upper front carriage was deformed. The rear view mirror and cover panels were torn out of their fixings and damaged.

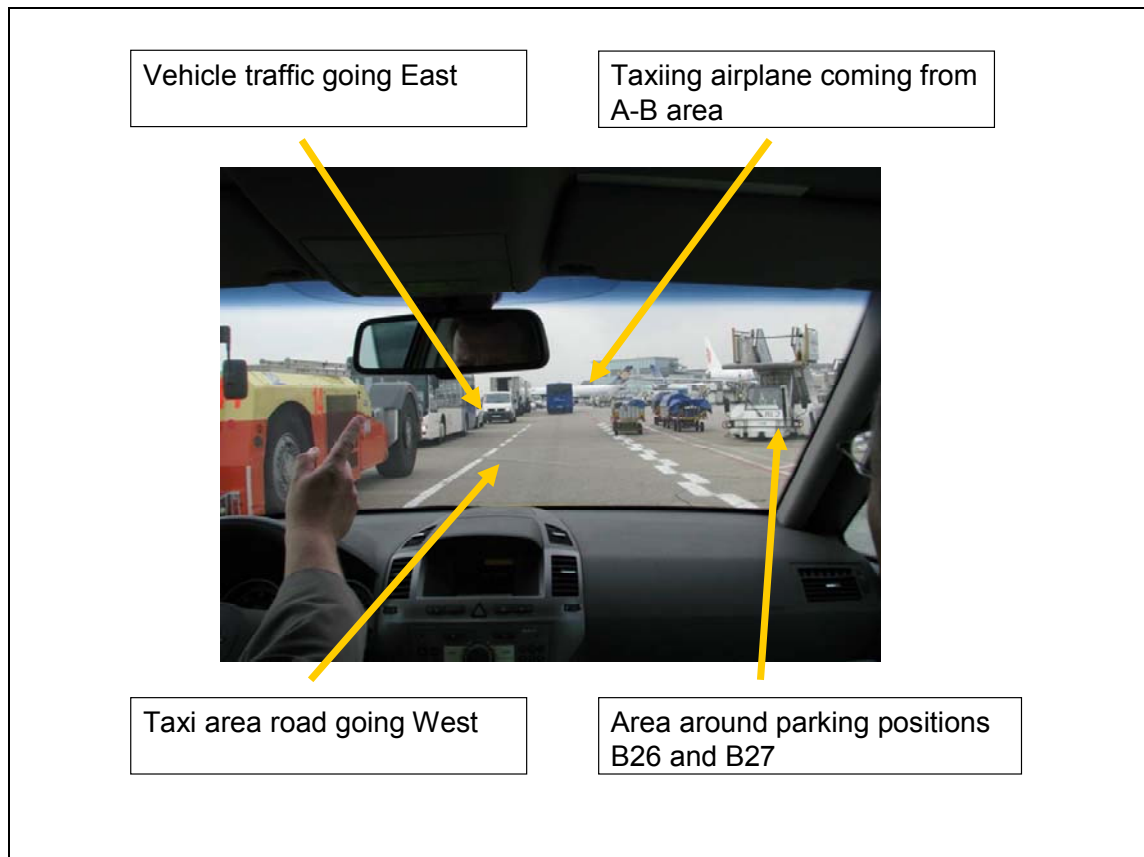
Traffic situation on the taxi area road

In the scope of the investigation an on-site inspection revealed that the traffic situation caused by taxiing aircraft and vehicles becomes confusing especially during peak periods.

The operator of the Frankfurt/Main Airport should ensure a spatial separation of the taxiing traffic and the vehicle traffic on the apron in the area of the crossing of taxiway G with the taxi guide line to position B26 by means of infrastructural measures (e. g. change of traffic routing).
