TECHNICAL REPORT

A-068/1999

Accident of aircraft
Fokker MK-100,
registration I-ALPL,
at Barcelona Airport
(Barcelona), on 7
November 1999

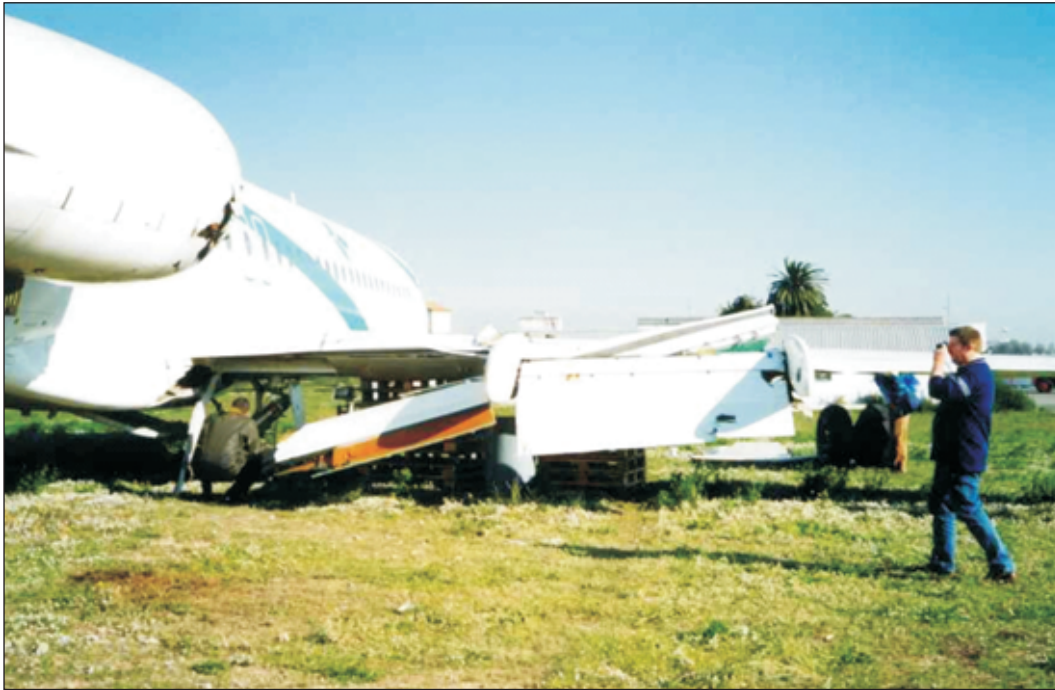
Photo 1.1.1

The air inlet cowl and the side cowl of the right-hand engine showed damage and perforations produced by the blow from the wheel carriage, formed by the two wheels of the right-hand main leg mounted on the sliding member unit, broken off from the leg. In this engine zone a fuel leak occurred, lasting several hours (Photo 1.1.1).

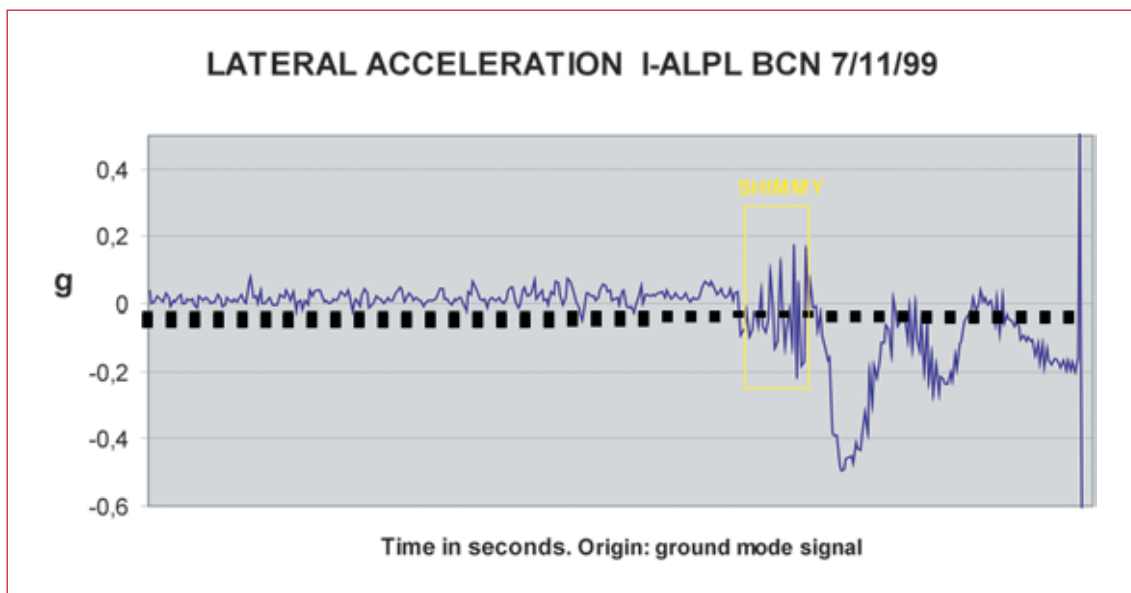
Figure 1.11.1

The installed DFDR records the parameter of lateral acceleration with a periodicity of a quarter of a second. The series of data recorded during the approach, touchdown and braking run until the aircraft came to a halt are shown in graphic form in figure 1.11.1. It can be seen that although the levels of lateral acceleration were low at all times, at touchdown they increased in absolute values and the frequency of the changes of direction of those accelerations also increased. After the breakage of the main landing gear leg, the aircraft zigzagged for several seconds, tending to pull to the right. The maximum acceleration in that direction reached almost 0.5 g, some 13 s after touchdown.

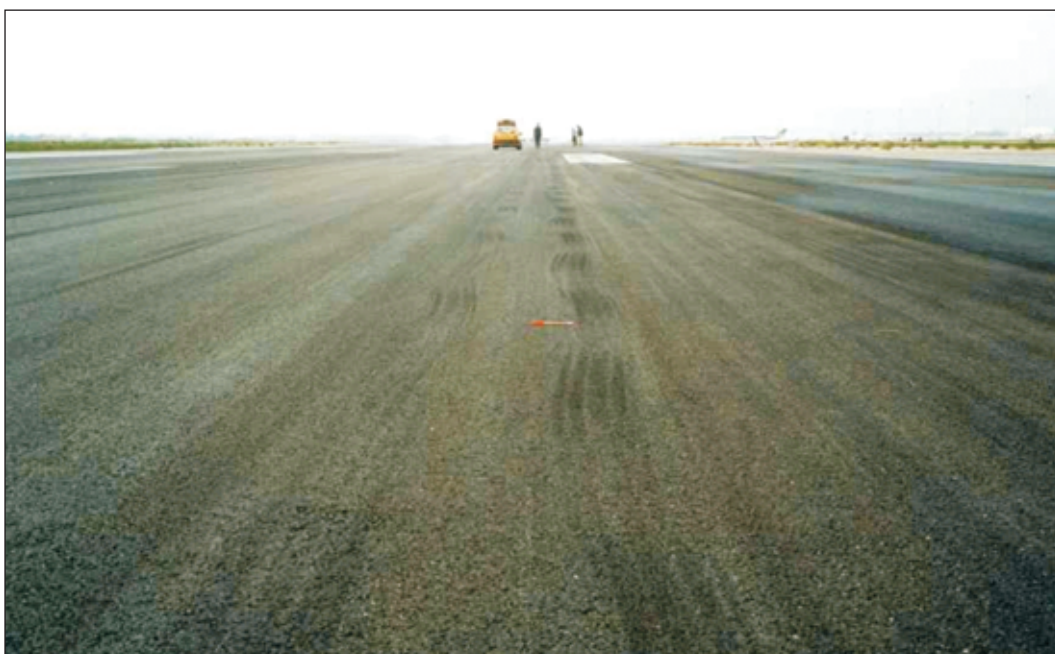
Photo 1.12.1

Finally, tracks were detected of the tyres of the nose and left-hand landing gear, which had left cycloid traces which crossed on two occasions and continued until the aircraft's stopping point.

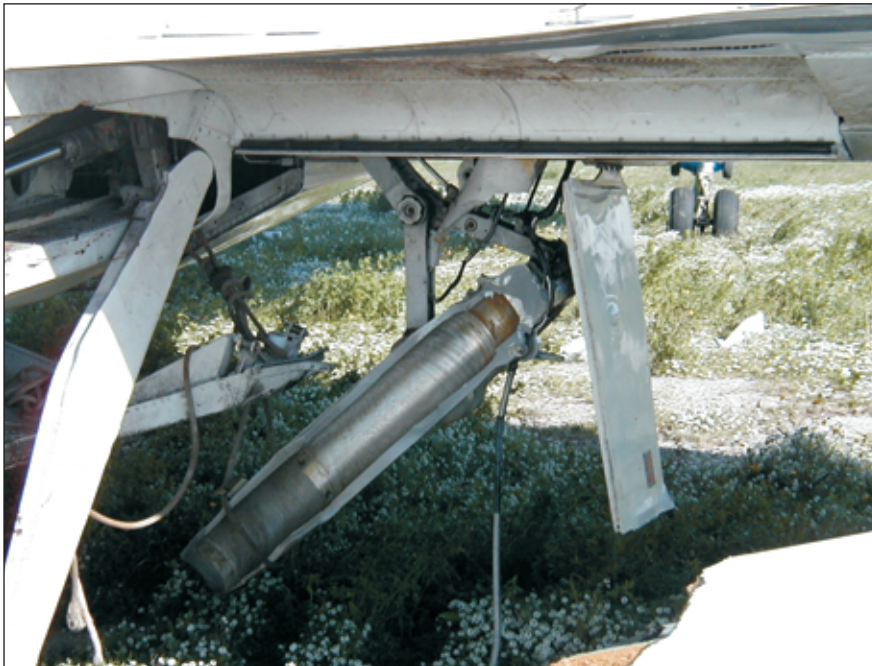
Photo 1.12.2

The right wing landing gear fixing was fractured. Of the main fitting of the right main leg, which had broken into fragments, there remained the front half-shell (Photo 1.12.2), attached to the wing structure by the extension/retraction joint.

The main joint was destroyed. The other fragments of the main fitting had broken off. The sliding member with wheels was separated.

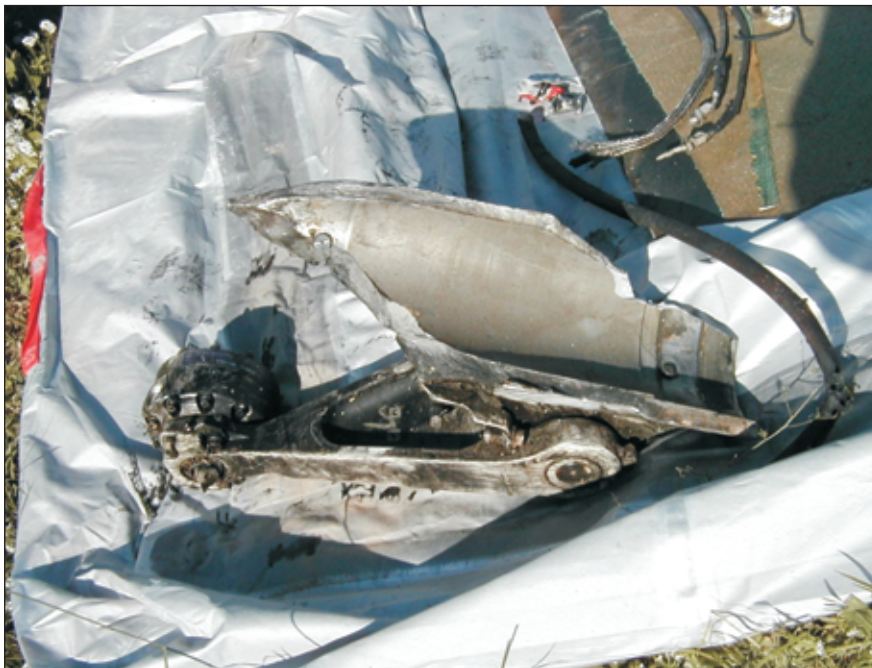
Photo 1.12.3

Another large piece of the main fitting included a triangular surface joined to the upper torque link (Photo 1.12.3). This arm of the torque link turned freely, and some play

could be appreciated in it in its connection with the main fitting. The housing of the shimmy damper was connected to the torque link.

After the breakage of the apex bolt of the torque links, the shimmy damper remained connected to the upper torque link (Photos 1.12.3 and 1.16.3). Its housing showed some damage but was still intact. The reservoir, (reserve hydraulic tank) of the damper was found broken off and separated.

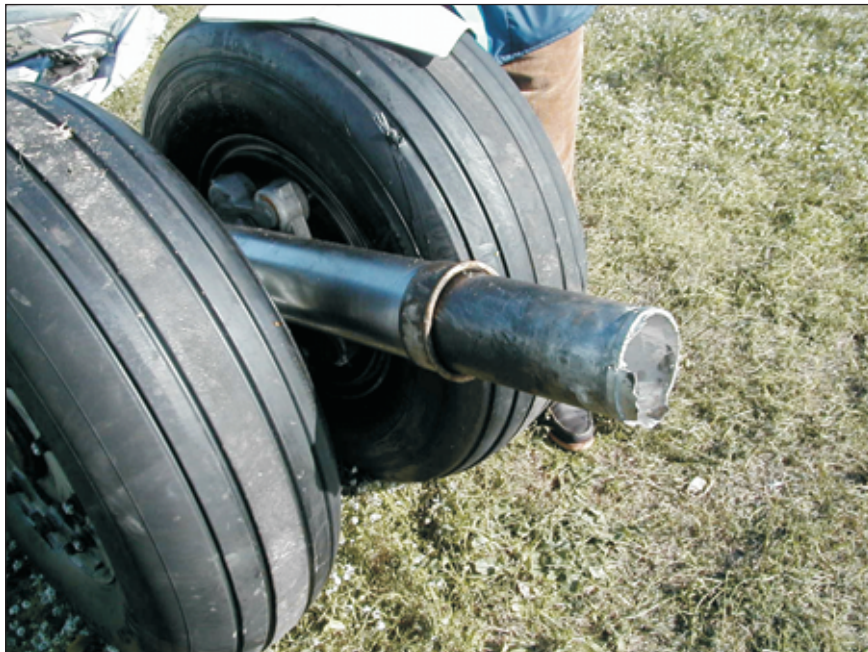
Photo 1.12.4

The tyres had not burst and they maintained pressure. No previous defects such as flat spots were observed. The circumferential damage they showed was due to friction with the upper torque link before shearing off.

The wheel units (tyres, brakes and rims) did not show any apparent anomalies or damage, apart from those mentioned in the tyres and a few small impact traces on the outer rims.

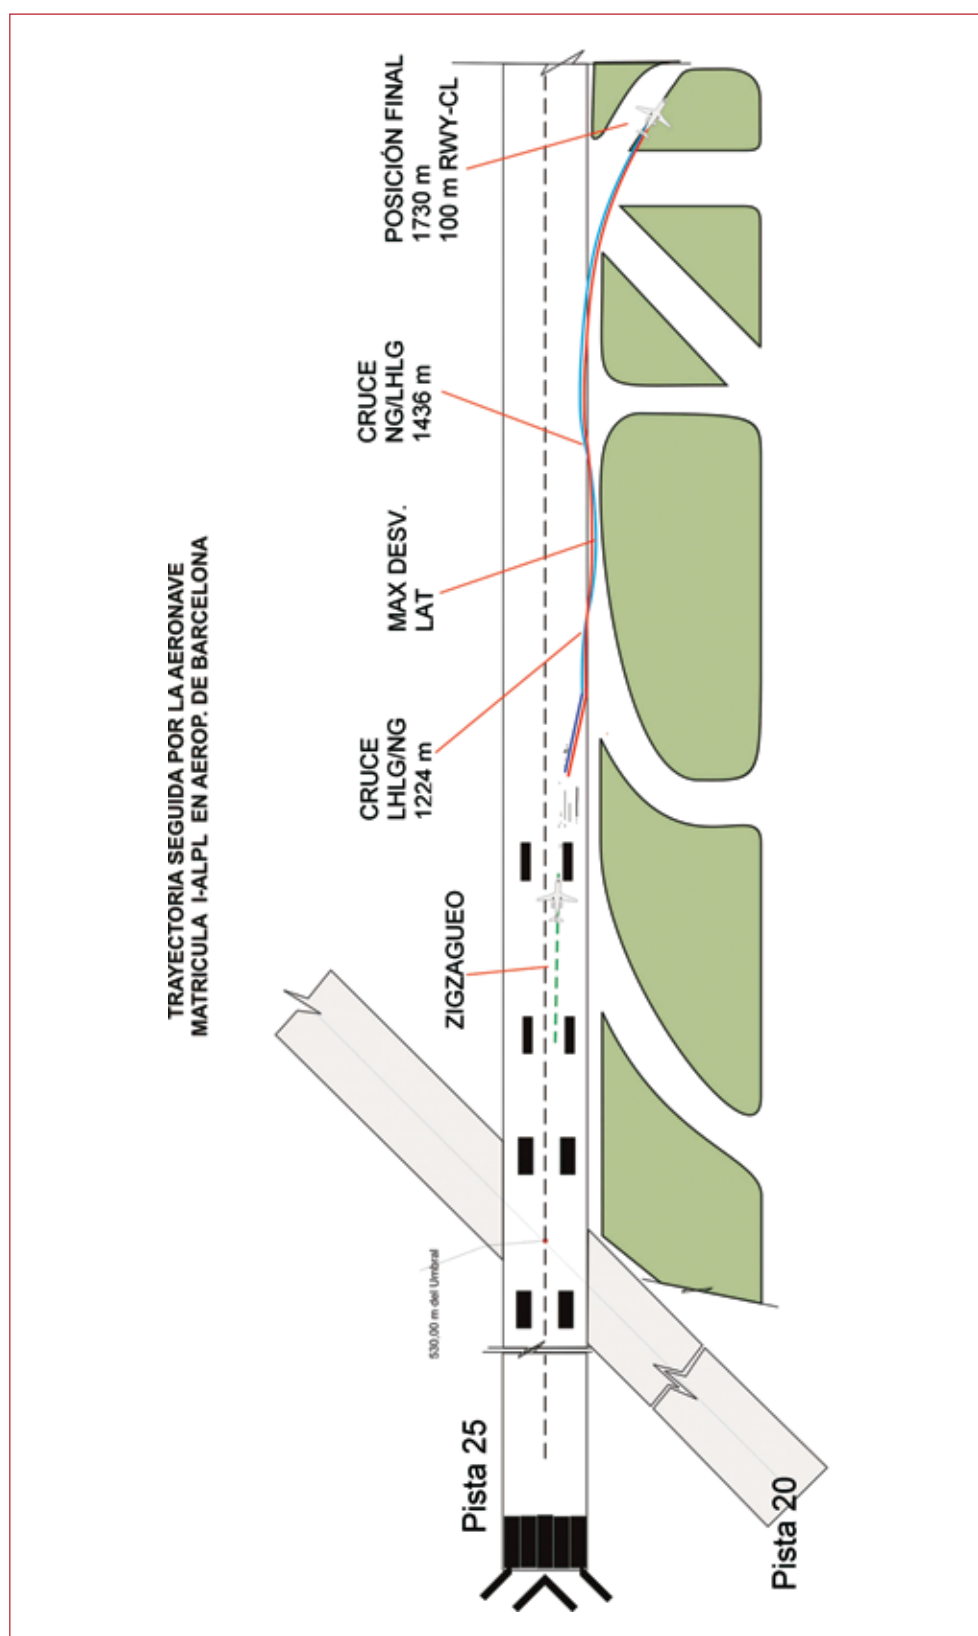
Diagram B.1. Trajectory and tracks of the wheels in the landing run

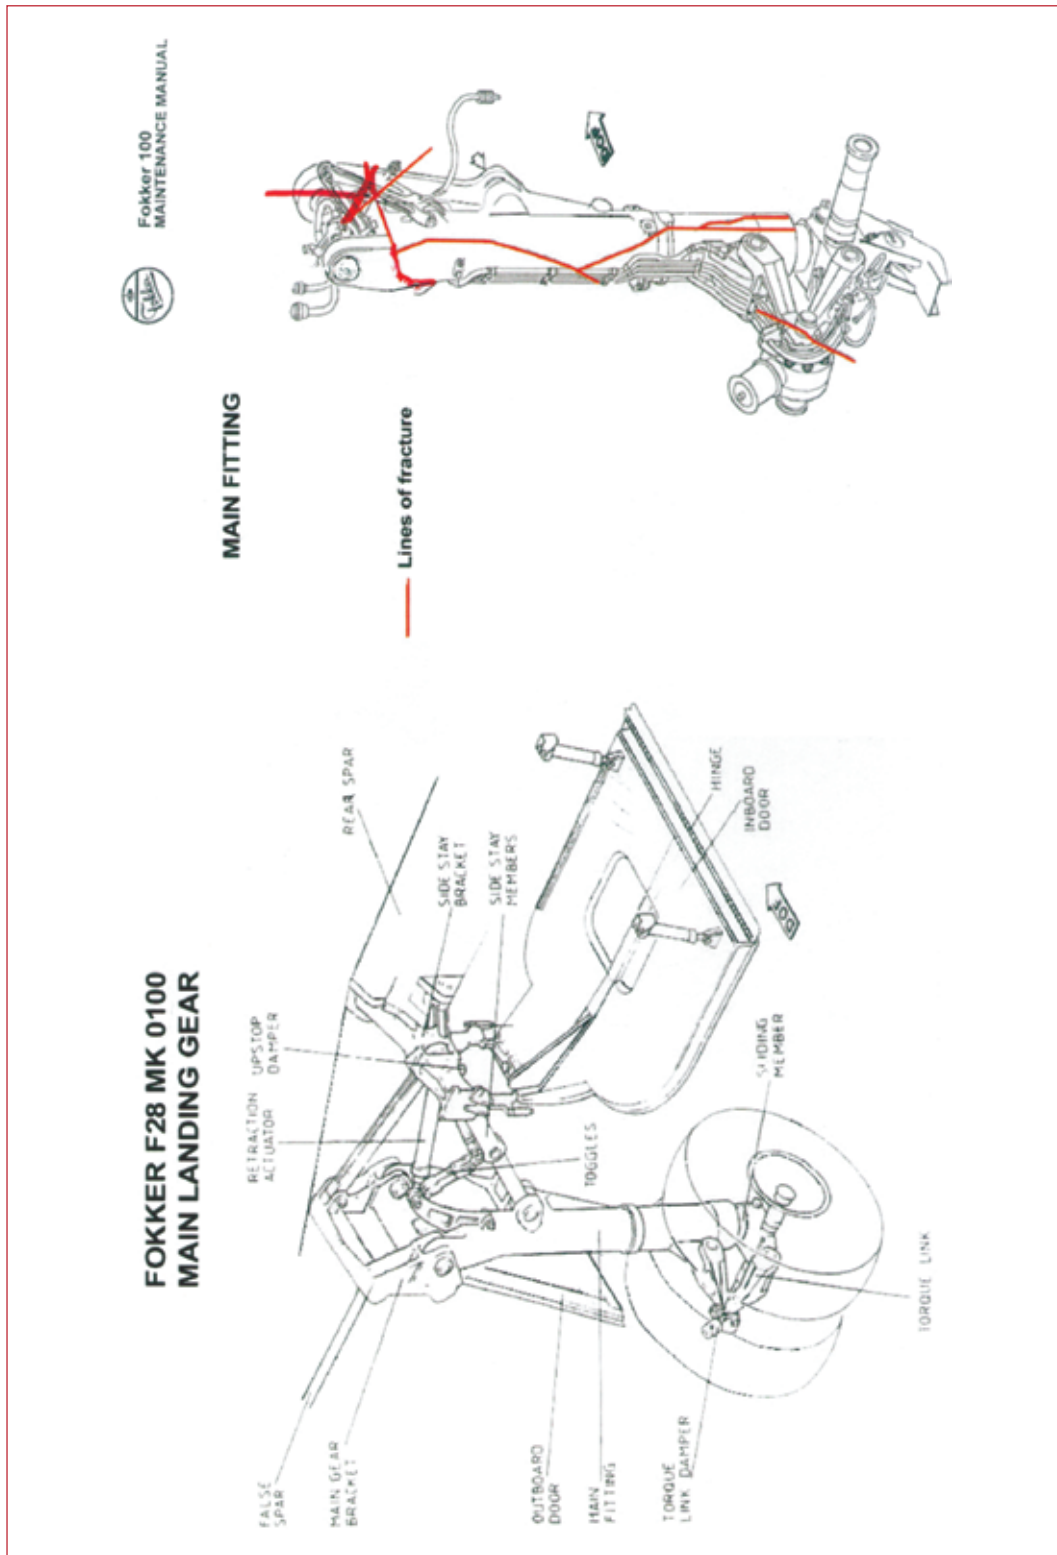
In general the play levels found were within tolerances but close to the permitted upper limit. Some diameters measured at the sleeves of the forward lug of the main fitting, were out of tolerance with dimension up to 57.835 mm where the maximum wear limit stated is 57.22 mm. This was the lug which split into two halves when the landing gear collapsed (See Figure C.7 in Appendix C).

Figure C.1. Left leg of main landing gear. The right-hand leg has the side stay fitted on the left-hand side of the leg. The fracture lines of the main fitting are marked in red

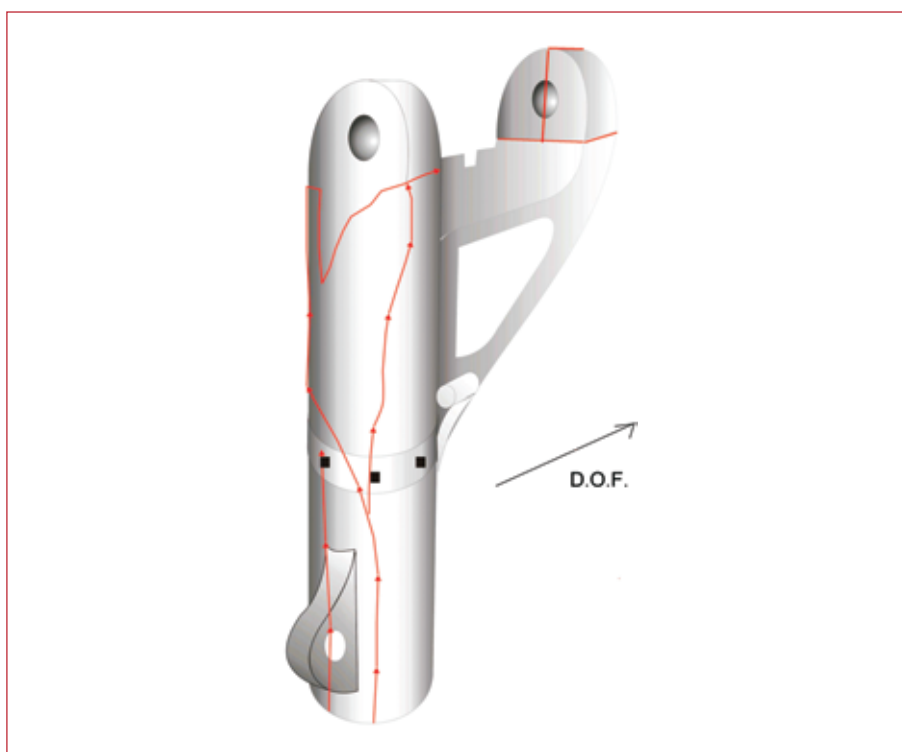
The crack that is expected to be the primary initial crack was located at the outer surface of the main fitting adjacent to the RH centreline of the upper main fitting torque link section. This is the location where the highest stresses occur in case of local bending due to torsion introduced by torque links. From this location the crack run upwards and downwards.

Cracking occurred exclusively in an overload mode and no evidence of pre-existing damage could be found such as fatigue, corrosion or forging damage.

A second crack initiation was observed at the LH side of the main fitting torque link lug section. The position of this initiation site was located closer to the lower end of the main fitting and started not at the outer surface but at the inner surface, suggesting that this initiation was caused by similar torsion bending loads following from the RH crack. Also from this initiation the crack ran to lower and upper direction.

Two secondary initial cracks were observed on fragmented parts of the main fitting. These cracks most likely were caused by the sliding member splitting the main fitting open during separation.

Photo 1.16.2 shows the fragments collected, with indication of the direction of extension of the cracks. Figures C.2 and C.3 of Appendix C show drawings of lines of cracks and fragmentation of the main fitting.

Figure C.2. *Extension lines of the cracks in the collapse of the right-hand main fitting*

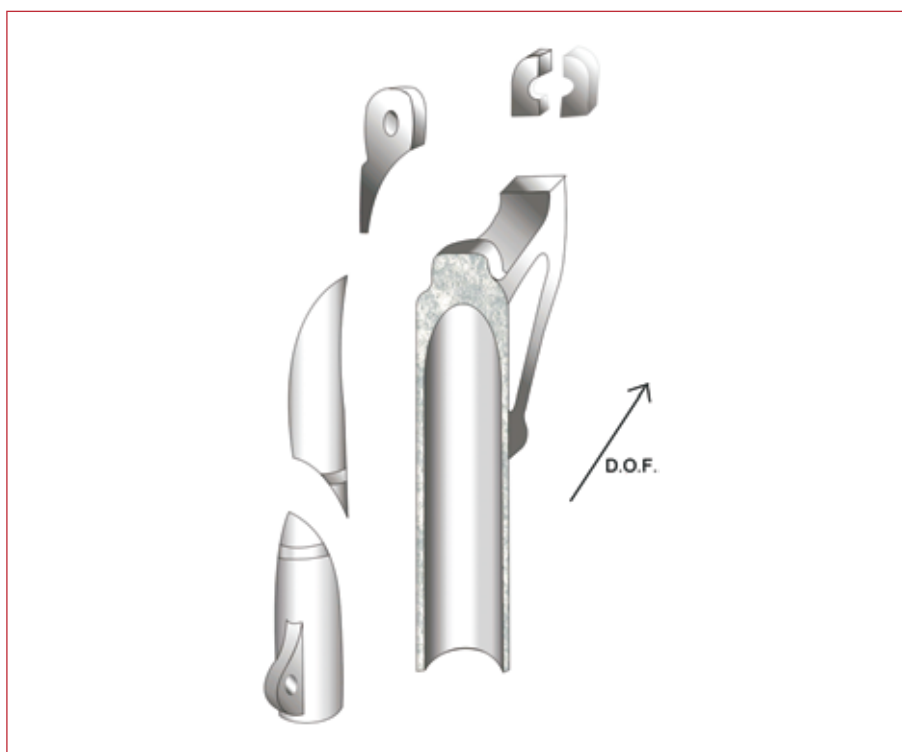
Figure C.3. *Principal fragments of the right-hand main fitting*

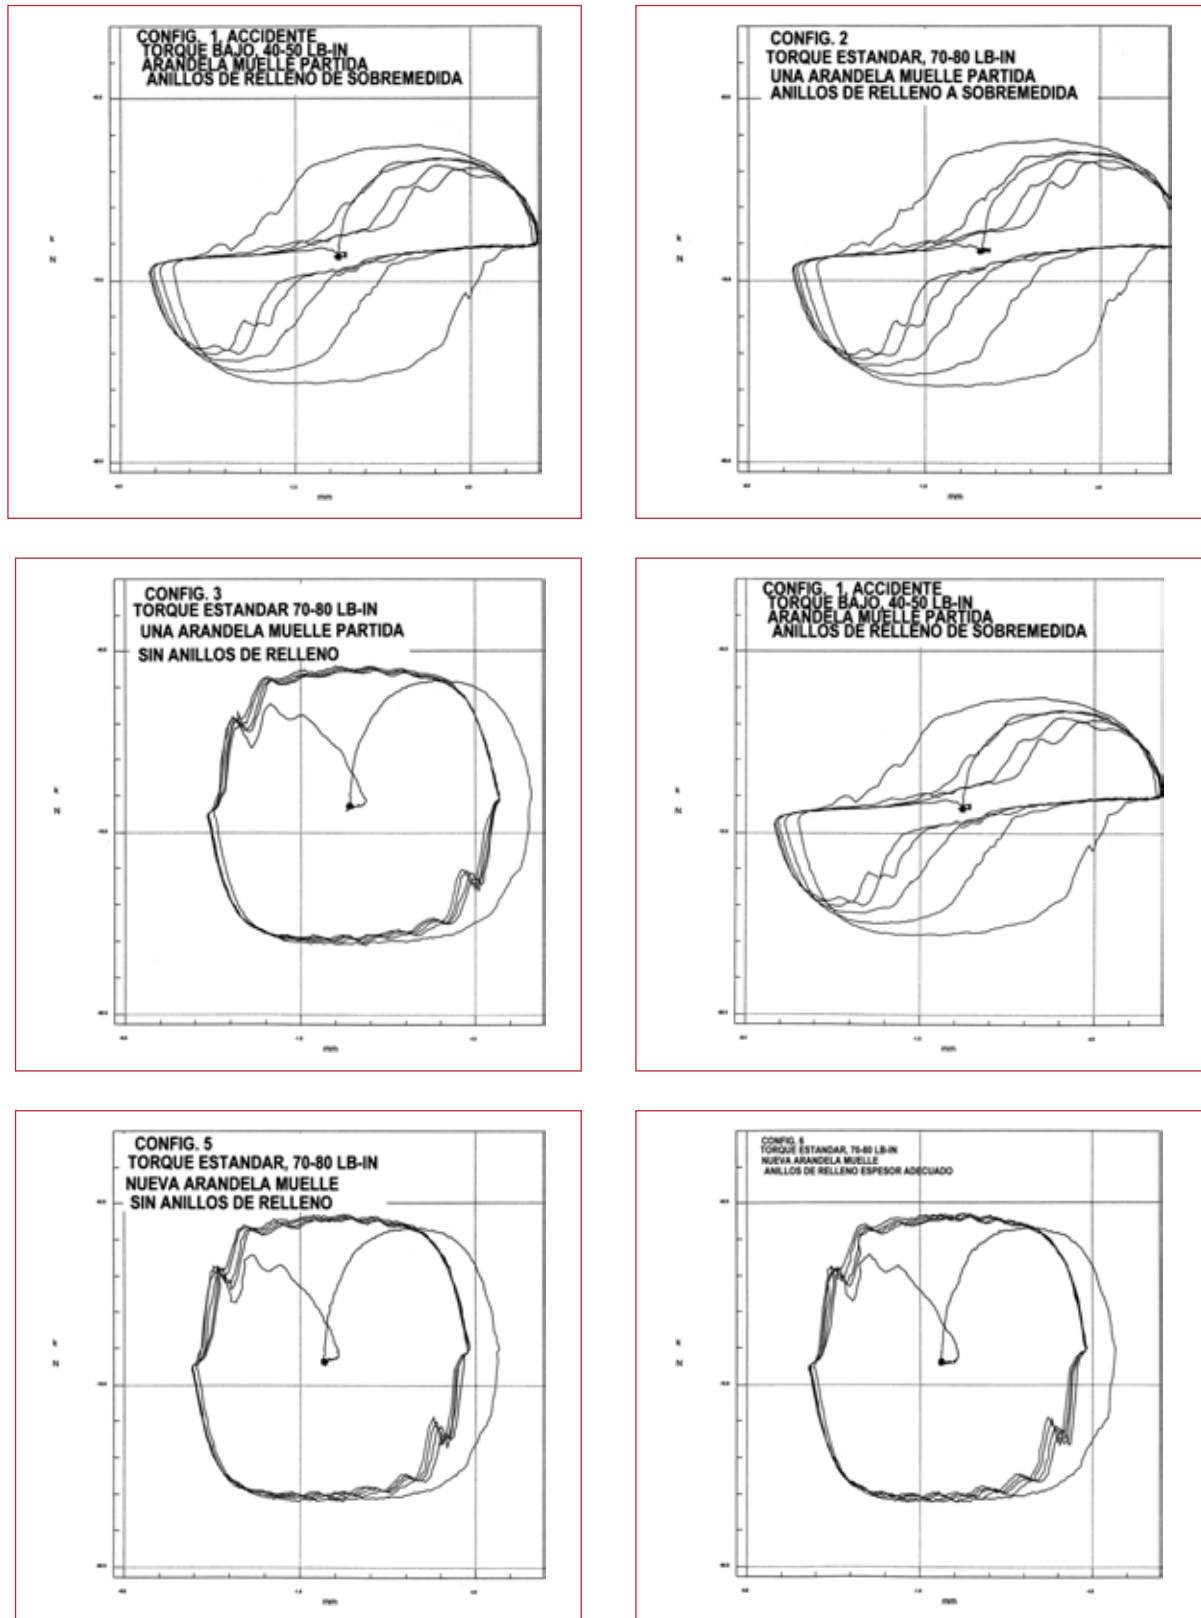
mance of the damper at frequencies of 8, 16 and 20 Hz in the condition found in the accident and in other assembly configurations for comparison purposes (see graph in Appendix D of the comparative results of the tests at 20 Hz).

- At frequencies of over 16 Hz the damper in the accident configuration had a much lower damping capacity, less than 50%, than the damper in the configuration complying with the requirements of the functional test CMM 1.C (1).
- The defect of one split washer had no influence on the damping capacity.
- The increase in the tightening torque did not improve the performance of the damper in the configuration of excess shim thickness.

Figure D.1. Comparison of the results of dynamic excitation tests on the shimmy damper s/n MAL176
