# **FINAL REPORT**

## **CONTACT BETWEEN AIRBUS A320 AND AEROBRIDGE**

**5 OCTOBER 2012**

**AIB/AAI/CAS.087**

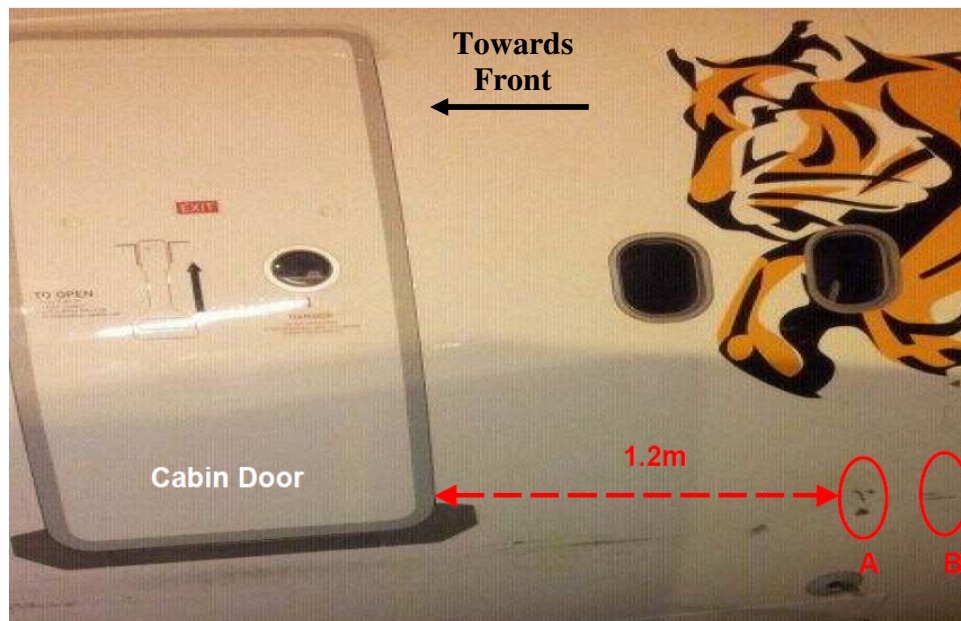
- 1.3.1 The scratch marks and skin puncture were located at about 1.2 m aft of the front cabin door, in line with the bottom level of the door opening (see the areas marked as A and B in **Figure 1**).

Figure 1: Location of damage on aircraft fuselage

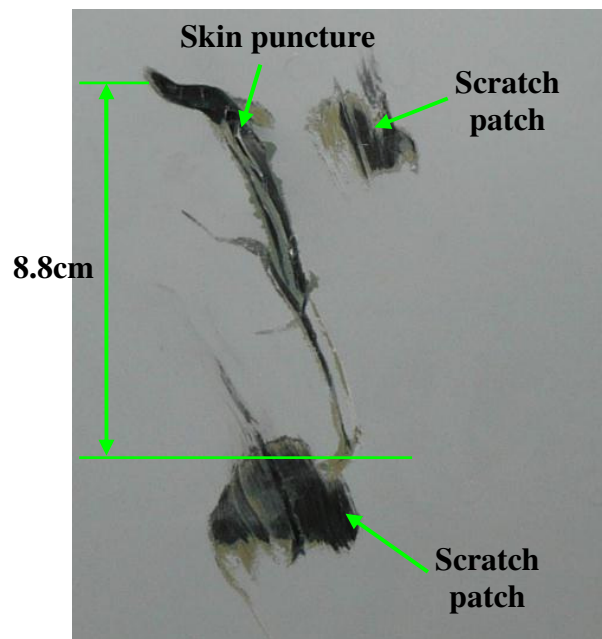
- 1.3.2 The damage at the area marked A in Figure 2 consists of an 8.8 cm long gouge mark (including the skin puncture) and two scratch patches (see **Figure 2**).

Figure 2: Close-up of damage area A

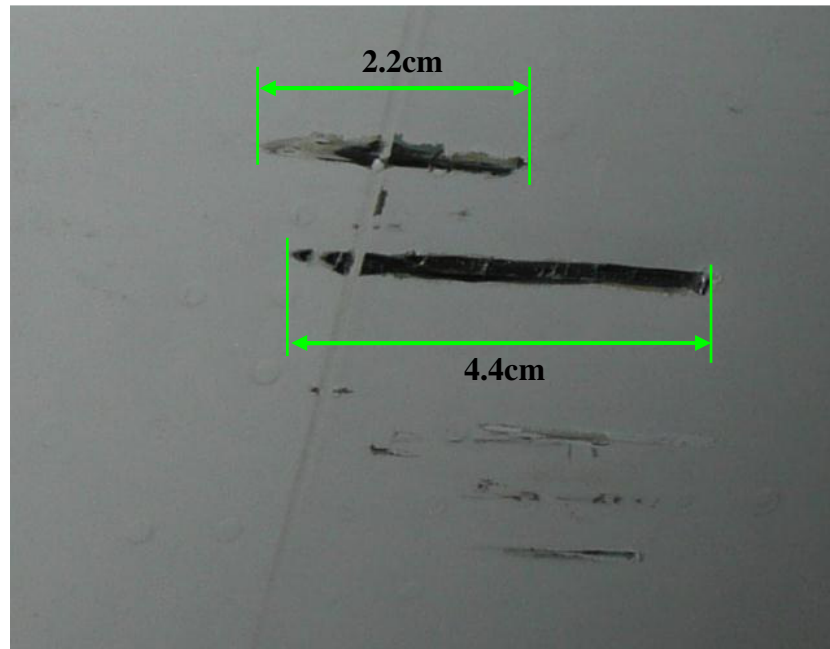
- 1.3.3 The damage at the area marked B in Figure 2 consists of two long gouge marks, one measuring 2.2 cm and the other 4.4 cm (see **Figure 3**).

Figure 3: Close-up of damage area B

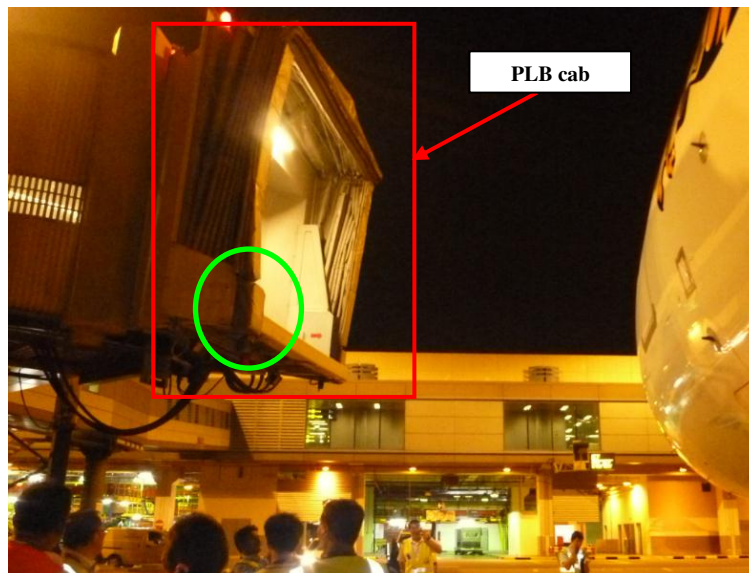
- 1.4.1 The right side metal plate and padding of the PLB operator cabin (PLB cab) were damaged (see **Figures 4, 5 and 6**).

Figure 4: Damage area (green circle) on PLB cab

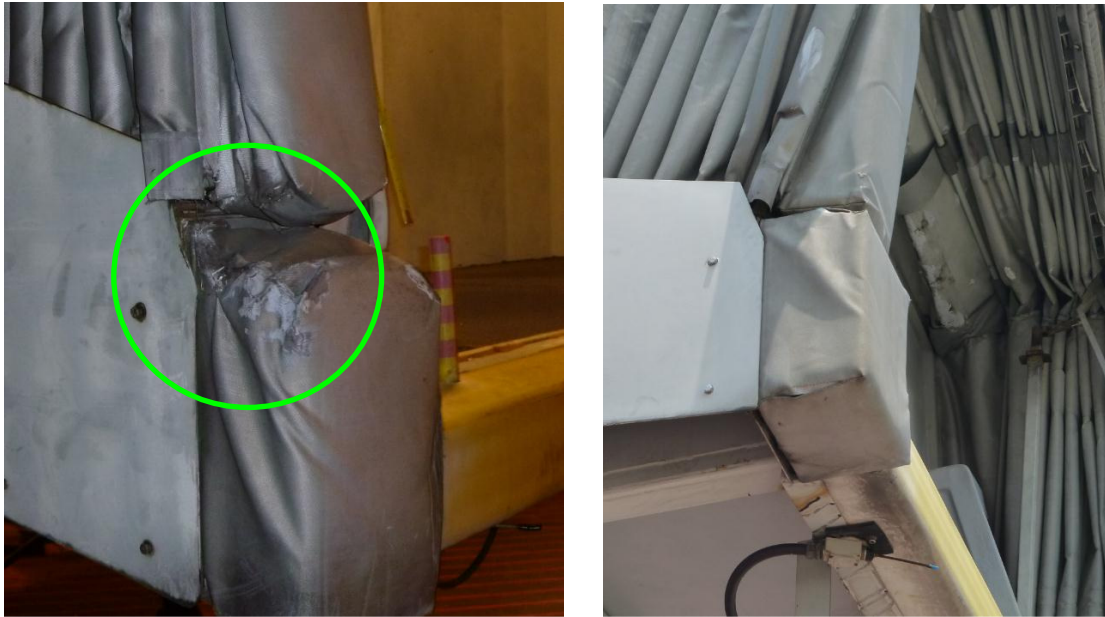
Figure 5: (Left) Damaged padding on incident PLB  
(Right) Undamaged padding on normal PLB

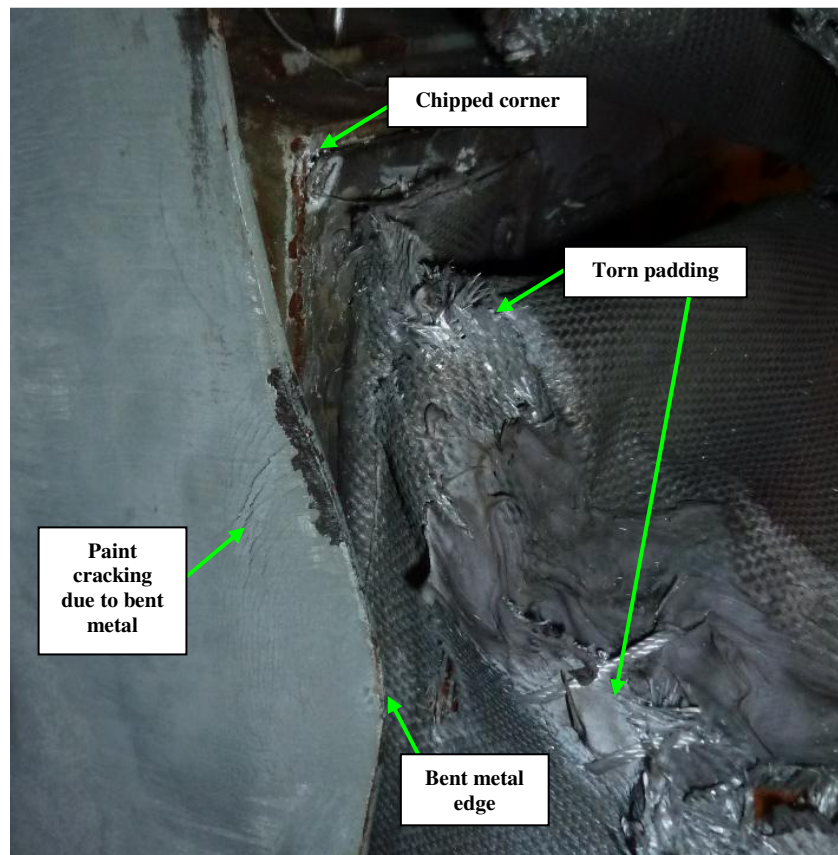
Figure 6: Details of the damaged padding of PLB

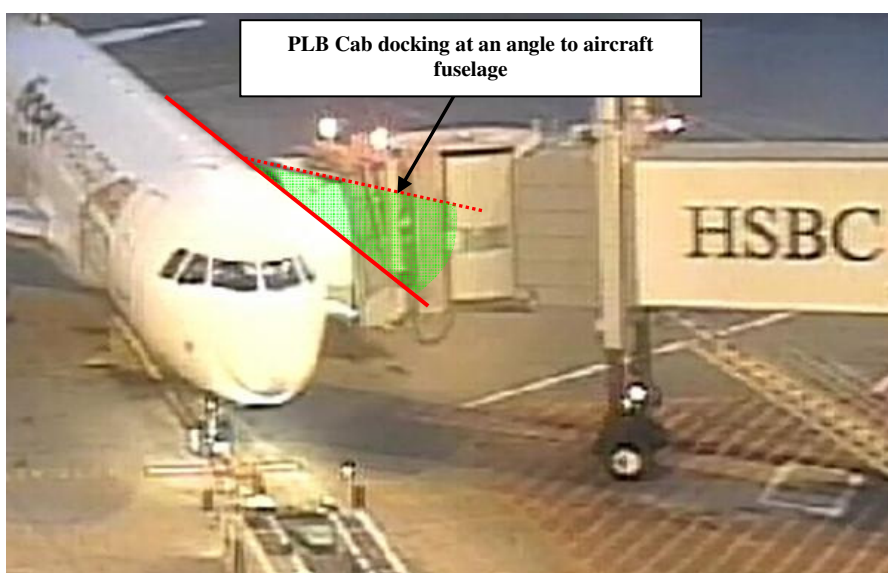
1.7.2 It is observed that, when the PLB cab was being re-docked, the PLB cab was tilting left and making an angle with the aircraft fuselage (see **Figure 7**).

Figure 7: Docking position of PLB at the time of the occurrence

- 3.1 Evidence shows that the PLB cab had contacted the fuselage during the re-docking. The PLB cab was not parallel to the fuselage. It was tilting towards the left at an angle when it approached the aircraft, resulting in the lower corner of the right edge of the PLB cab coming into contact with the fuselage.
- 3.2 In the non-parallel docking position, the safety-interlocking sensors under the PLB cab did not prevent the PLB cab from contacting the fuselage.

- 4.1 Following the incident, the airport ground handling provider has taken the following safety actions:
- Amending the PLB training manual to include a warning to PLB operators that highlights the importance of ensuring that the PLB cab is parallel to the aircraft fuselage, particularly when making adjustments when the bridge is 1.5 m and 0.5 m away from the aircraft. The amendment includes also a warning that non-parallel docking can cause damage to the aircraft fuselage.

- Emphasising to PLB operators that the PLB cab has to be parallel to the aircraft fuselage to ensure that the safety-interlocking sensors is effective in detecting potential contact with the aircraft.

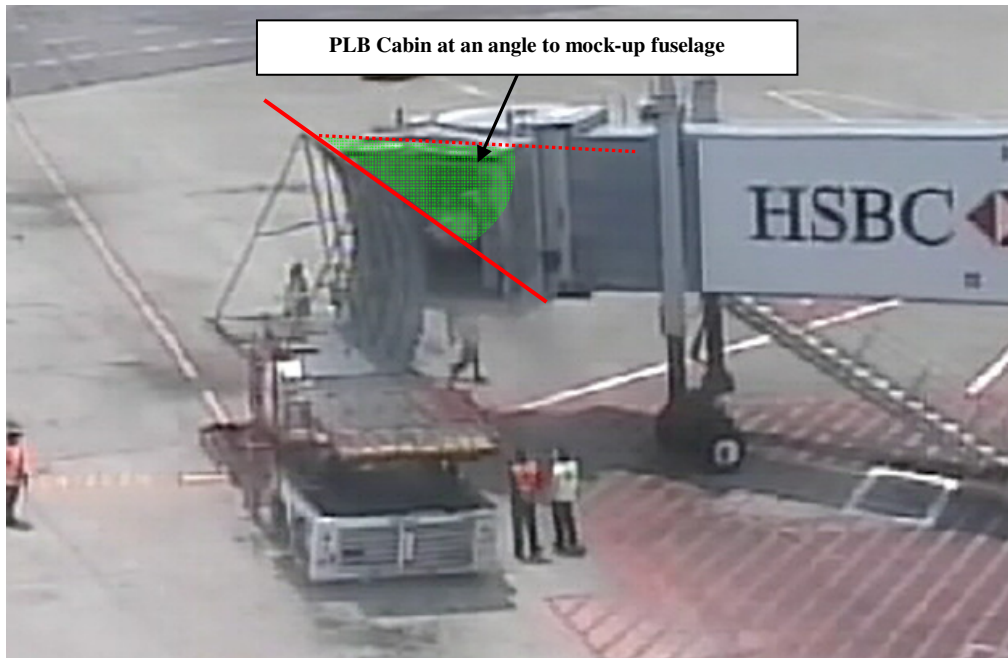
- 1.8.1.3 For the non-parallel angle docking, the PLB cab was positioned at an angle to the mock-up fuselage (see **Figure 11**). It was observed that the gap between the PLB cab and the mock-up was too wide for safe crossing of passengers. Although the gap produced in the simulation was larger than the gap seen in the incident footage, it should be noted that the simulation serves as a reference to demonstrate what a non-parallel docking would look like and to replicate any unsafe conditions that may exist as a result of a non-parallel docking scenario.

Figure 11: Non-parallel docking position of PLB during simulation

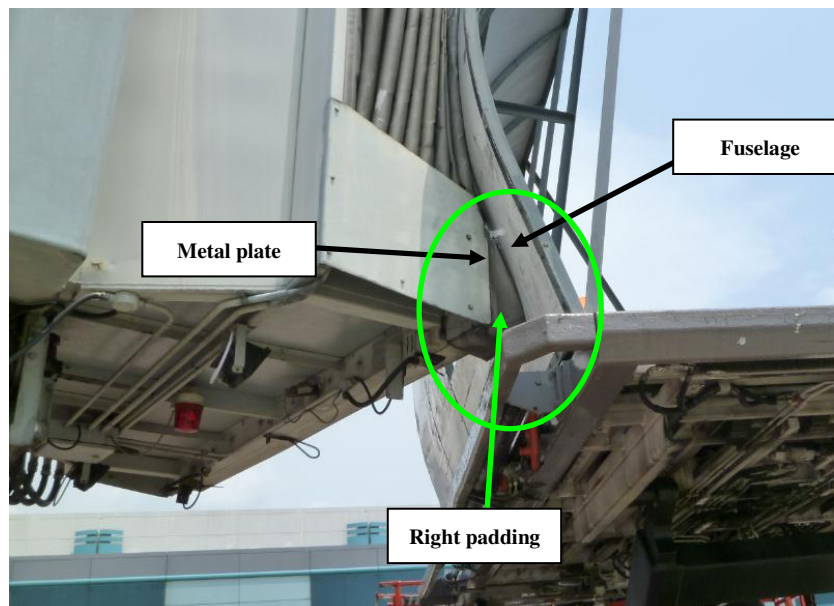
- 1.8.1.4 It was observed in the non-parallel docking scenario that the PLB cab's right padding was highly compressed against the fuselage, and the PLB's side metal plate came in contact with the fuselage (see **Figure 12**).

Figure 12: The PLB right padding and metal plate contacted the aircraft fuselage during non-parallel docking simulation

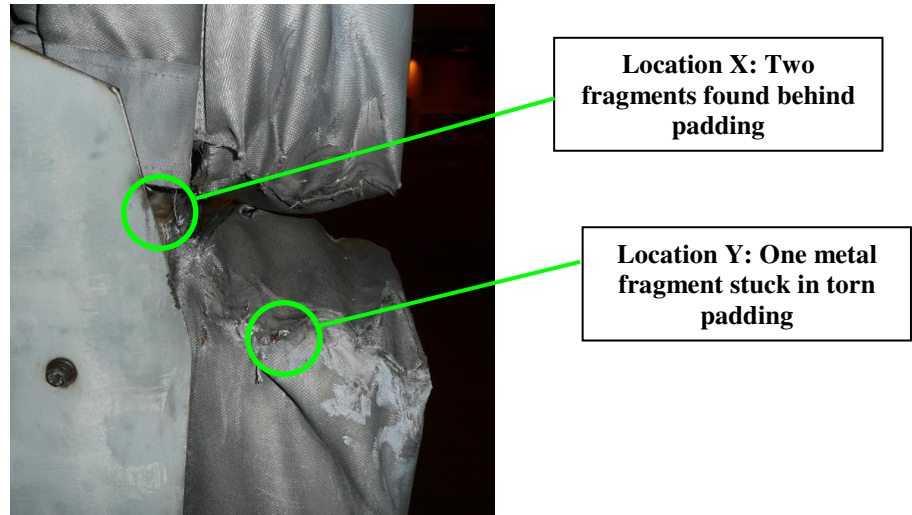
1.8.2.1 Several debris fragments were recovered from the damaged right padding on the PLB cab. The locations of the debris are shown in **Figure 13** below.

Figure 13: Metal fragments found on PLB cab padding

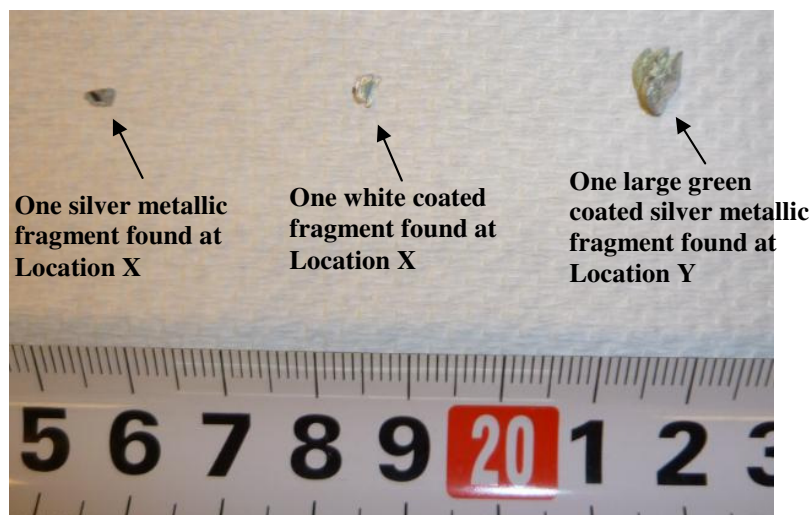
- (a) At Location X, one fragment had a silver metallic appearance and the other had a white coated surface.
- (b) At Location Y, the larger silver metallic fragment had a green coated surface (see **Figure 14**).

Figure 14: Close-up of metal fragments

- 1.8.2.5 It was found that:
- (a) the elemental composition of the two fragment samples from the silver metallic fragment from Location X and the green coated silver metallic fragment from Location Y was similar to that of the aircraft skin, which was 2024 aluminium alloy; and
  - (b) the fragment sample from the white coated metallic fragment from Location X did not match the aircraft skin<sup>3</sup>, but contained titanium and other elements like silicon, aluminium, iron and oxygen. The sample had an EDX spectrum similar to titanium dioxide,  $\text{TiO}_2$  which is commonly used as a white pigment in paint.

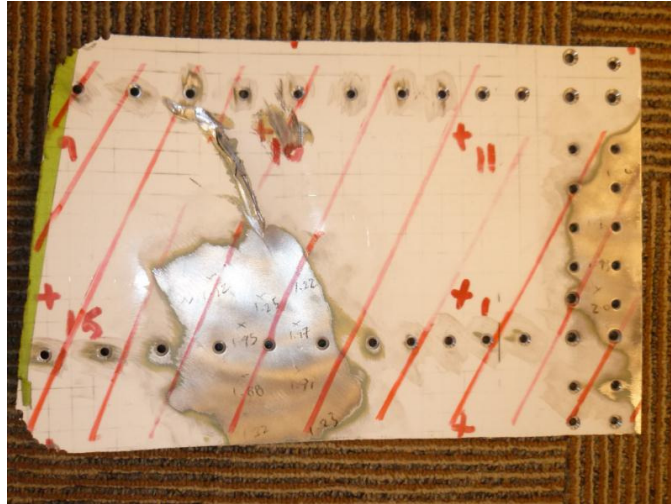
Figure 15: Cut out of the damaged aircraft skin

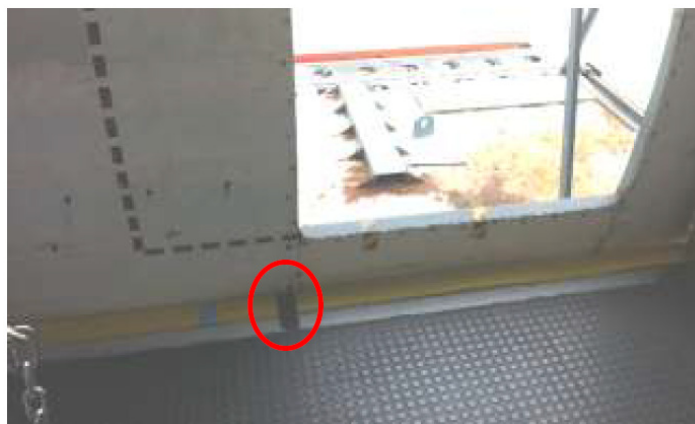
1.9.2.2 From inside the PLB cab, the PLB operator uses a black marking on the floor to gauge correct alignment with the front cabin door. For a satisfactory docking, the black marking is to be aligned with the left edge of the aircraft front cabin door (see **Figure 16**). The PLB operator told the investigation team that during the initial phase of the re-docking, the black marking was not aligned with the left edge of the cabin door but he subsequently readjusted the PLB cab and got the black marking to be 15 cm to the right of the cabin door edge. Although the black marking was not aligned, the PLB operator felt it was sufficiently safe to allow the opening of the door.

Figure 16: Position of black marking aligned with left edge of front cabin door during normal docking with the mock-up fuselage

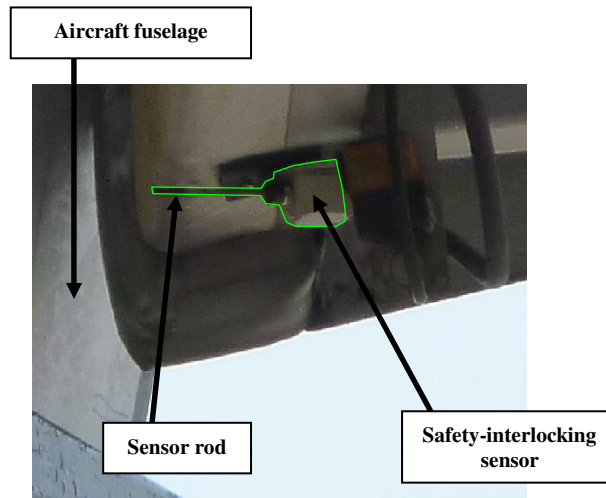
- 1.9.3.1 There are two safety-interlocking sensors under the PLB cab, one on the left and one on the right. They are installed to prevent the PLB from moving once the sensor rods have come into contact with an obstacle. The position of the two end sensors are shown in **Figure 17**.
- 1.9.3.2 It is noted that in the non-parallel docking scenario when the PLB cab's right padding had already contacted the aircraft fuselage, the end sensor closest to the fuselage (i.e. the one on the right) was not touching the fuselage and was therefore not activated as shown in **Figure 18**. Thus the PLB cab could still be manoeuvred further forward towards the aircraft fuselage.

Figure 18: Details of the safety-interlocking sensor and its relative position from the aircraft fuselage, the sensor did not activate even after the PLB cab's right padding had contacted the aircraft fuselage in a non-parallel docking

- 2.1 Evidence from the CCTV footage shows that the PLB made contact with the aircraft during the re-docking process. The contact is also evidenced from the debris fragments found on the PLB cab's damaged right padding.
- 2.2 The safety-interlocking sensors under the PLB cab were designed to work when the PLB is relatively parallel to the aircraft fuselage. In a PLB non-parallel position, the sensor rod would be much farther from the fuselage and would not have prevented the PLB cab from contacting the fuselage.
- 2.3 Thus, as the non-parallel PLB cab was approaching the aircraft fuselage, the effectiveness of the PLB's safety-interlocking sensors was compromised. The sensor on the right side was unable to detect the closing in of the PLB onto the aircraft fuselage.

- 4.2 The aerodrome operator is currently in the process of replacing all their older PLBs (similar to the incident PLB) with a newer model of PLB equipped with an auto-docking safety feature. This feature can guide the PLB cab to within 0.5 m from the aircraft and can reduce manual operational errors.
