FINAL REPORT

BOEING B777-200, REGISTRATION 9V-SRP CARGO CONTAINER INGESTION

19 DECEMBER 2013

AIB/AAI/CAS.100

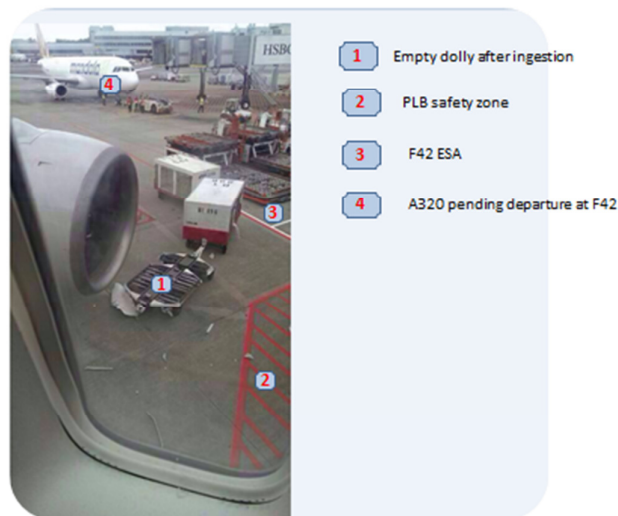
- 1.1.1 On 19 December 2013 at about 1645 hours, the Boeing B777 aircraft (registration 9V-SRP) ingested an empty cargo container (which was sitting on a dolly¹) into its left engine while docking at bay F37 at Changi Airport after arrival from Mumbai (see **Figure 1**). The engine sustained serious damage and had to be replaced. There was no injury to any person.

Figure 1: Empty dolly and surroundings after the incident

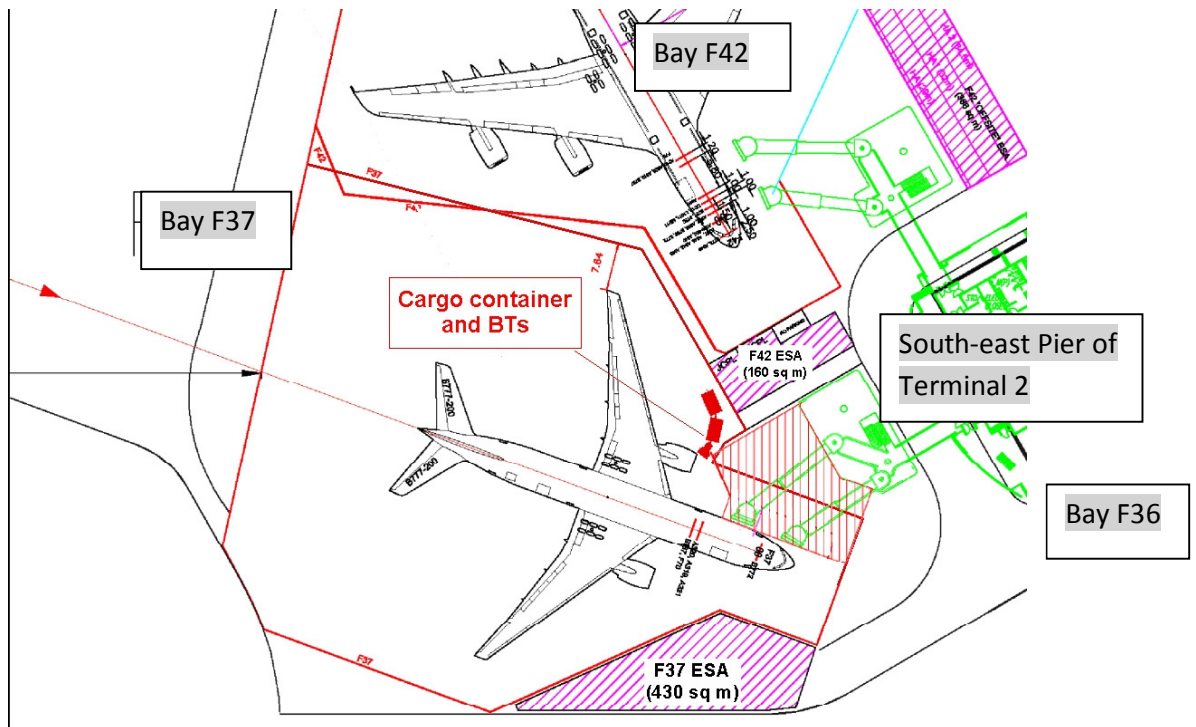
- 1.1.2 At the time of the occurrence, the cargo container and two baggage trailers (BTs) were left in the equipment restraint area (ERA)² of F37, just outside the red hatch lines of the passenger loading bridge (PLB) safety zone.
- 1.1.3 **Figure 2** shows a layout of F37. The bay's equipment staging area (ESA) is to the right of the docking aircraft. F37 is a bay at the far end of the Southeast Pier of Terminal 2 of the Changi Airport. The apron configuration is such that the ESA of the adjacent bay F42 is very close to the ERA of F37.

Figure 2: Layout of bay F37

- 3.3 The aerodrome operator has since limited the use of F37 to smaller aircraft, thus freeing up space to make for bigger ESAs for F37 and F42 as well as for better roadways for service vehicles in the area.
- 3.4 The aerodrome operator has engaged a consultant to undertake a review of the aircraft parking bay layout at Changi Airport. The review included the issue of adequacy of space for ground support equipment staging areas.

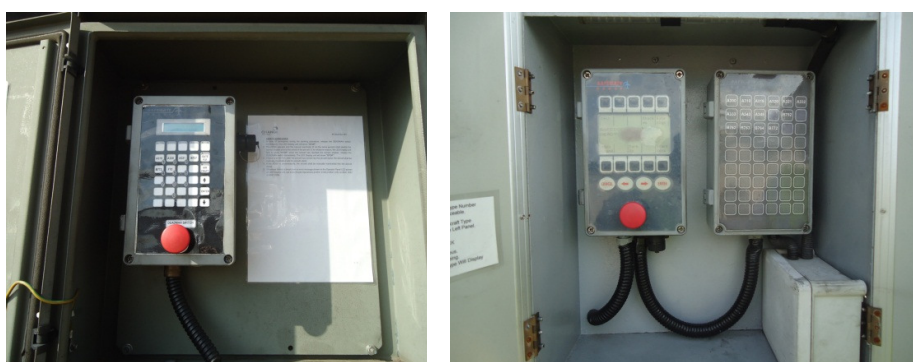
- 1.5.1 The operator panel of the ADGS installed at the airport is of either the 30-key or 54-key type (see **Figure 3**). That at F37 is of the 30-key type⁶.

Figure 3: 30-key (L) and 54-key (R) operator panel

- 1.5.2 The difference in the operating procedures between the 30-key and 54-key panel is:
 - (a) 30-key panel – One needs to press and hold the deadman switch and then key in the aircraft type to activate the ADGS for the pre-arrival check and for the aircraft arrival.
 - (b) 54-key panel – One needs to key in the aircraft type and then press and hold the deadman switch to activate the ADGS for the pre-arrival check and for the aircraft arrival. If the aircraft arrives within 30 minutes after the pre-arrival check, one need not key in the aircraft type again and just needs to press and hold the deadman switch to operate the ADGS.

2.5 The problem with the ADGS as perceived by PIC was due to LT's inexperience in operating the ADGS operator panel, i.e. failure to select the aircraft type, and not to any malfunction of the ADGS. LT might have mixed up the operational steps of the 30-key and 54-key operator panel of

- 3.5 The aerodrome operator has since replaced the remaining 30-key ADGS operator panel in all the three terminals of Changi Airport with the 54-key operator panel to standardise the ADGS operating procedure.

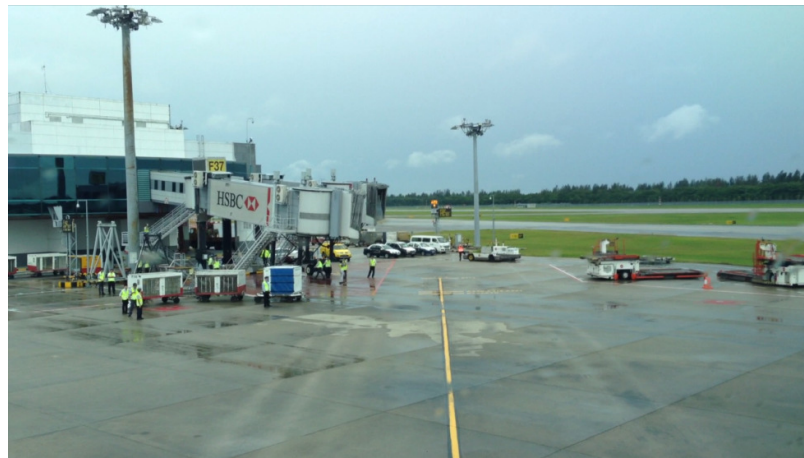
- (a) The investigators could have a reasonably good view of the equipment in the bay after turning into the bay.
- (b) It was not easy to judge whether the cargo container and the two BTs were in, or not in, the ERA (see **Figure 4**). However, one could infer, from the fact that the PLB safety zone could not be seen, that the cargo container and the BTs were in the ERA obscuring the PLB safety zone.
- (c) Likewise, one could infer, from the fact that the wheels of the aerobridge could not be seen, that the cargo container and the BTs were in the ERA.

Figure 4: View of the cargo container and the BTs in the simulated docking

- 4.2 It is recommended that the airline operator remind its flight crews that if the view of the hatch lines of the PLB safety zone or the wheels of the aerobridge was obscured, it could suggest an abnormal situation in the ERA. [AAIB Recommendation R-2015-006]
