INTERIM REPORT

Accident
on 24 July 2014
in the region of Gossi in Mali
to the MD-83 registered EC-LTV
operated by Swiftair S.A.

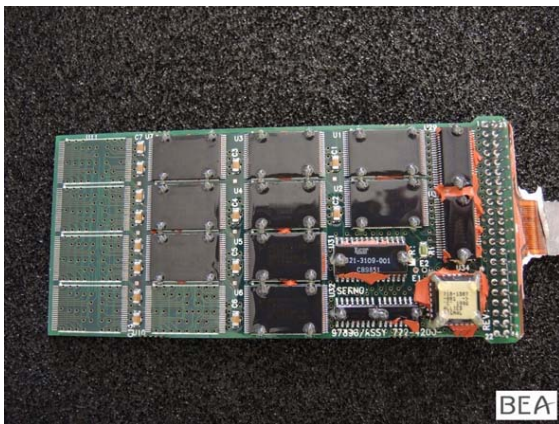
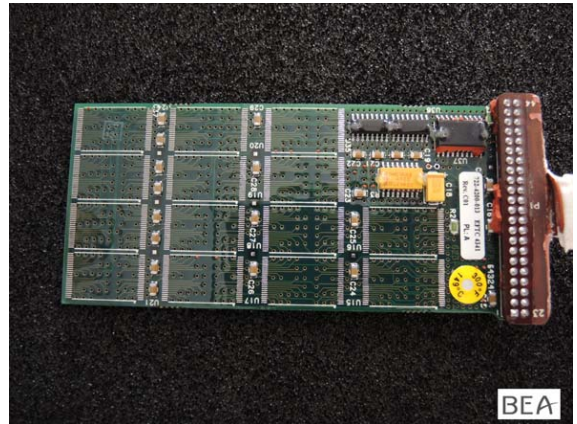
Electronic card without the protective layer

Visual examinations showed no apparent damage to the card. Entry impedance measurements on the electronic card were made. The values recorded were in accordance with Honeywell specifications.

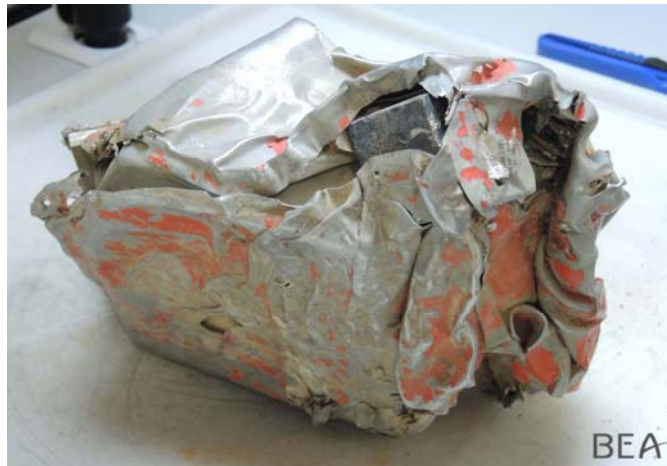
Initial state of the CVR

The CVR was significantly damaged. The recorder was compressed and deformed during the accident. However, it was not exposed to fire.

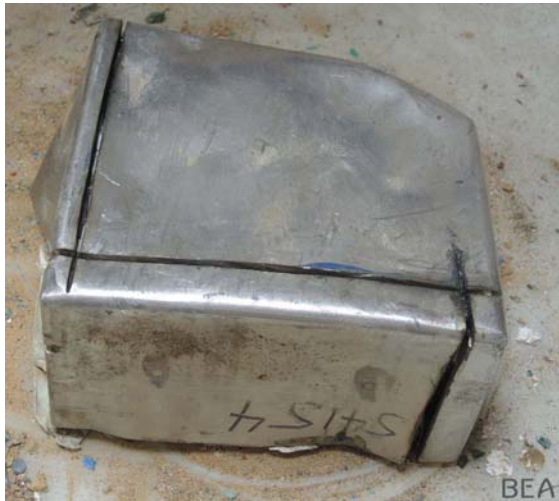
Protected Module after extraction

Visual examination of the protected module revealed that it was also damaged during the accident. In order to access the magnetic tape on which data are recorded, it was necessary to open the protected module using a grinder.

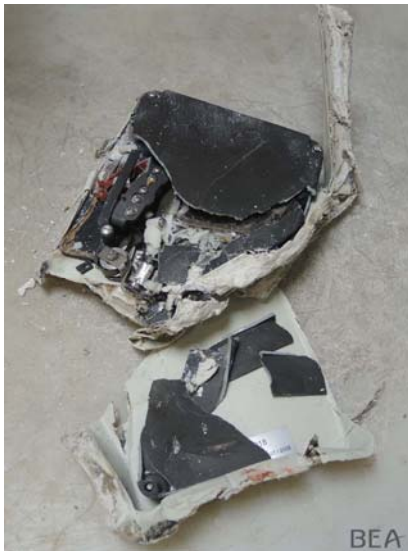
*Magnetic tape mechanism
after extraction*

After removing the heat shield, it was noted that the tape mechanism had been destroyed and the tape was damaged. It was broken in several places.

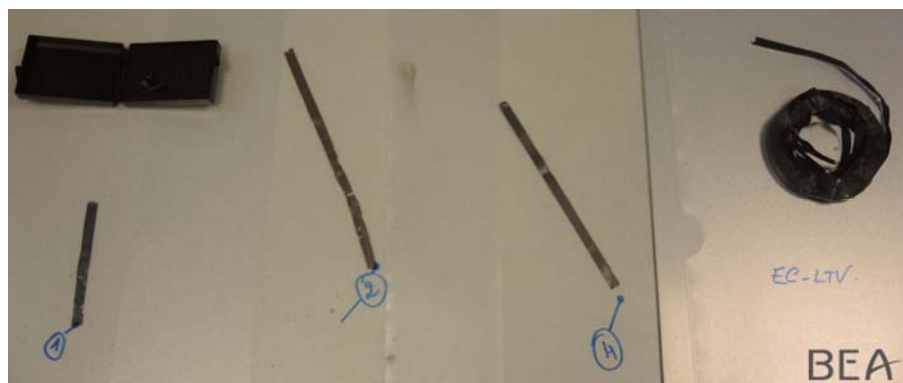
Pieces of magnetic tape recovered during opening operations

The various pieces of tape were identified and numbered. To read the tape in its entirety, repair operations were necessary.

These operations consisted in reinforcing the magnetic tape at the locations where damage was greatest.

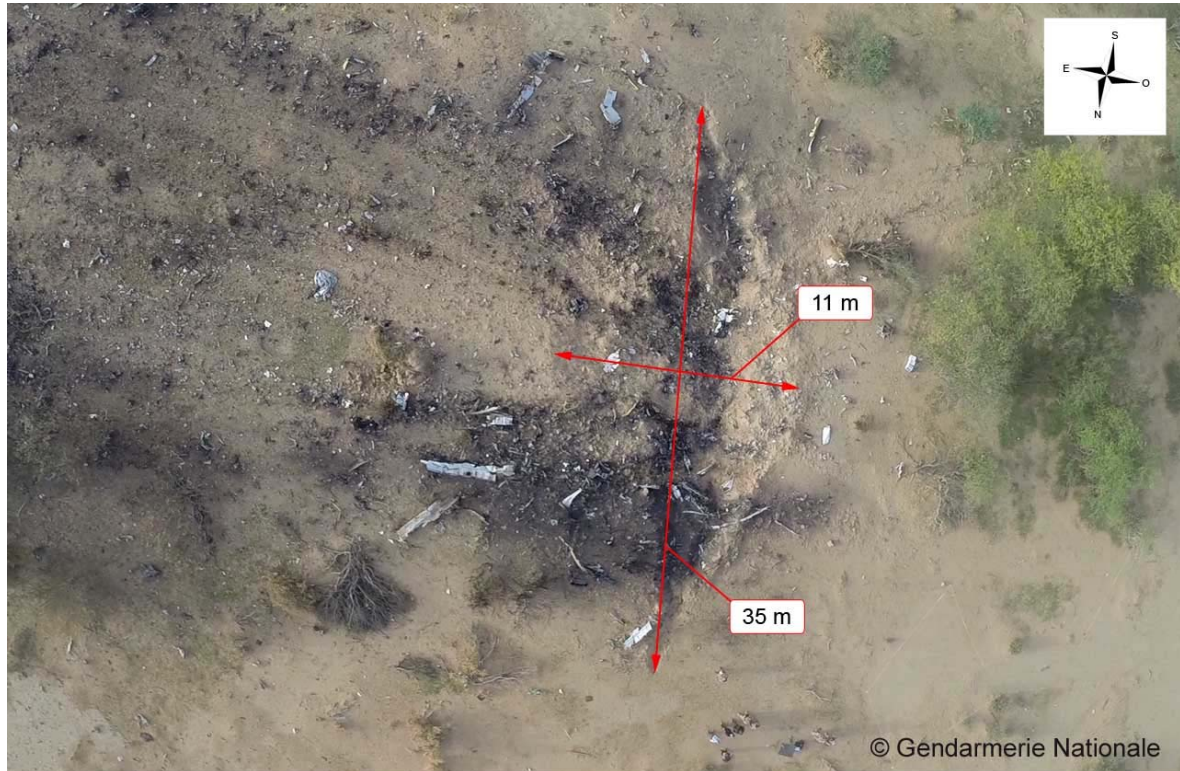
Top view of the crater

On aeroplane impact with the ground, a crater approximately 35 m long, 11 m wide and 1 m deep was formed¹³.

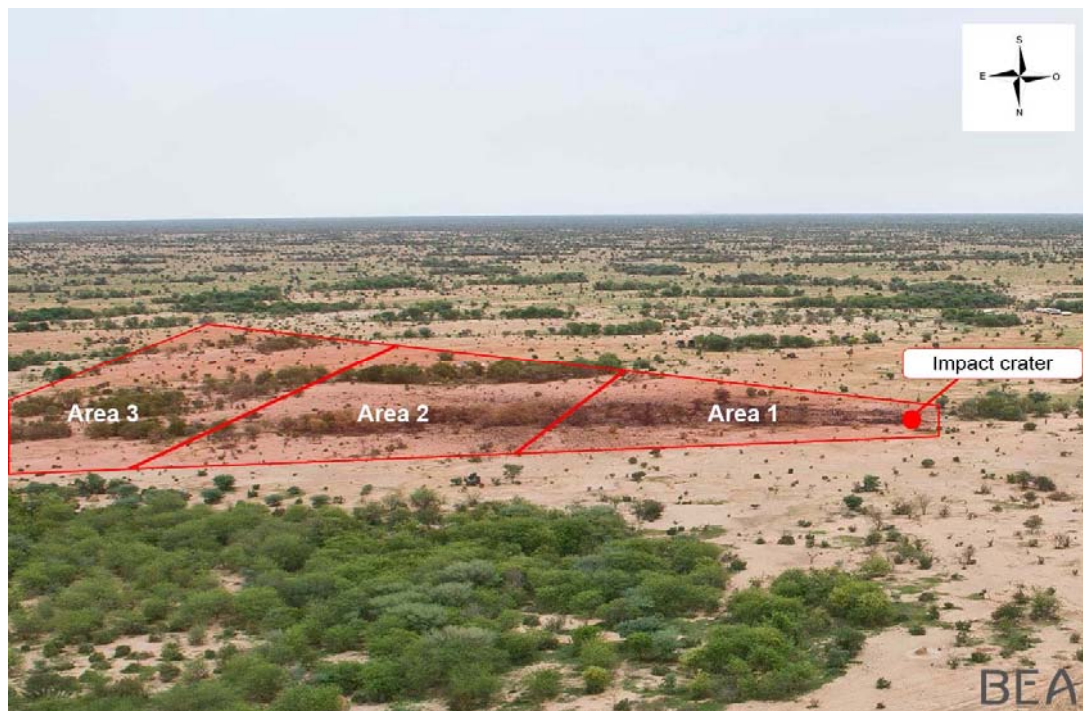
Aerial view of the debris field

The wreckage was spread over a triangular area with a length of 420 m, the summit of which was the point of impact, which spread out to a width of 340 m. The general distribution of the debris was along a mean axis oriented at 090°.

From the impact zone¹⁴ and moving eastward, three debris distribution areas were defined:

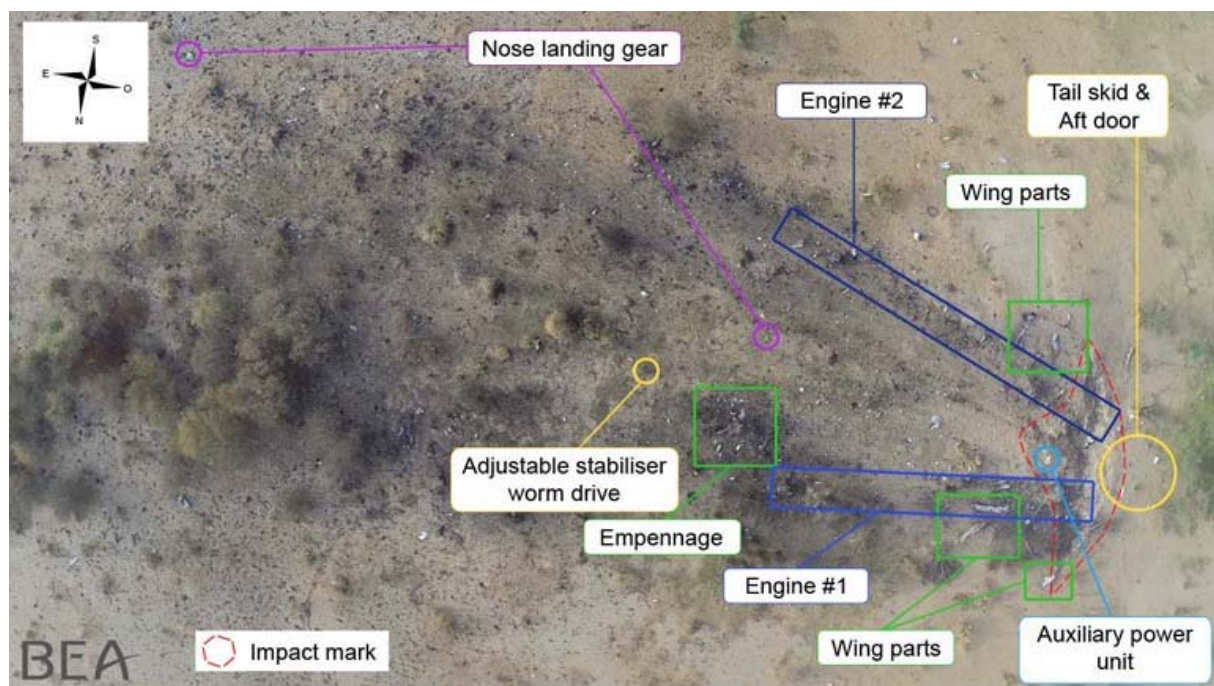
Distribution of debris in the first area

The debris found in the impact crater was mainly pieces from the wings, from the auxiliary power unit, as well as from the nacelles and engine accessories.

The upper parts of the nose gear were found 50 m away and its lower part, 125 m from the impact crater.

The fin was about 50 m away and the trimmable horizontal stabilizer (THS) jackscrew was about 65 m away.

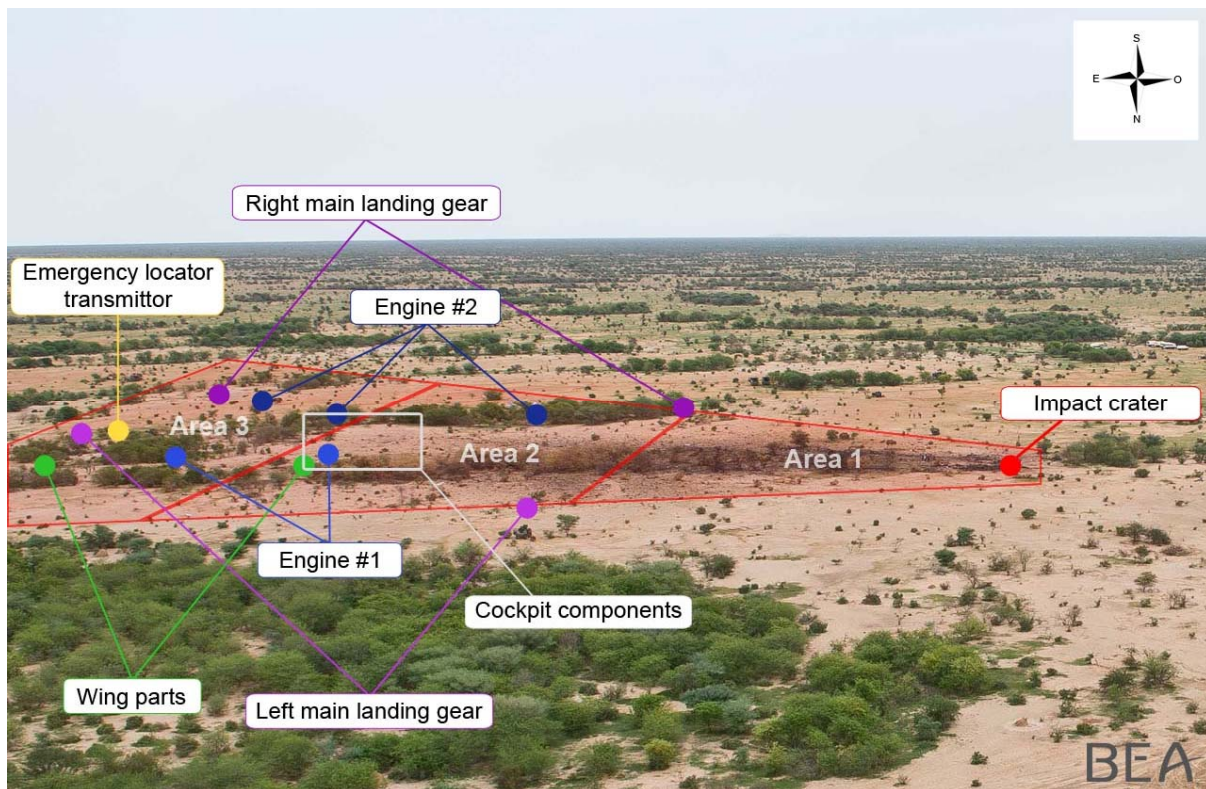
Distribution of wreckage in areas 2 and 3

The upper parts of the main landing gear were found 120 m from the impact crater for the left gear and 205 m away for the right gear.

This area, between 170 m and 190 m from the impact crater contained parts of the instrument panel (altimeter, speed indicators, circuit breaker panel) and a piece of windshield.

Parts from engine n°1 were found 160 m and 230 m away. Parts from engine n°2 were found 185 m, 260 and 300 m away. Two pieces of the wing were found 140 m and 240 m away. The final parts belonged to the lower parts of the main landing gear; the left main landing gear was 295 m and the right 375 m away.
