Civil Aviation Administration  
of China

Report No.: 20100914YFZQ

CSC A319/B-6054 Stall During Approach

## Investigation Report of Serious Flight Incident

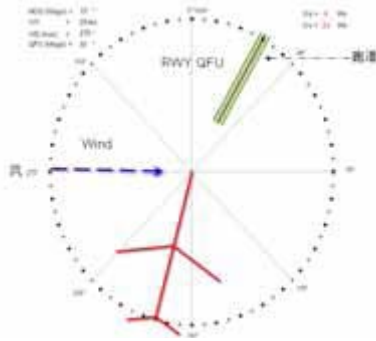
The horizontal wind speed at 09:29:20: 25kt

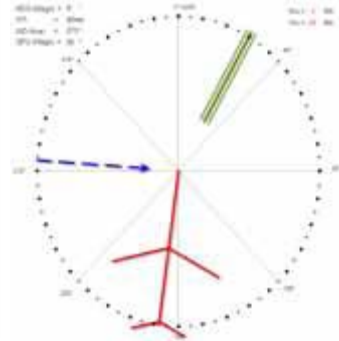
The horizontal wind speed at 09:29:46: 40kt

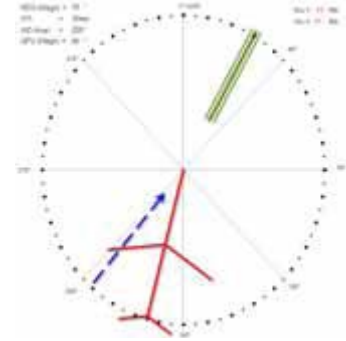
The horizontal wind speed at 09:29:51: 35kt

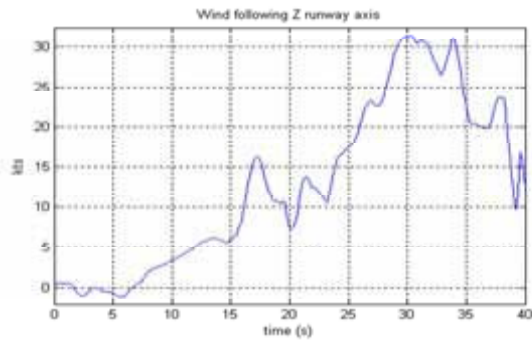
Vertical Downward Wind Speed Chart  
From 09:29:21 to 09:29:51, the downward air flow gradually increased to 30kt (the shadow part in the chart cannot reflect the actual situation due to high AoA of aircraft.)

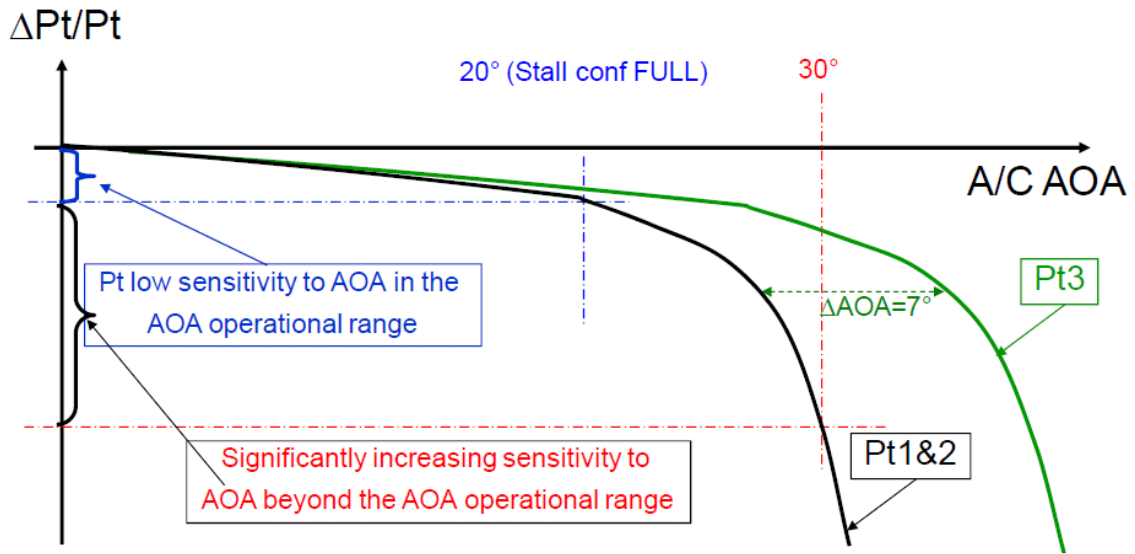
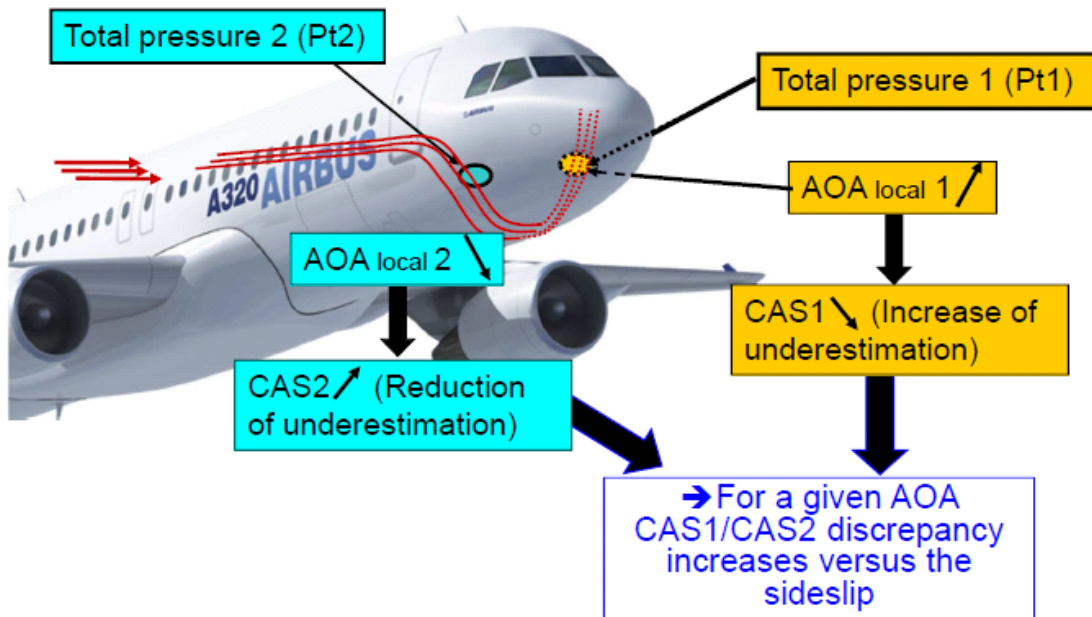
CAS is derived from full pressure and static pressure. If the AoA exceeds its sensor's effective working range, the full pressure accuracy will decrease as the AoA increases, making CAS significantly below its actual level as the AoA increases, which causes huge deviation. At the same time, sideslip can also significantly impact the CAS. (Refer to the following chart)

Besides, for the given AOA, the deviation between CAS No.1 and 2 is related to sideslip. At the time of the incident (09:29:56), sideslip also occurred. This further explains why the deviation between CAS No.1 and No.2 was over 10kt, which caused FAC's failure to apply all the three ADR data.

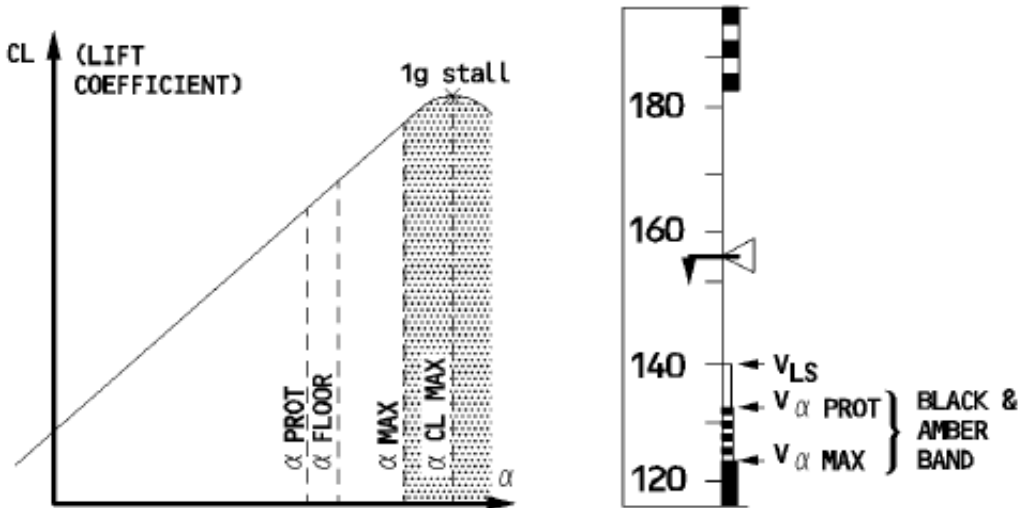
Illustration for the relationship between protected AoAs

alpha MAX (refer to the following chart), AoA will be directly controlled by side stick. Even if the pilot pulls the side stick to the very back, AoA will not exceed the alpha MAX. This function to protect from stall and windshear enjoys higher priority over other protections.

When AoA is bigger than alpha prot plus 1 (alpha prot + 1 =13 degrees), Auto Pilot will disconnect. This applies with design requirement.
