*Serious incident on
23 November 1997
on approach to Orly (94)
to the McDonnell Douglas MD83
registered F-GRMC
operated by AOM Minerve S.A*

REPORT
Translation
f-mc971123a

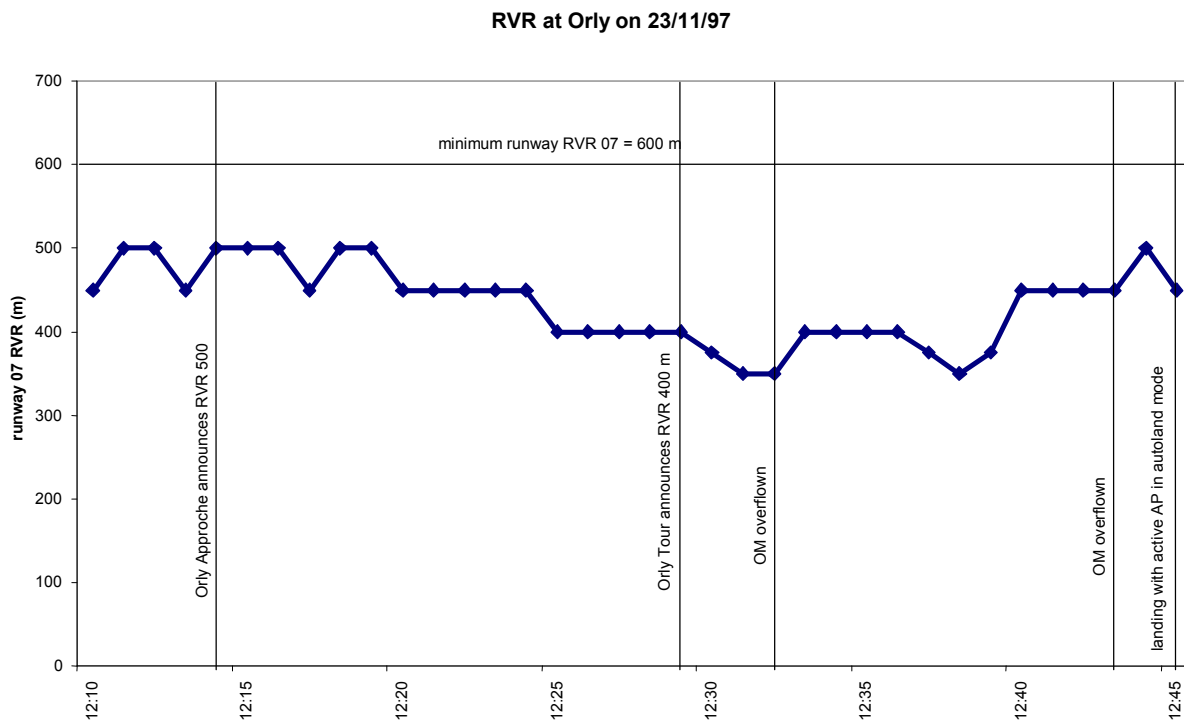
Figure 3

The runway 07 RVR figures are shown in the chart below. The crew's operational minima, overflight time at the Outer Marker and landing time and the times when ATC communicated the RVR figures are also shown.

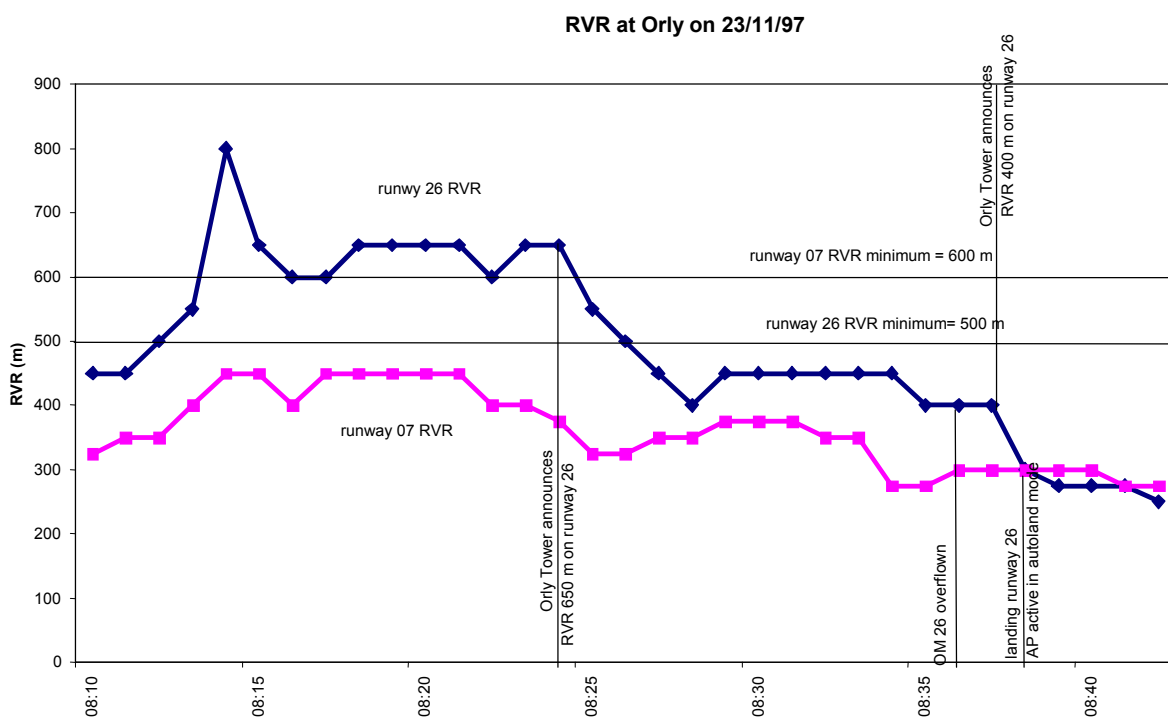
Figure 4

The RVR's recorded at Orly at the time of the morning Toulon-Orly flight are shown in the following chart. The crew's operational minima are also shown.

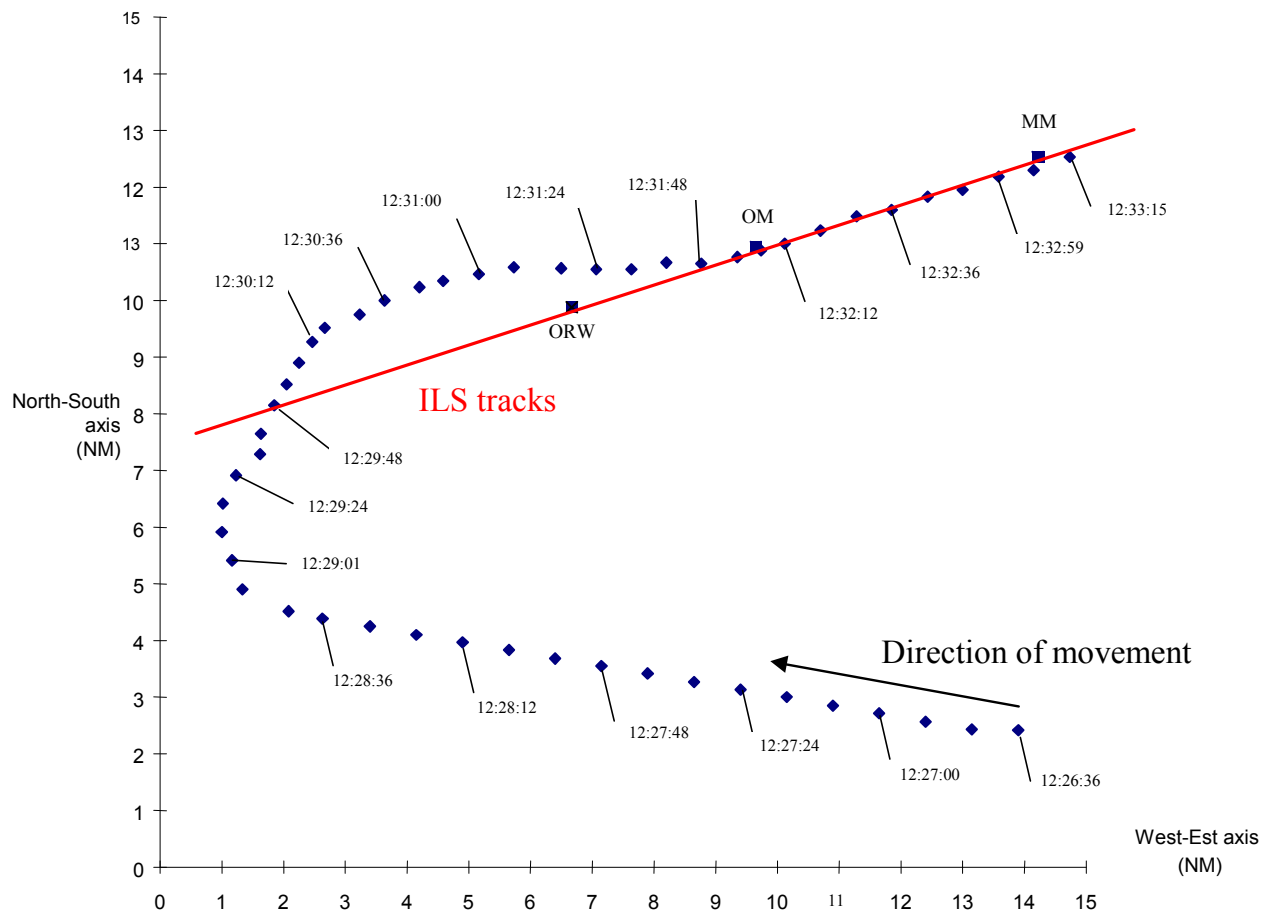
Figure 5

- the airplane's ground track,

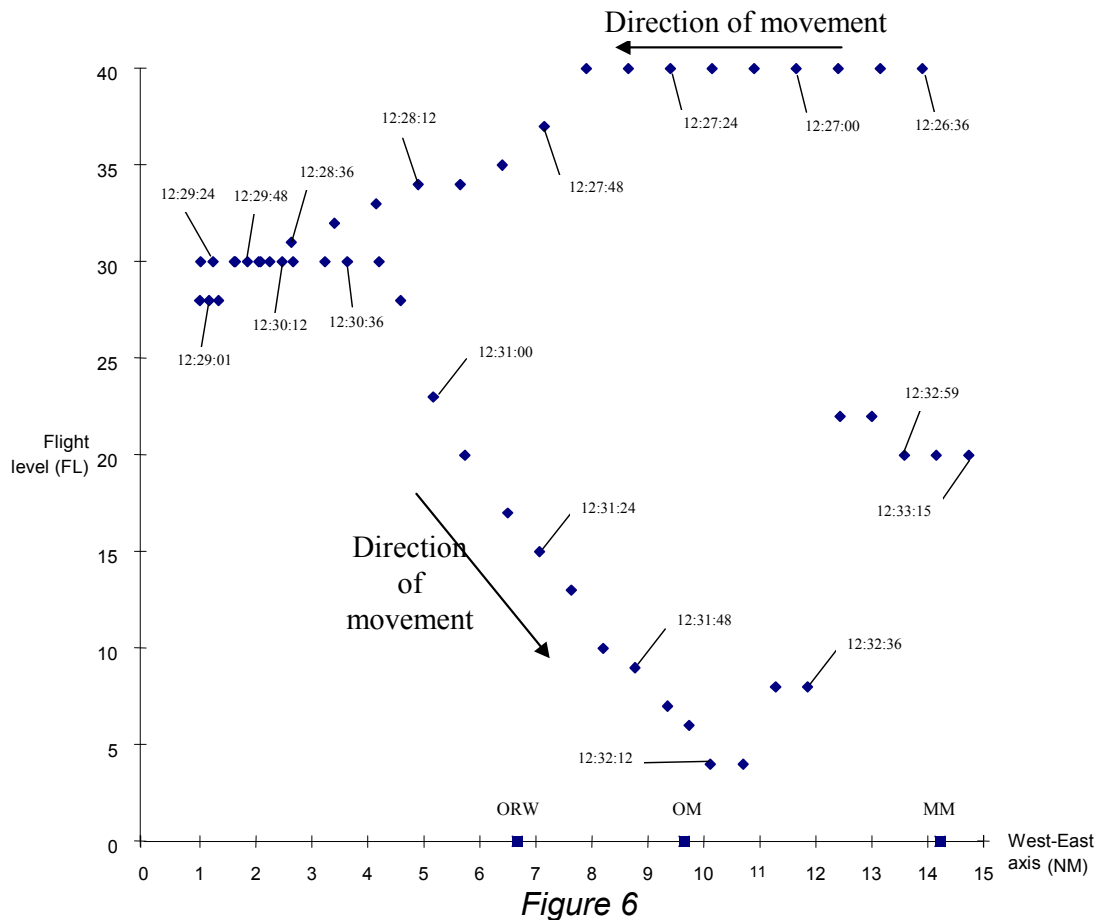
- and the airplane's vertical track thanks to the alticoder on board:

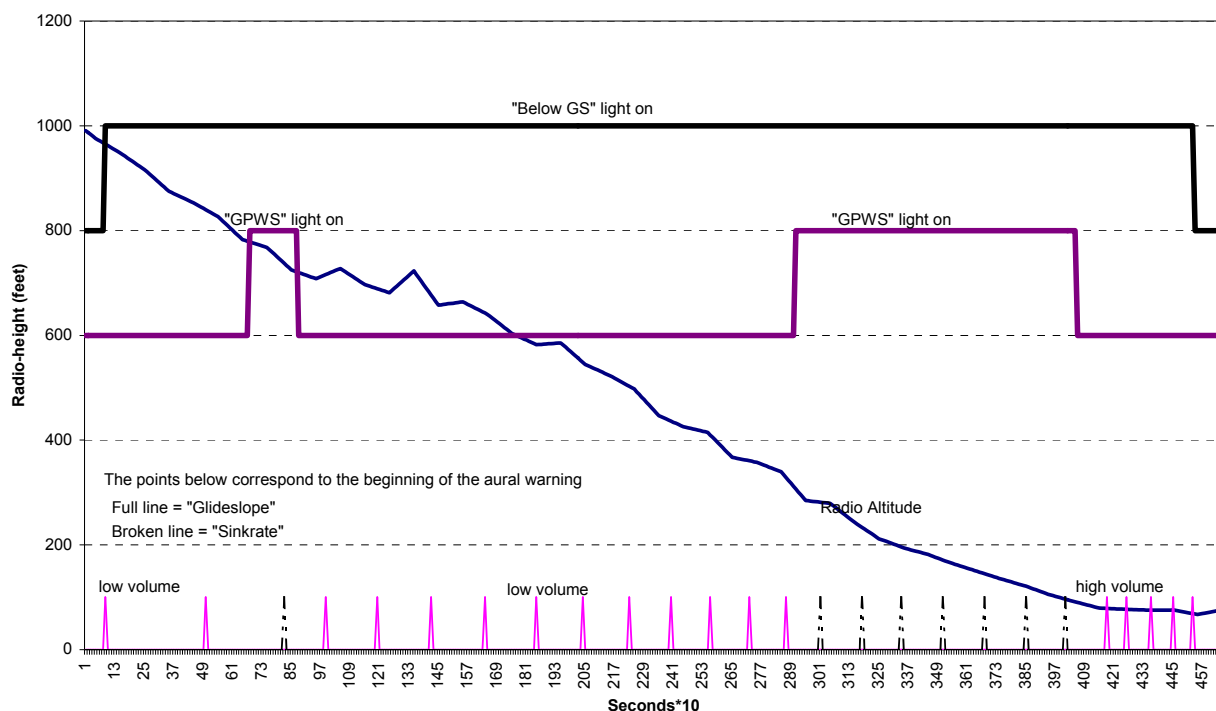
Figure 9

In May 1998 Allied Signal, at the request of the BEA, carried out a simulation of GPWS MK VII warnings using data from the flight. The results of this simulation were as follows:

The warnings which appeared are of the "Low Volume Glideslope", "Sinkrate", and "High Volume Glideslope" type. The times when the "Glideslope" and "Warning" lights came on during the simulation correspond to the respective times when the "Glideslope" and "Terrain" warnings were recorded on the QAR.

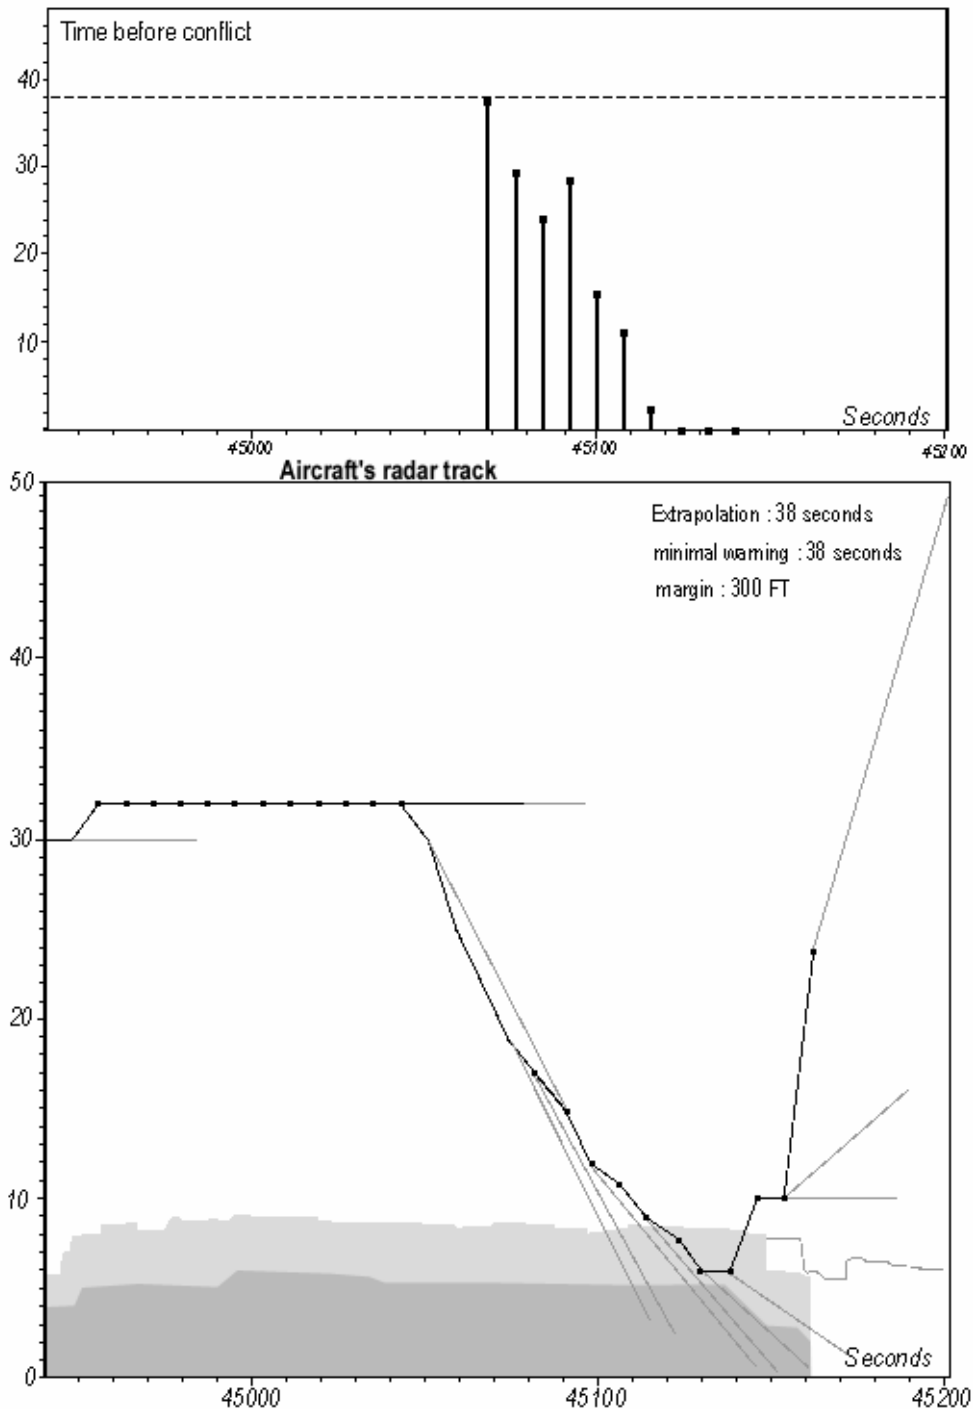
Figure 10

radar data, warns the controller in case the airplane's proximity to the ground is judged too dangerous. At the request of the BEA, the CENA (Centre d'Etude de la Navigation Aérienne) performed a simulation of the MSAW functions based on the Rheims radar recording. Parameters identical to those used at Lyon Satolas were used since this system is not installed at Orly. The vertical speed had to be estimated, since it was not available on the radar recordings.

In the simulation report, the CENA concluded: "*Supposing a correct Vz STR (accurate estimate of the vertical speed) the MSAW warning could have been transmitted to the controller at 12 h 31 min 24 s. Allowing time for the controller's*

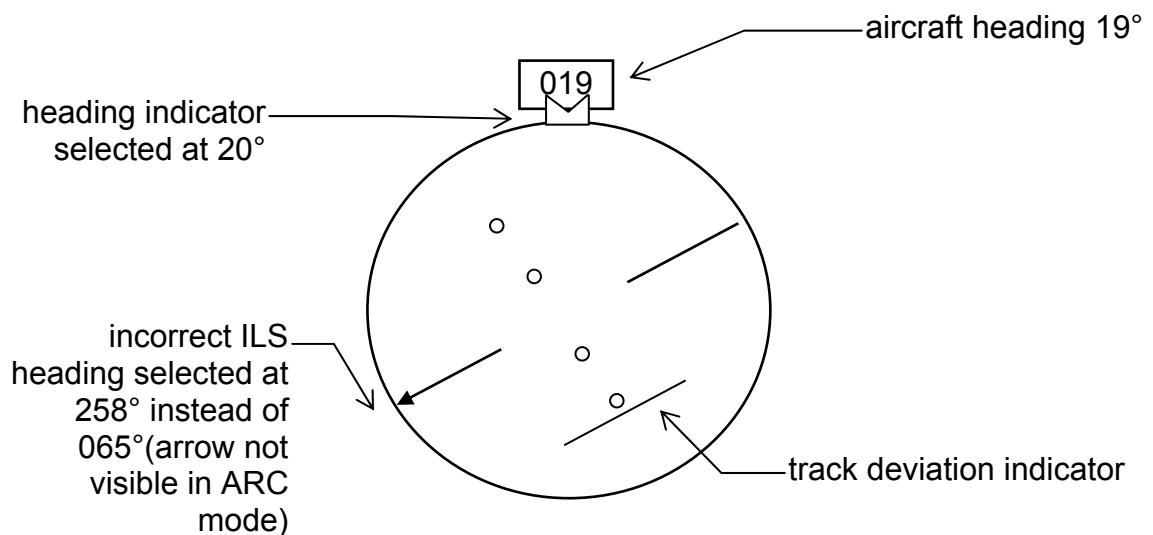
At 12 h 29 min 36s, intercepting the runway 07 ILS, the runway line-up deviation indicator began to move. A simplified representation of the Captain's HSI would show (the HSI is shown throughout in "ROSE" mode for more legibility):

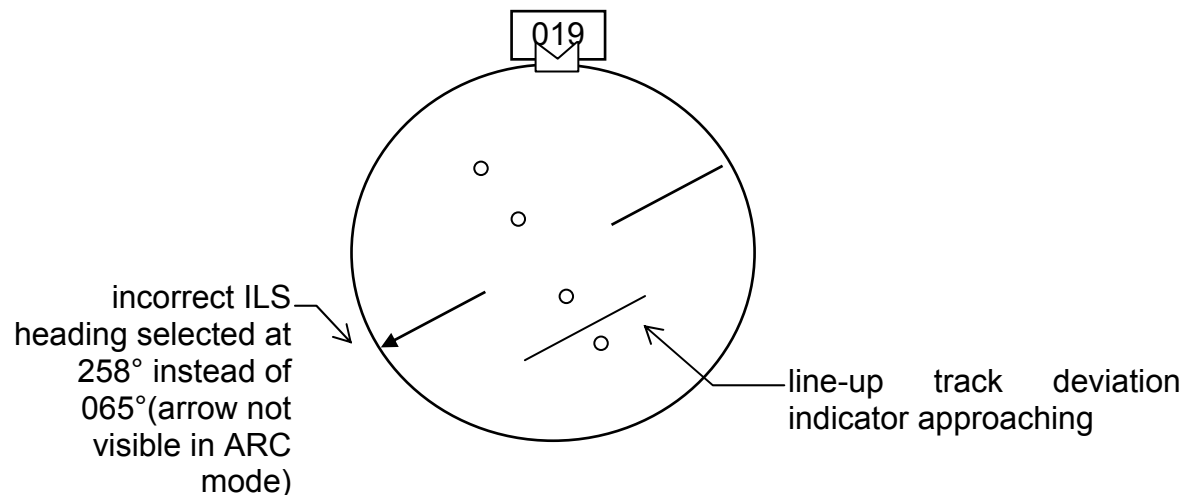
At 12 h 29 min 43 s, the LOC capture mode was displayed on the FMA. At that moment, a simplified representation of the Captain's HSI would show:

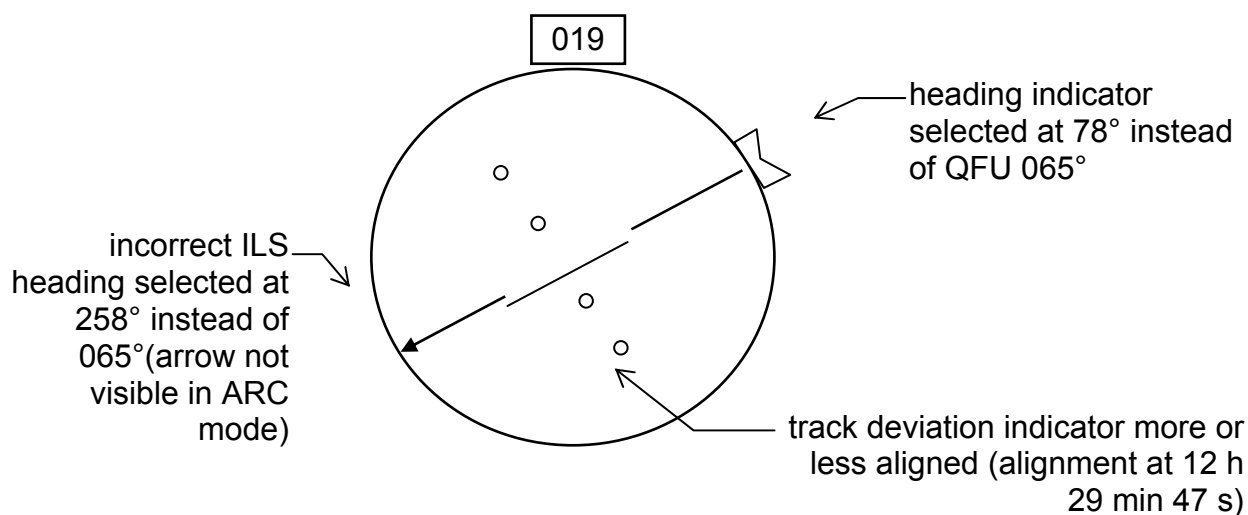
The Captain believed he was bringing the heading indicator up in line with the head of the ILS indicator arrow, but in fact he was he was bringing it to the tail of the ILS. He then noticed that the heading indicated 78° whereas he expected the QFU of runway 07. He tried to understand the difference between the expected heading and the displayed heading, which increased his workload. From this moment on, he was working alone. The co-pilot, who was no longer informed of the situation, could no longer understand the Captain's actions. A simplified representation of the Captain's HSI would show:

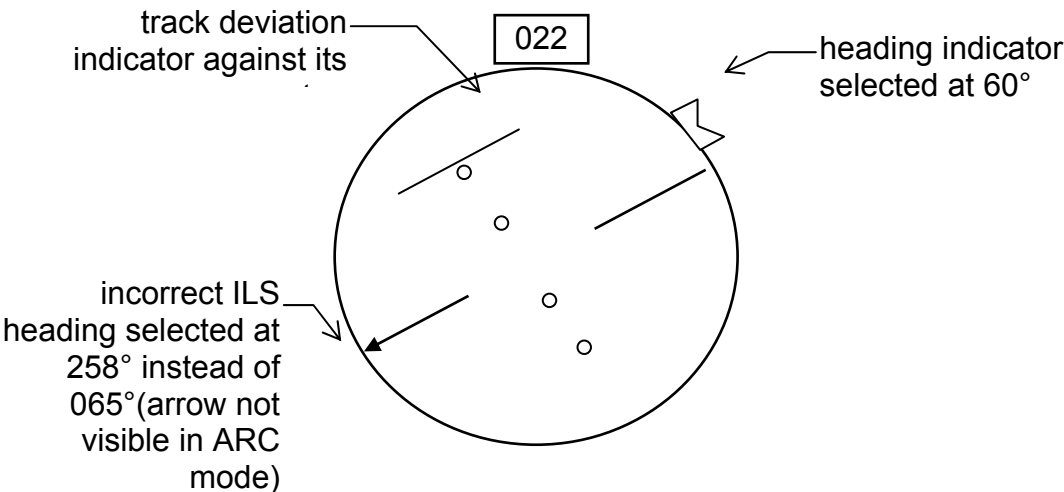
At 12 h 29 min 57 s, the track deviation indicator reached its stop. Two seconds later, the Captain selected a heading of 60° on the DFGS, probably to return

towards the localizer track which he believed to be to the left, with a heading close to the approach track. In fact, he still had not realized that the tip of the ILS heading selection arrow was pointing more or less 180° away from the ILS heading. In this configuration, the localizer track was displayed on the left on the HSI. This selection caused disarming of the "Autoland" mode, and replaced the "LOC CAPTURE" mode with "HEADING" mode. Note that if the Captain had not selected any heading, the airplane would have continued on a constant bearing without ever intercepting the localizer track. A simplified representation of the Captain's HSI would show:

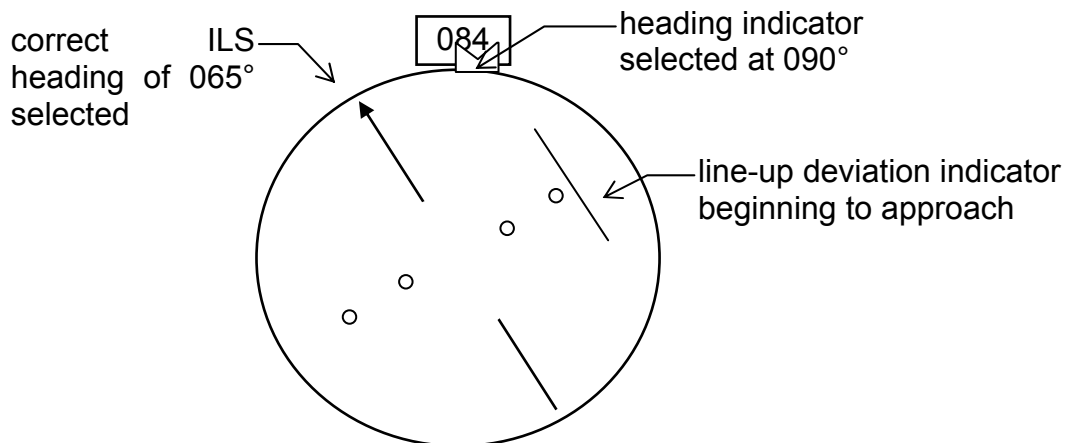
At 12 h 31 min 30 s, the airplane descended through 1,250 feet QNH and the altitude alarm triggered again and was superimposed on the GPWS alarm. It was not cancelled by the crew, and continued to sound until the airplane reached 1 250 feet QNH in climb after the go around. At 12 h 31 min 30 s, the "LOC capture" mode was displayed on the FMA and the localizer beacon indicator, until then at its stop to the right, began to move. The flight director, which was centred until that time, then indicated to the pilot the trajectory to follow to rejoin the localizer track. The Captain turned the airplane left to intercept the approach track:
