AAIS Case Reference: 13/2010

# **AIR ACCIDENT INVESTIGATION REPORT**

**Uncontained Cargo Fire Leading to Loss of Control  
Inflight and Uncontrolled Descent Into Terrain**

Boeing 747-44AF  
N571UP  
Dubai  
United Arab Emirates  
03 September 2010

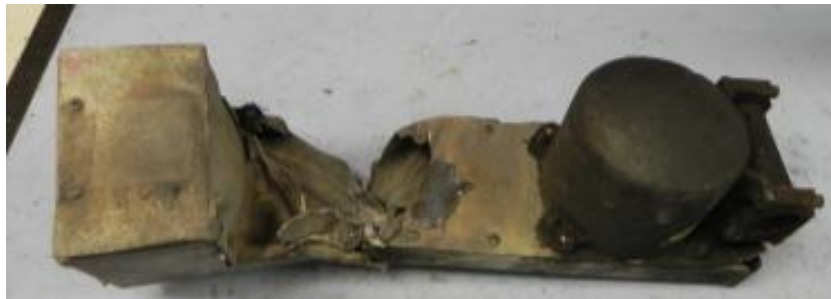
The recorder had extensive heat and impact damage

Picture 3 Damaged Flight Data Recorder in the Recovered condition

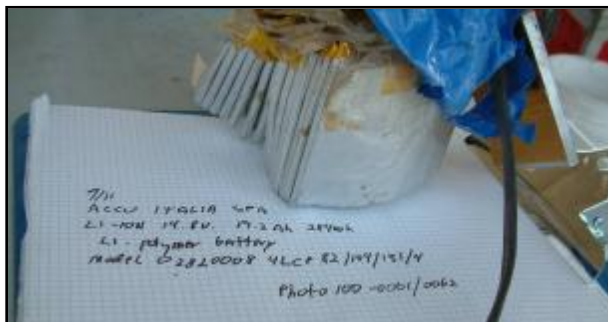
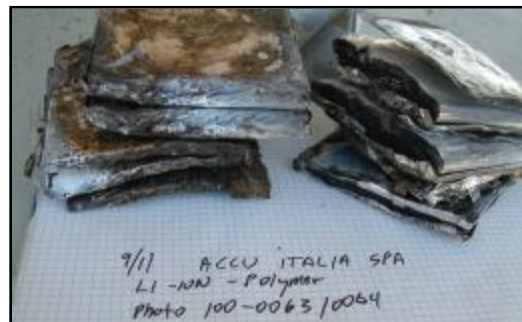
Lithium-ion polymer type battery pack [LH]/ Lithium-ion polymer type battery pack with thermal damage [RH]

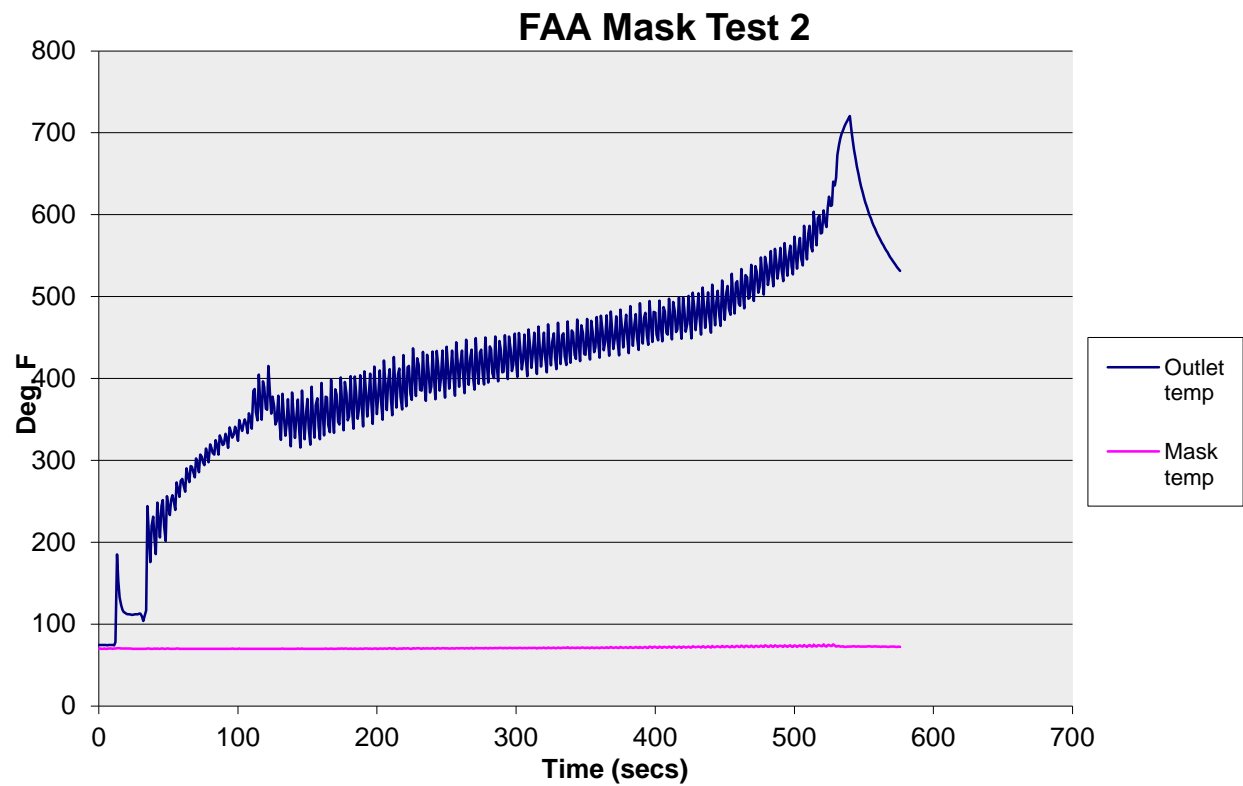
Mask Test #2 Flex Hose 60B50059 hose failure
