## **AIRBUS A320, REGISTRATION 9M-AHA FOREIGN OBJECT INGESTION INCIDENT AT SINGAPORE CHANGI AIRPORT ON 28 FEBRUARY 2010**

**AIB/AAI/CAS.063**

**Air Accident Investigation Bureau of Singapore  
Ministry of Transport  
Singapore**

**7 December 2010**

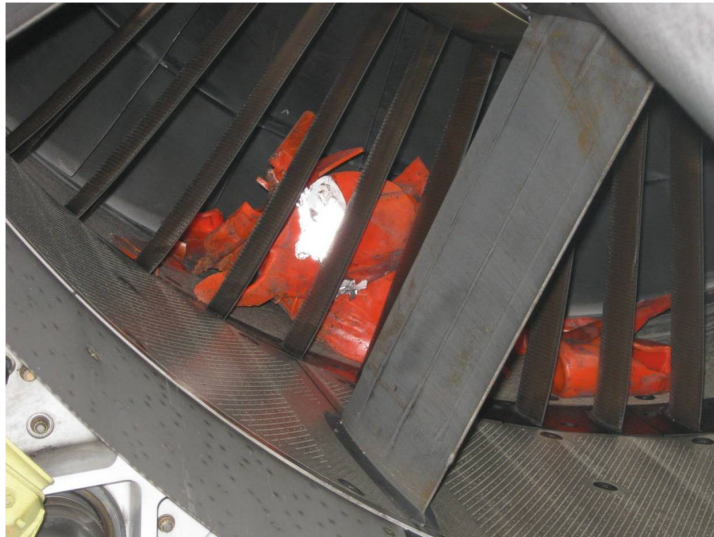
1.1.4 Both the EOs approached the aircraft to perform their allocated tasks. Upon seeing the ADGS “stop’ display, EO 2 moved towards the No. 2 engine. He was carrying one cone in each hand, with the intention of placing the cones to mark the hazard zone around the engine. After placing one cone in front of the No. 2 engine, the second cone was sucked out of his hand and was ingested into the engine. The ingestion of the cone resulted in a loud “POP” sound. The ingested safety cone was shredded by the engine blades. (see **Figure 1**)

Figure 1: Cone ingested into the No. 2 engine

1.3.1 The No. 2 engine was inspected and tested. No damage or anomaly was found.

- 3.1 The GHA conducted refresher training on airside safety for all the handling staff immediately after the incident, paying particular attention to aircraft arrival procedures and safe practices when working around aircraft. Since June 2010, the GHA had instituted recurrent training for their staff. All staff who work at the ramp are required to attend recurrent training once every two years.
- 3.2 The GHA shared the safety lessons arising from this incident with its ground handling staff.
