Aircraft Serious Incident Investigation Report

**PT. Garuda Indonesia
PK – GGQ
Boeing Company 737-300
Soekarno – Hatta Airport, Jakarta
Republic of Indonesia**

30 October 2009

FAILURE ANALYSIS REPORT ON THE DETACHMENT OF NUMBER 2 WHEEL FROM THE AXLE OF GARUDA INDONESIA BOEING 737-300 AIRCRAFT PK-GGQ AT SOEKARNO – HATTA AIRPORT ON 30 OCTOBER 2009

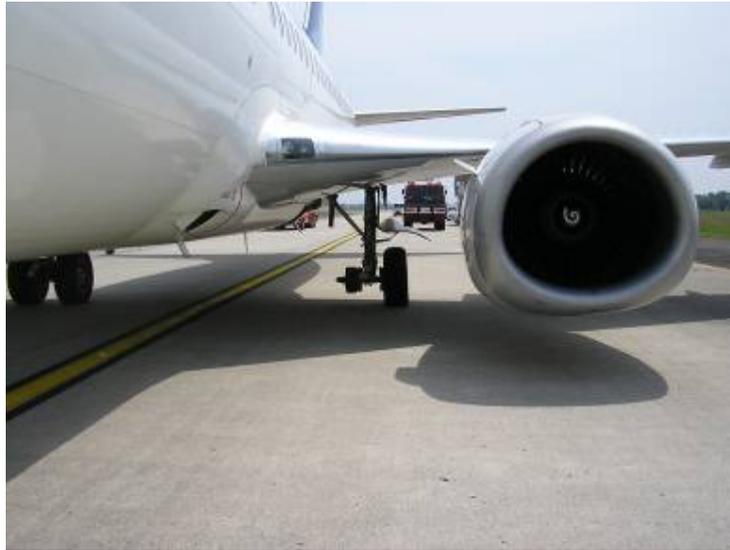
Figure 1: View after landing showing the number-two axle without wheel

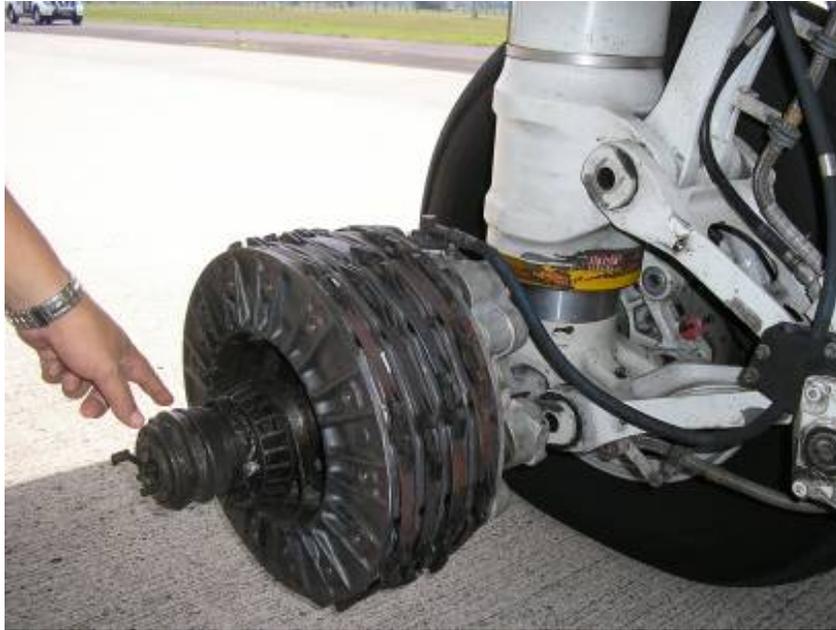
The number-two main wheel separated from the axle. The axle was damaged and required replacement. However, the aircraft was not damaged.

Figure 2: The number-two main wheel separated from its axle

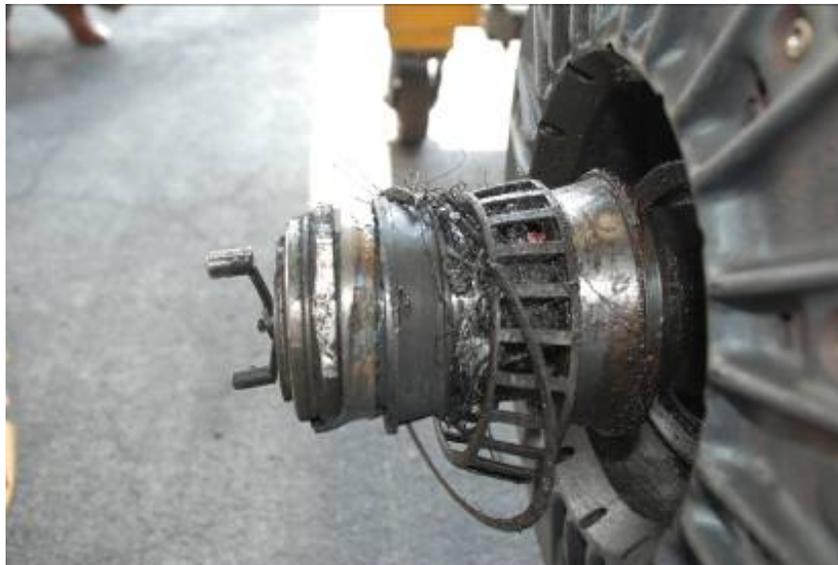
Figure 3: Damaged inner and outer wheel bearing race on number-two axle

The investigation determined that the detachment of the number-two main wheel from its axle was due to the catastrophic failure of the wheel bearings. It is likely that the bearing failures resulted from an under-torque condition during the re-installation of the number-two main wheel, following the replacement of the brake unit. The investigation determined that it was likely that the wheel was not correctly positioned on the axle when the wheel nut was being tightened. The manufacturer's specified torque value was reported to have been applied. However, if the wheel was not correctly positioned on the axle, once the aircraft was lowered back onto the ground and with the aircraft weight on wheels, the wheel may have moved on the axle. The torque value of the wheel nut may then have been inaccurate, and therefore less than manufacturers specifications. The torque value applied at fitment may therefore have been false.

In this case, it is likely that the under-torque condition, and resultant catastrophic bearing failure, ultimately caused the wheel hub to separate from its axle.

The National Transportation Safety Committee recommends that PT. GMF AeroAsia should review its maintenance procedures and practices to ensure that appropriate guidance documentation, training, and supervision is provided, to ensure that correct practices are followed, and an appropriate maintenance environment is available at all times.

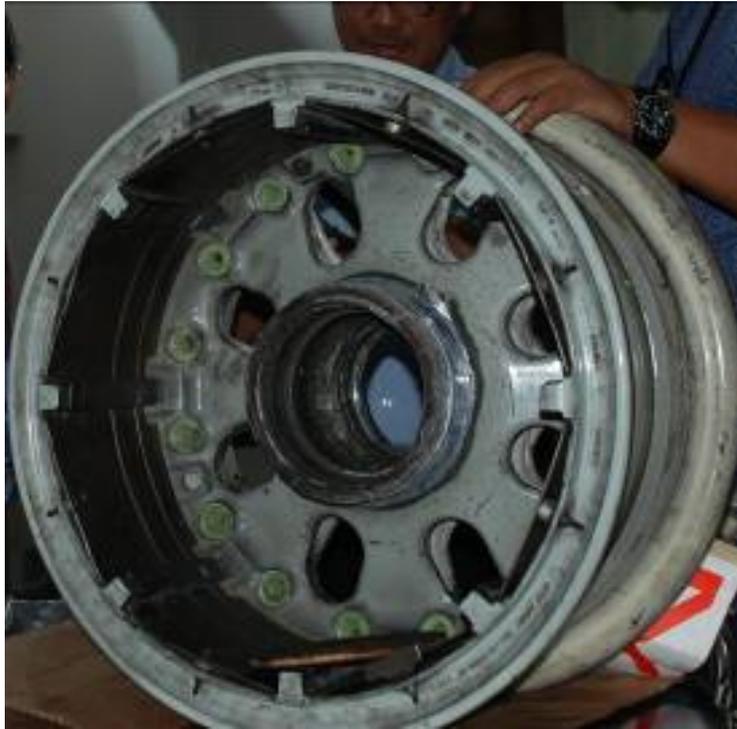
Figure 4: Number-two main wheel hub assembly after removal of the tire.

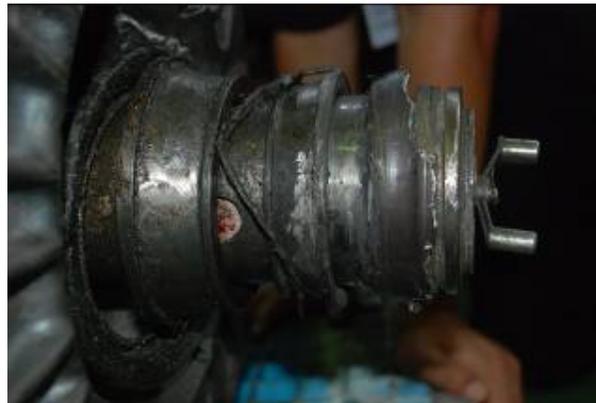
The axle nut was still on its original position with its locking mechanism. The failed bearings were dismantled from the axle on 4 November 2009 (Figure 1). The outer raceways which were still attached on its place in the wheel-hub were then removed by pressing them out of the wheel hub. There was no bearing roller found in the axle and wheel hub assembly.

Figure 1: Bearing failures on the axle.

Note the axle nut and the severely deformed spacer.

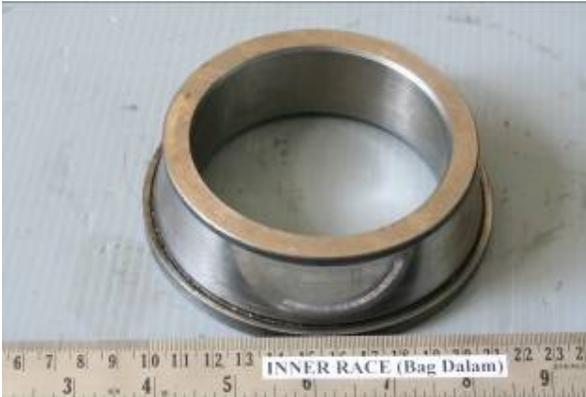
Visual observation on the inner race of the inboard bearing (Figure 2) showed indentation marks of the rollers at about equal distance on the shiny surface of the raceway (Figure 3).

Figure 2: Shiny surface of the inner raceway of the inboard bearing

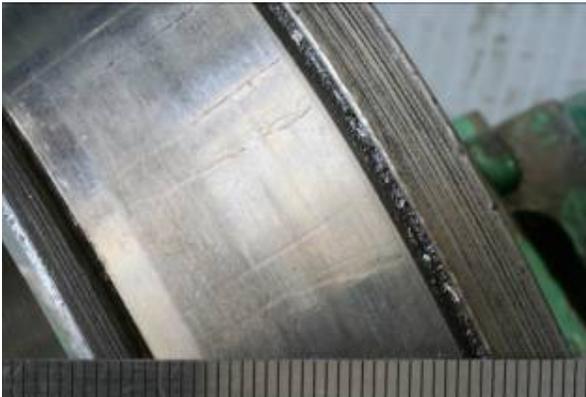
Figure 3: Roller impressions on the shiny surface of the inner raceway were indications of true Brinelling as a result of under torque.

Each of indentation markings showed two lines; one line was parallel to the axis of the axle, and another line was at angle to the axis.

- 4.1. The marking lines on the shiny surface of the inner race are indentations of the rollers. It is a characteristic of true Brinelling which is associated with improper mounting of the bearing⁸, in this case due to an under-torque situation. This situation might lead to a misalignment of the rollers relative to the raceway causing the contact surface to be smaller. The roller markings were also due to hammering during static loading. In case of such an under torque, excessive loads were exerted between the rollers and the raceway. It caused an abnormal operation of the bearing, and led to destruction of the bearings.

It can be concluded that the cause of the bearing failures was due to improper mounting of the bearing and wheel assembly, more specifically due to an under torque.

To prevent an improper wheel mounting, more specifically an under torque situation, a continuous rotation of the wheel shall be performed during tightening, loosening (until zero torque) and re-tightening of the axle nut to the prescribed torque value.

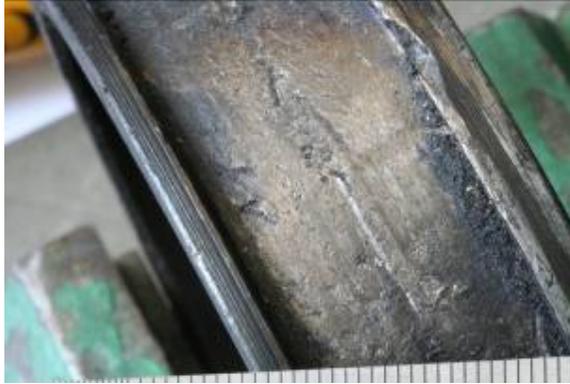
The inner race of the outboard bearing showed a dull appearance with several roller indentations (Figure 4).

Figure 4: Dull surface on the inner raceway of the outboard bearing.
Note the roller impressions indicating false Brinelling due to vibration.
