FINAL
KNKT.07.02.05.04

Aircraft Accident Investigation Report

**PT. Adam SkyConnection Airline (Adam Air)
Boeing 737-300 ; PK-KKV
Juanda Airport, Surabaya, East Java
Republic of Indonesia**

21 February 2007

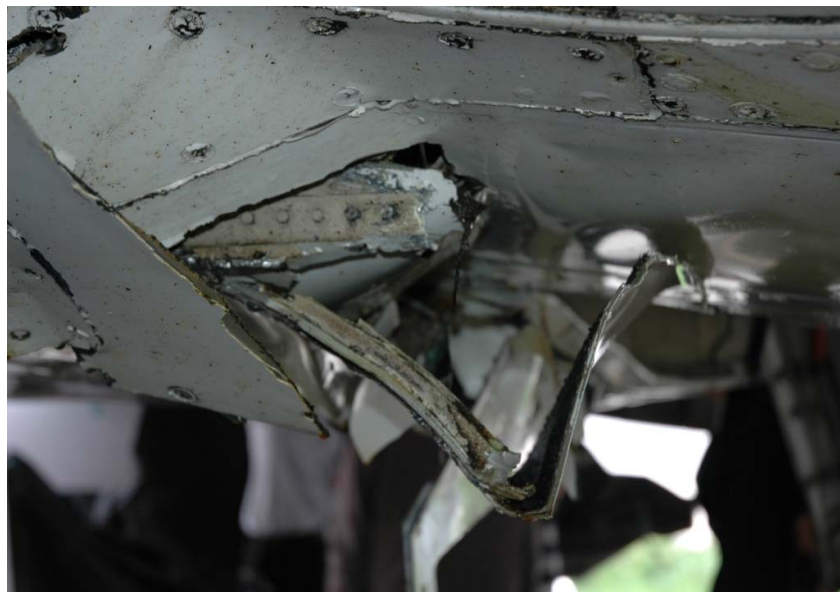
The keel beam of the lower fuselage in the wheel well area was damaged due to excessive bending moment and torsion load. The aft part of the keel beam was crushed and twisted counter clock wise, displaced about 15 cm. (Figure 3 and Figure 4)

Figure 3: The Keel beam was broken

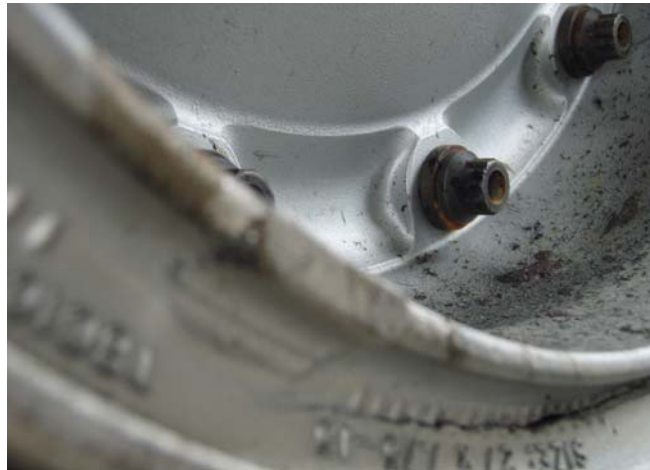
The right hand of the nose landing gear showed crack on wheel hub and damage on its bearing.

Figure 8: Wheel hub of the nose landing gear: crack

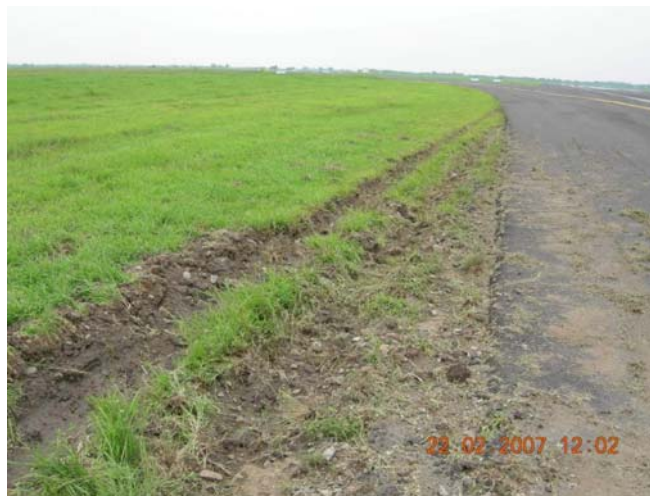
Figure 10: Tire marking

The right wheel track was found out of the runway for about 4 meter away and return to the runway. The aircraft stopped for about 100 meters from taxiway N3.

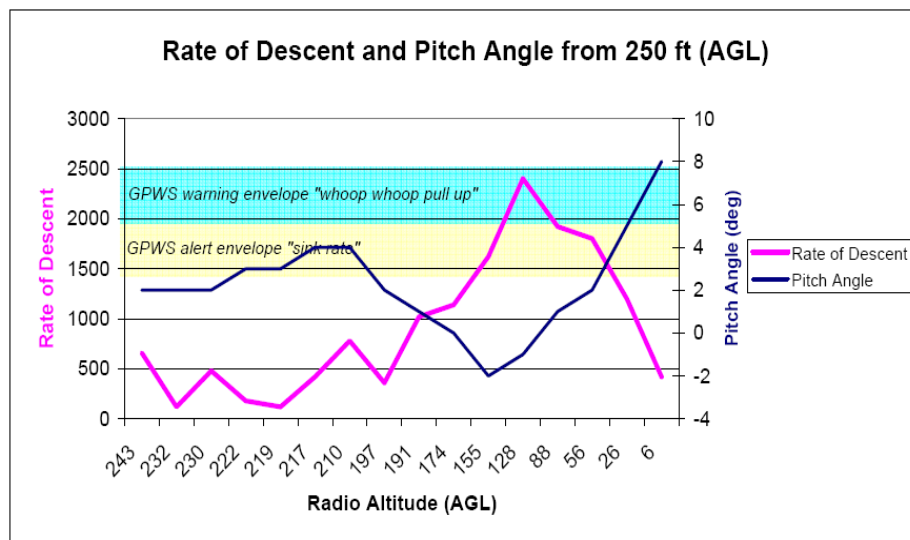
Figure 12: FDR graph of rate of descend and pitch angle below 250 feet

During the approach, PIC mentioned that the approach was too high twice, first when the aircraft altitude was 1000 feet, and 200 feet. At 500 feet, the GPWS alert of 'sink rate, sink rate' was recorded. This shown that the aircraft rate of descend was greater than 1500 feet. After the PIC reminded that the approach was too high at 200 feet, the PIC decided to take over the control.

After the PIC had the control of the aircraft, GPWS alert and warning of 'sink rate, sink rate' and 'whoop, whoop, pull up' was recorded in the CVR. The sink rate alert is triggered when the rate of descend was greater than 1500 feet/minute, while the warning 'whoop, whoop, pull up' is triggered when rate terrain closure is greater than 2500 feet/minute.

The FDR revealed that during this time, the pitch attitude was two degrees down and the rate of descend was greater than 2000 feet.
