# NATIONAL TRANSPORTATION SAFETY COMMITTEE

*Aircraft Accident Investigation Report*

**PT. Lion Mentari Airline (Lion Air)**

**Boeing 737-900ER**

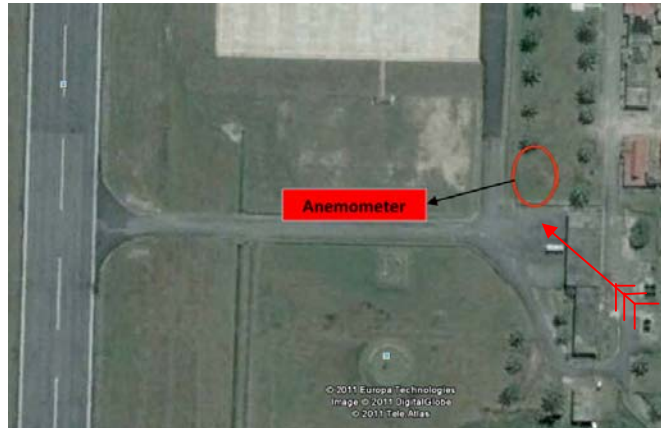
During the aircraft on final approach, the tower controller issued wind information based on the indication at wind indicator in tower. The wind indicator in tower source was from the anemometer which was surrounded by vegetation and building which may cause inaccuracy in the reading.

**Figure 1: Location of anemometer and the wind direction at the time of landing**

The discrepancy of the surface wind data might arise from the fact that the location of the anemometer was surrounded by vegetation and building which might generates turbulence that might cause reading inaccuracy. Based on this condition it can be concluded that the wind speed report from the Tower controller might be incorrect.

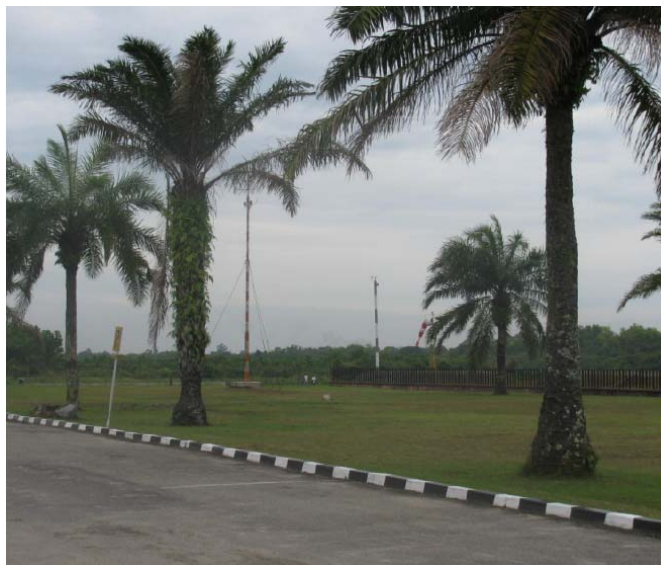
**Figure 2: location of anemometer for tower wind indicator**

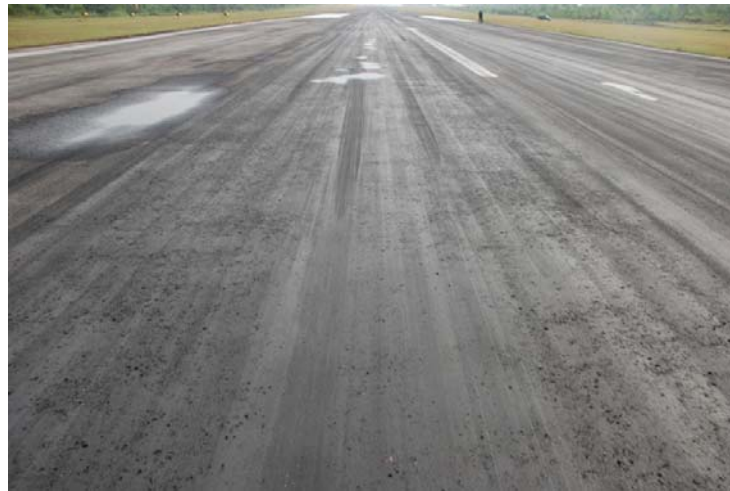
**Figure 3: Rubber deposit on the touchdown zone runway 18.**

The airport operator scheduled for rubber deposit removal on six month interval bases. The last runway rubber deposit removal was performed on 31 December 2010 on the end of runway 36 and the result was good. (Refer to letter number BAC.14.09.04/12/2010/330)

The last runway overlay was performed at 2010. After the overlay, the runway skid resistance was measured by Mu meter. The measurement found that the skid resistance was 0.55 to 0.59. According to the DGCA Advisory Circular number SE.04 issued in 2012, the minimum skid resistance was 0.6.

At the day of the serious incident, the rubber deposit was found on the runway especially between the thresholds up to touch down zone runway 18 (see figure 3).

Observation on the runway performed after the serious incident found rubber deposit on the runway especially between the thresholds up to touch down marker runway 18. The touchdown markers located at 1000 feet from the runway thresholds. The examination also found some water spots. The combination of the rubber deposit and water spots would significantly reduce both the runway friction and brake effectiveness.

1. The airport authority of Sultan Syarif Kasim II was revised the interval schedule for the rubber deposit cleaning. The previous cleaning schedule was 6 (six) months, the revised schedule became "*On Condition*", depends on the inspection result;
2. The airport authority of Sultan Syarif Kasim II was conducted some repair on runway surface to ensure the standing water will be eliminate;
3. The airport authority of Sultan Syarif Kasim II shall issue a notam<sup>2</sup> to inform that the runway skid resistance was 0.55 and was below the minimum requirements of 0.60. This condition may result in poor braking action when the runway is wet.

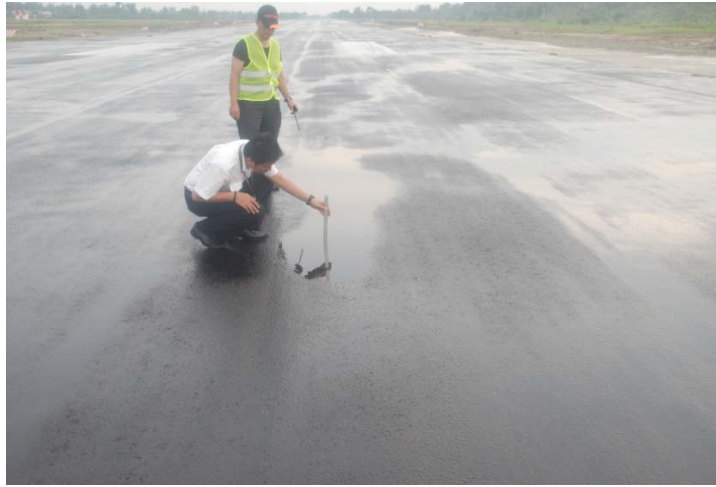
After the serious incident, the runway was examined for existing of standing water. It found several water spots on the runway up to 3 cm depth.

**Figure 4: standing water examination performed 1 hour after rain.**

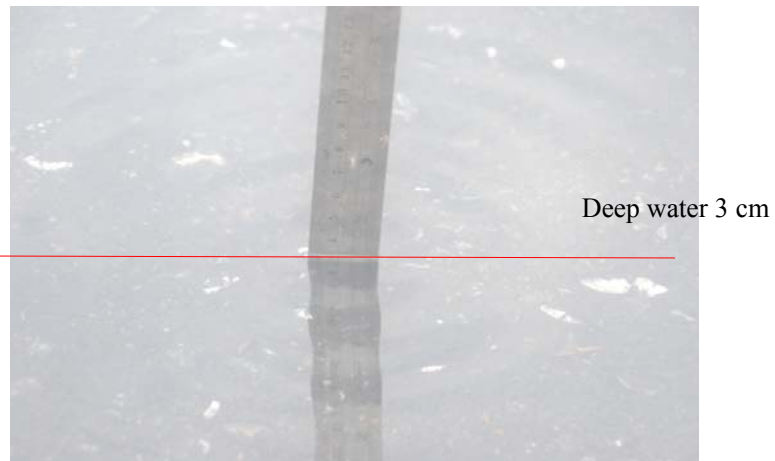
**Figure 5: standing water up to 3 cm**

- k) The runway examination found rubber deposit and water spots up to 3 cm depth on the runway along 1000 feet to the end of runway 36.
- l) The combination of the rubber deposit and water spots would significantly reduce both the runway friction and brake effectiveness.

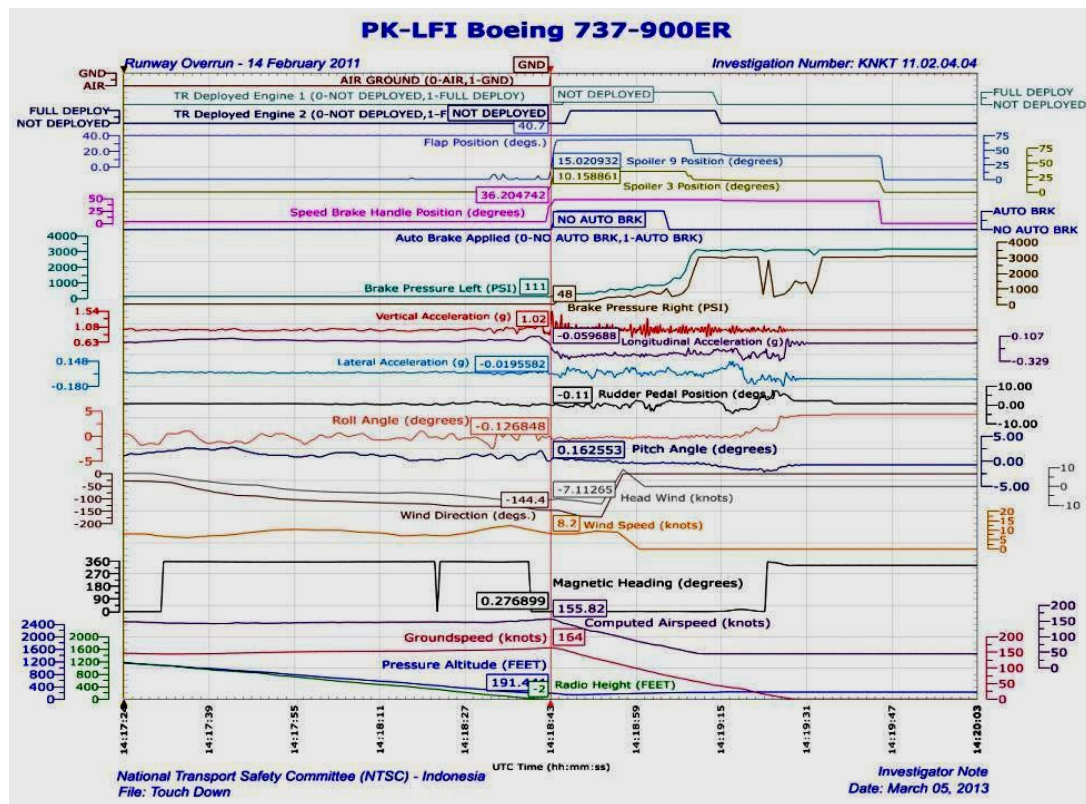
Figure 6: FDR data with special information during touch down

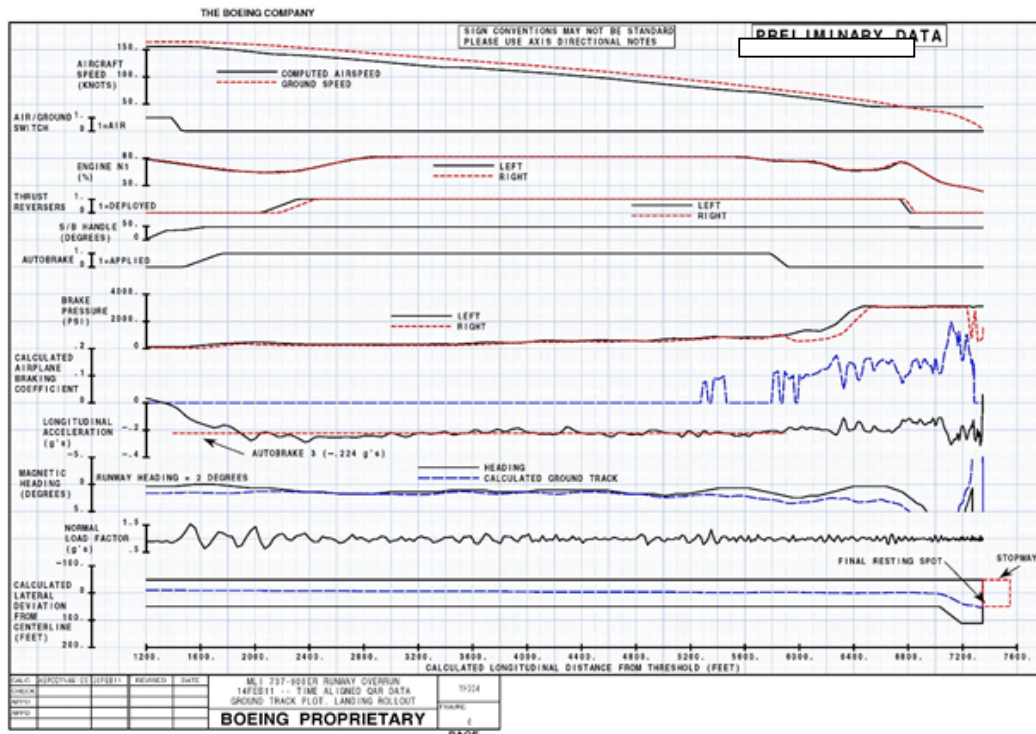
Figure 7: Boeing data on the landing roll phase retrieved from the DFDAU

to maximum; however, the rate of deceleration was decreasing. Boeing data retrieved from the DFDAU also found that Calculated Airplane Braking Coefficient was decreasing to average of -1.5. This indicated that the runway friction, which was one of the factors of stopping distance, was ineffective for aircraft deceleration.

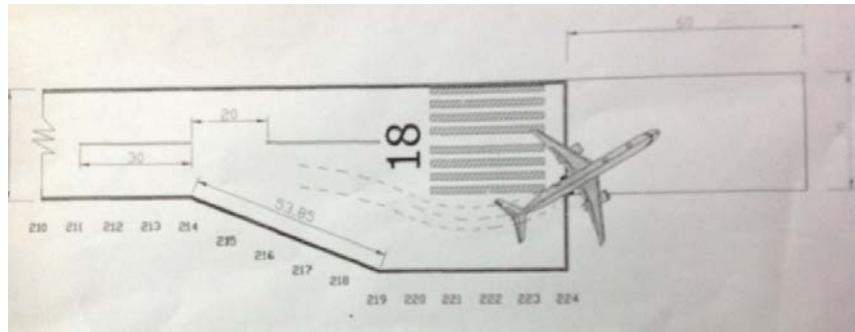
The investigation found several marks on the runway after the serious incident. The illustration below is based on the marks found on the runway.

Figure 8: Illustration on the last part of aircraft movement.

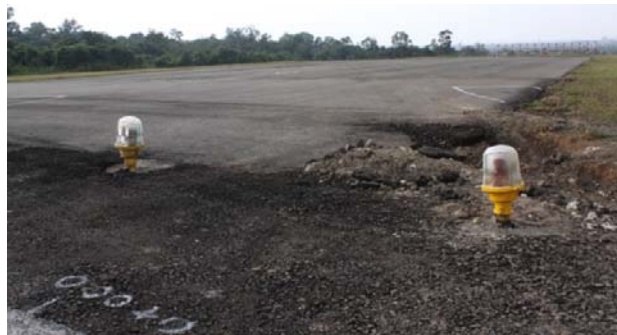
Figure 9: Final aircraft position after the aircraft has been removed
