**NATIONAL
TRANSPORTATION
SAFETY
COMMITTEE**

Aircraft Serious Incident Investigation Report

AIRBUS A320-321

PK-YVE

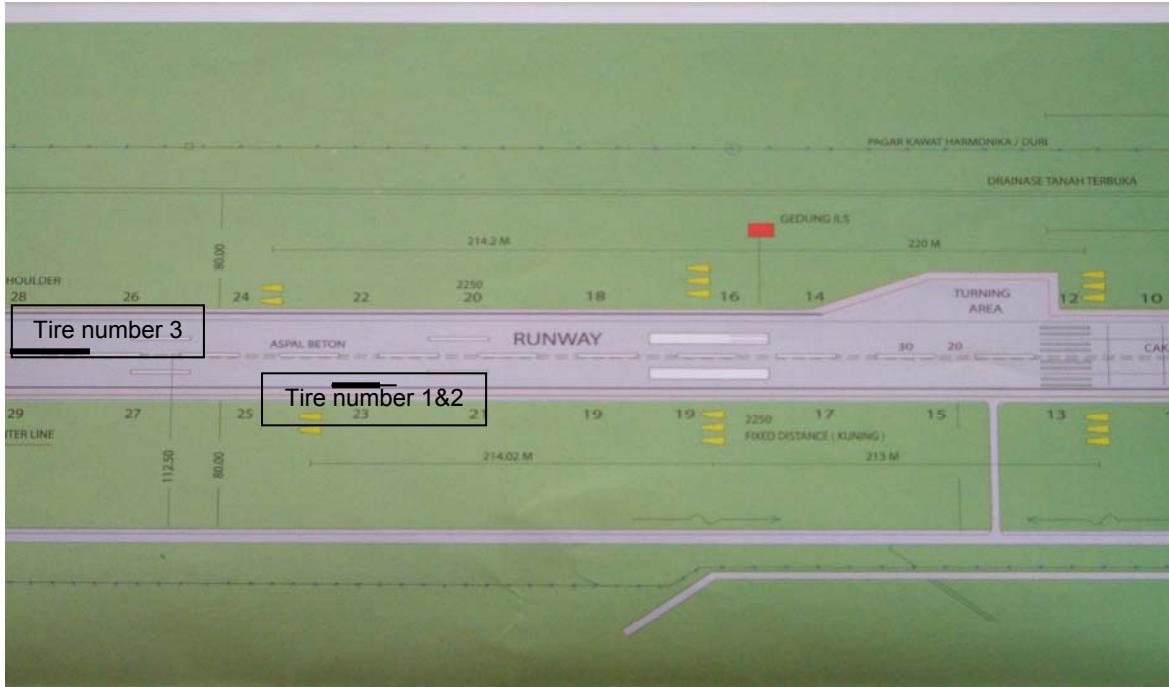
In the touch-down area, tire marks for PK-YVE were only clear for wheels 1 and 2. (Figure 2 and Figure 3).

Figure 2: Touch down tire marks on touch down area

The short distance of the tire marks for wheel numbers 1 and 2 indicated that the aircraft bounced, because the next evidence of tire marks was the tire marks for tire 3, approximately 200 meters beyond the initial touch-down marks for tires 1 and 2. This evidence showed that it was likely that the aircraft touched down with the left main landing gear, approximately at the departure end of the touch-down area. The aircraft then bounced and the right landing gear touched the runway followed shortly after by the left wheels contacting the runway again.

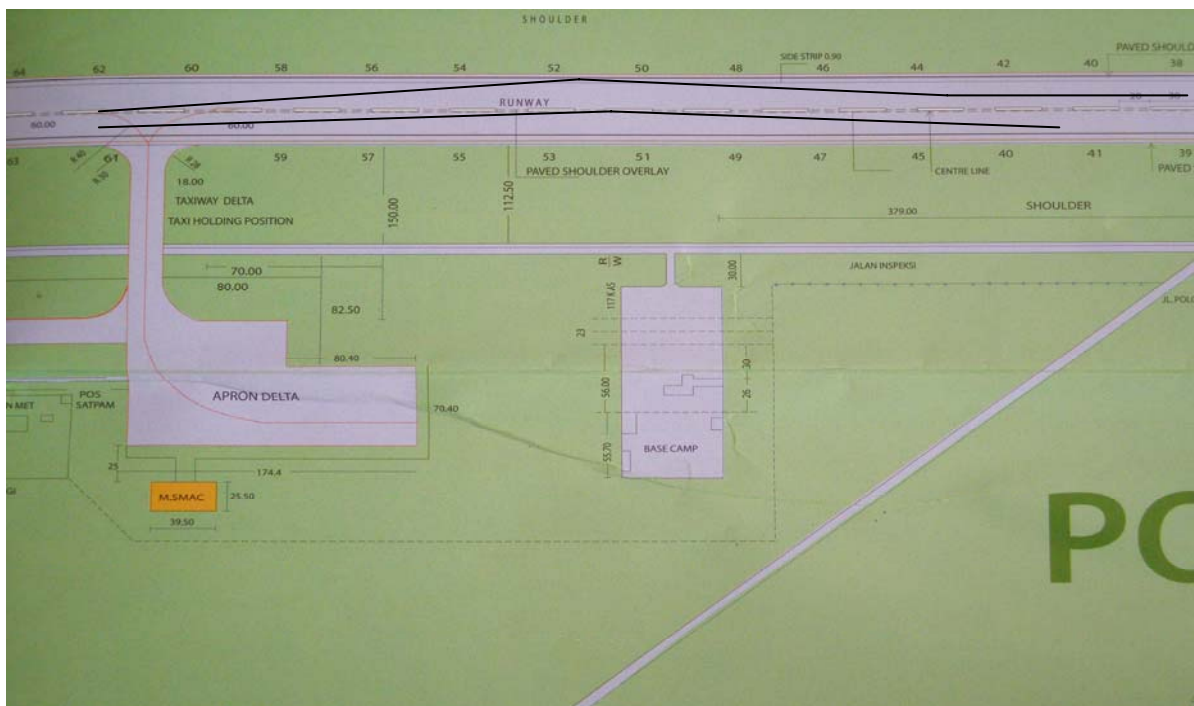
Figure 3: Rolling tire marks on runway up to final stop at adjacent to taxi way D

These marks were heavy and provided a continuous track of the aircraft along the runway to a position adjacent to taxiway D. There was evidence that the direction of those marks tracked initially right of centerline and then veered to the left of centerline. (See figures 3, 4, 5, 6, 7).

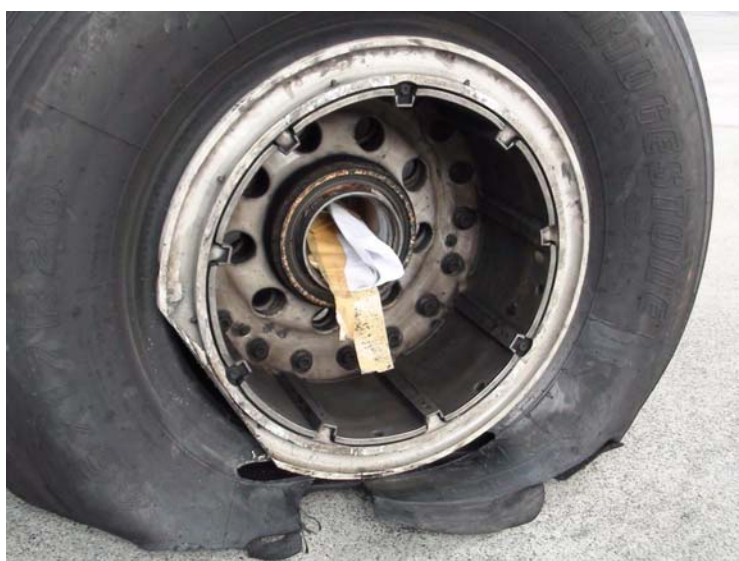
Tire numbers³ 1, 2 and 3 were substantially damaged and wheel numbers 1 and 2 were also substantially damaged.

Figure 4: Wheel number 1

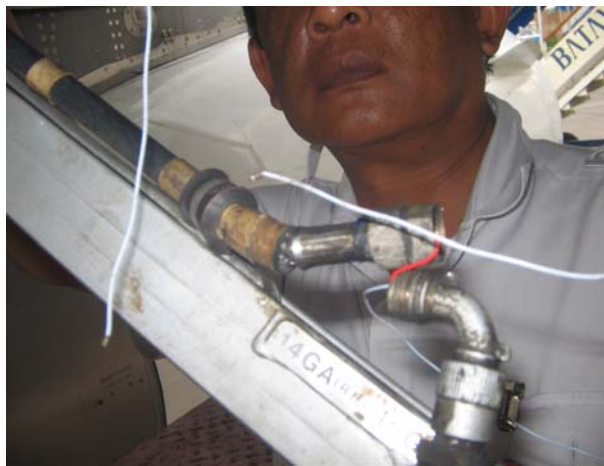
The left landing gear down-lock cable had been broken since the previous landing. The cable was shorter than the original cable. The cable may have been shortened during previous maintenance to change the proximity switch, effectively creating tension on the cable during landing gear extension and retraction cycles.

Figure 5: Broken left landing gear down lock cable

The investigation found that the left landing gear down-lock cable was broken. The aircraft touched down with the wheel brakes locked due to a hydraulic lock in the system, which was the result of an incorrect manual landing gear extension procedure being used by the pilots. All other landing gear systems were found to be normal.

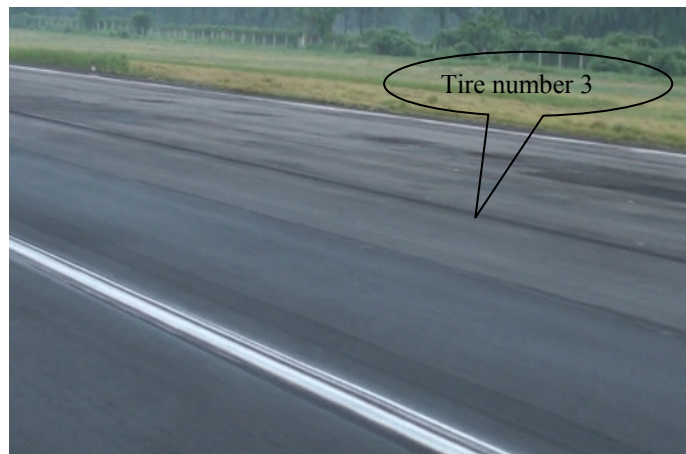
Figure 8: Tire number 3 mark

Tire marks on the runway indicated that wheels 1, 2, and 3 did not rotate during the landing. Other supporting evidence of wheels not rotating was the pattern of the damaged wheels and tires. (See figures 8 and 9). Wheel number 4 was not damaged and there were no distinctive tire marks on the runway from tire number 4. This indicated that wheel 4 was rotating during the landing roll. .

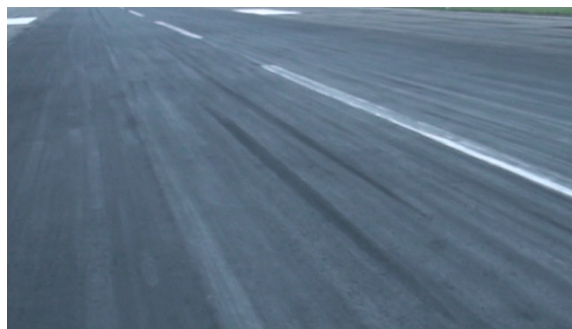
Figure 9: Touch down number 1 and number 2 tire marks
